APPLICATION FOR PERMIT
TYPE I MUNICIPAL SOLID WASTE FACILITY
MSW PERMIT NO. 2374
PESCADITO ENVIRONMENTAL
RESOURCE CENTER
RANCHO VIEJO WASTE MANAGEMENT, LLC
SOLID WASTE DISPOSAL FACILITY
LAREDO, WEBB COUNTY, TEXAS

March 28, 2011
Revised September 14, 2011

**Reference: Pescadito Environmental Resource Center – Webb County
Municipal Solid Waste (MSW) – Proposed Permit No. 2374
Response to First Notice of Deficiency (NOD)
Tracking No. 14710139; CN603835489/RN106119639**

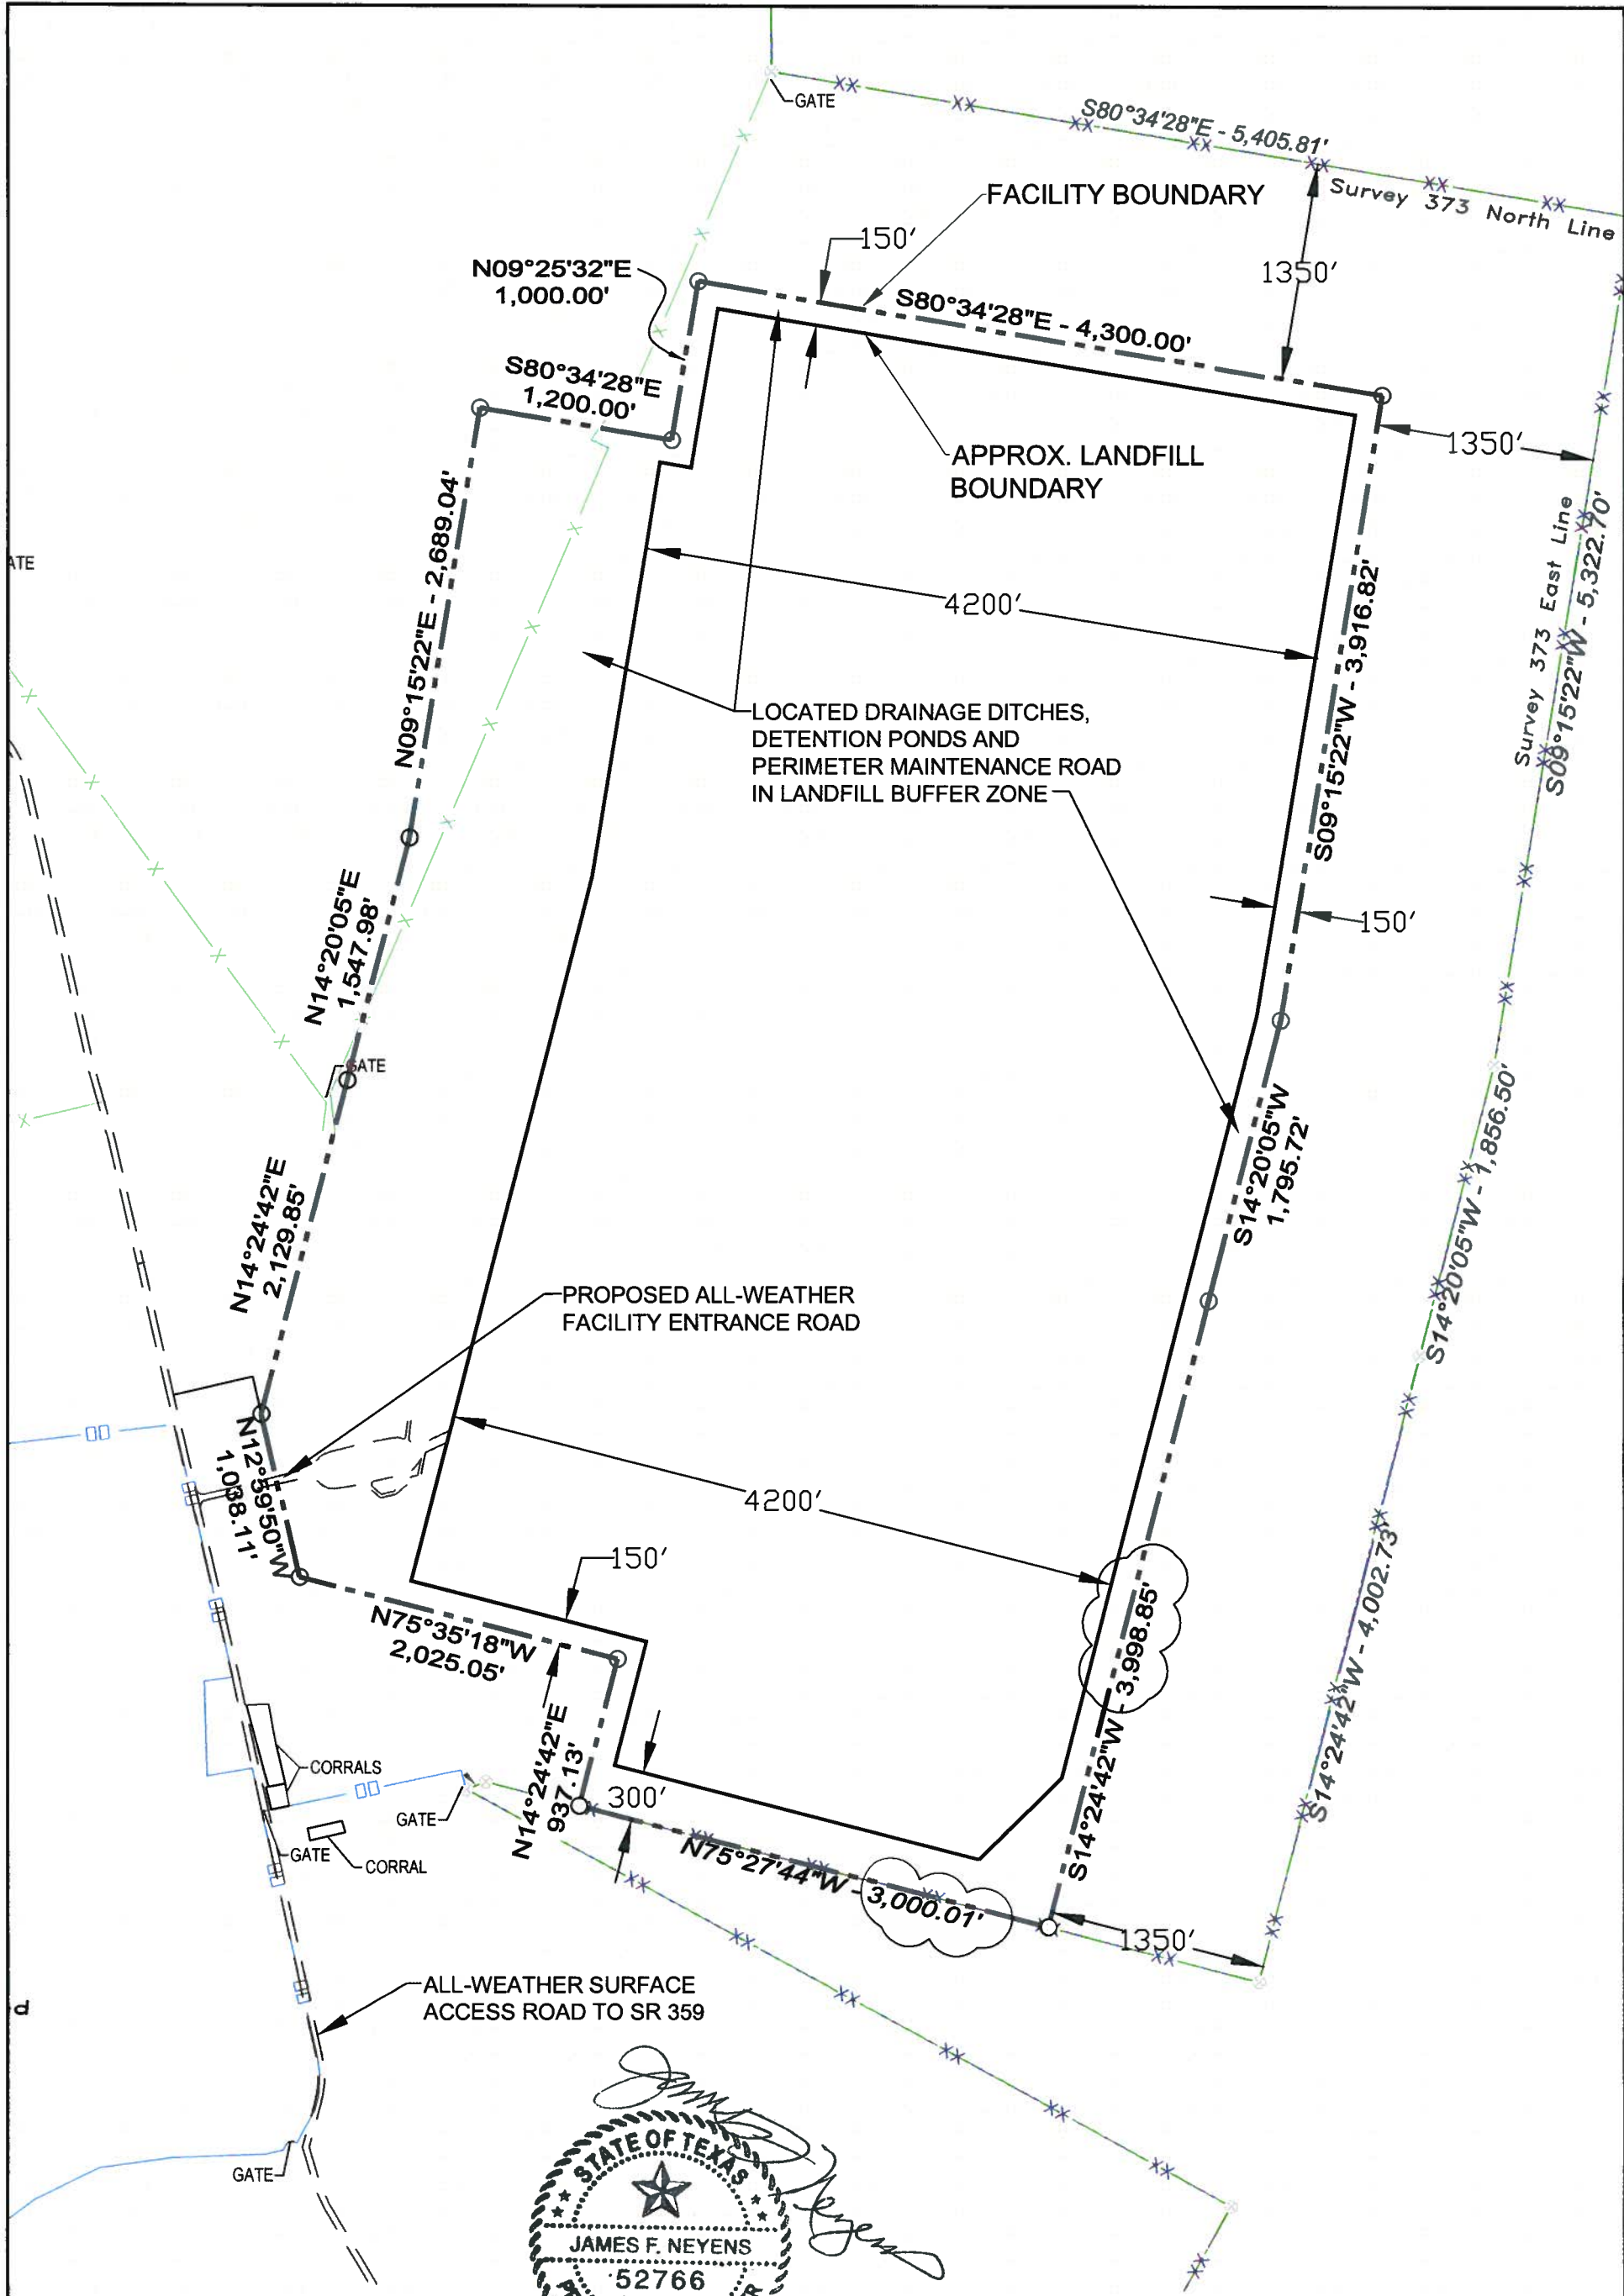
- LEGEND**
- FACILITY BOUNDARY LINE
 - APPROXIMATE LANDFILL LIMIT
 - x-x- FENCE
 - xx- PROPERTY LINE AND FENCE
 - o-o- 8' HOG FENCE

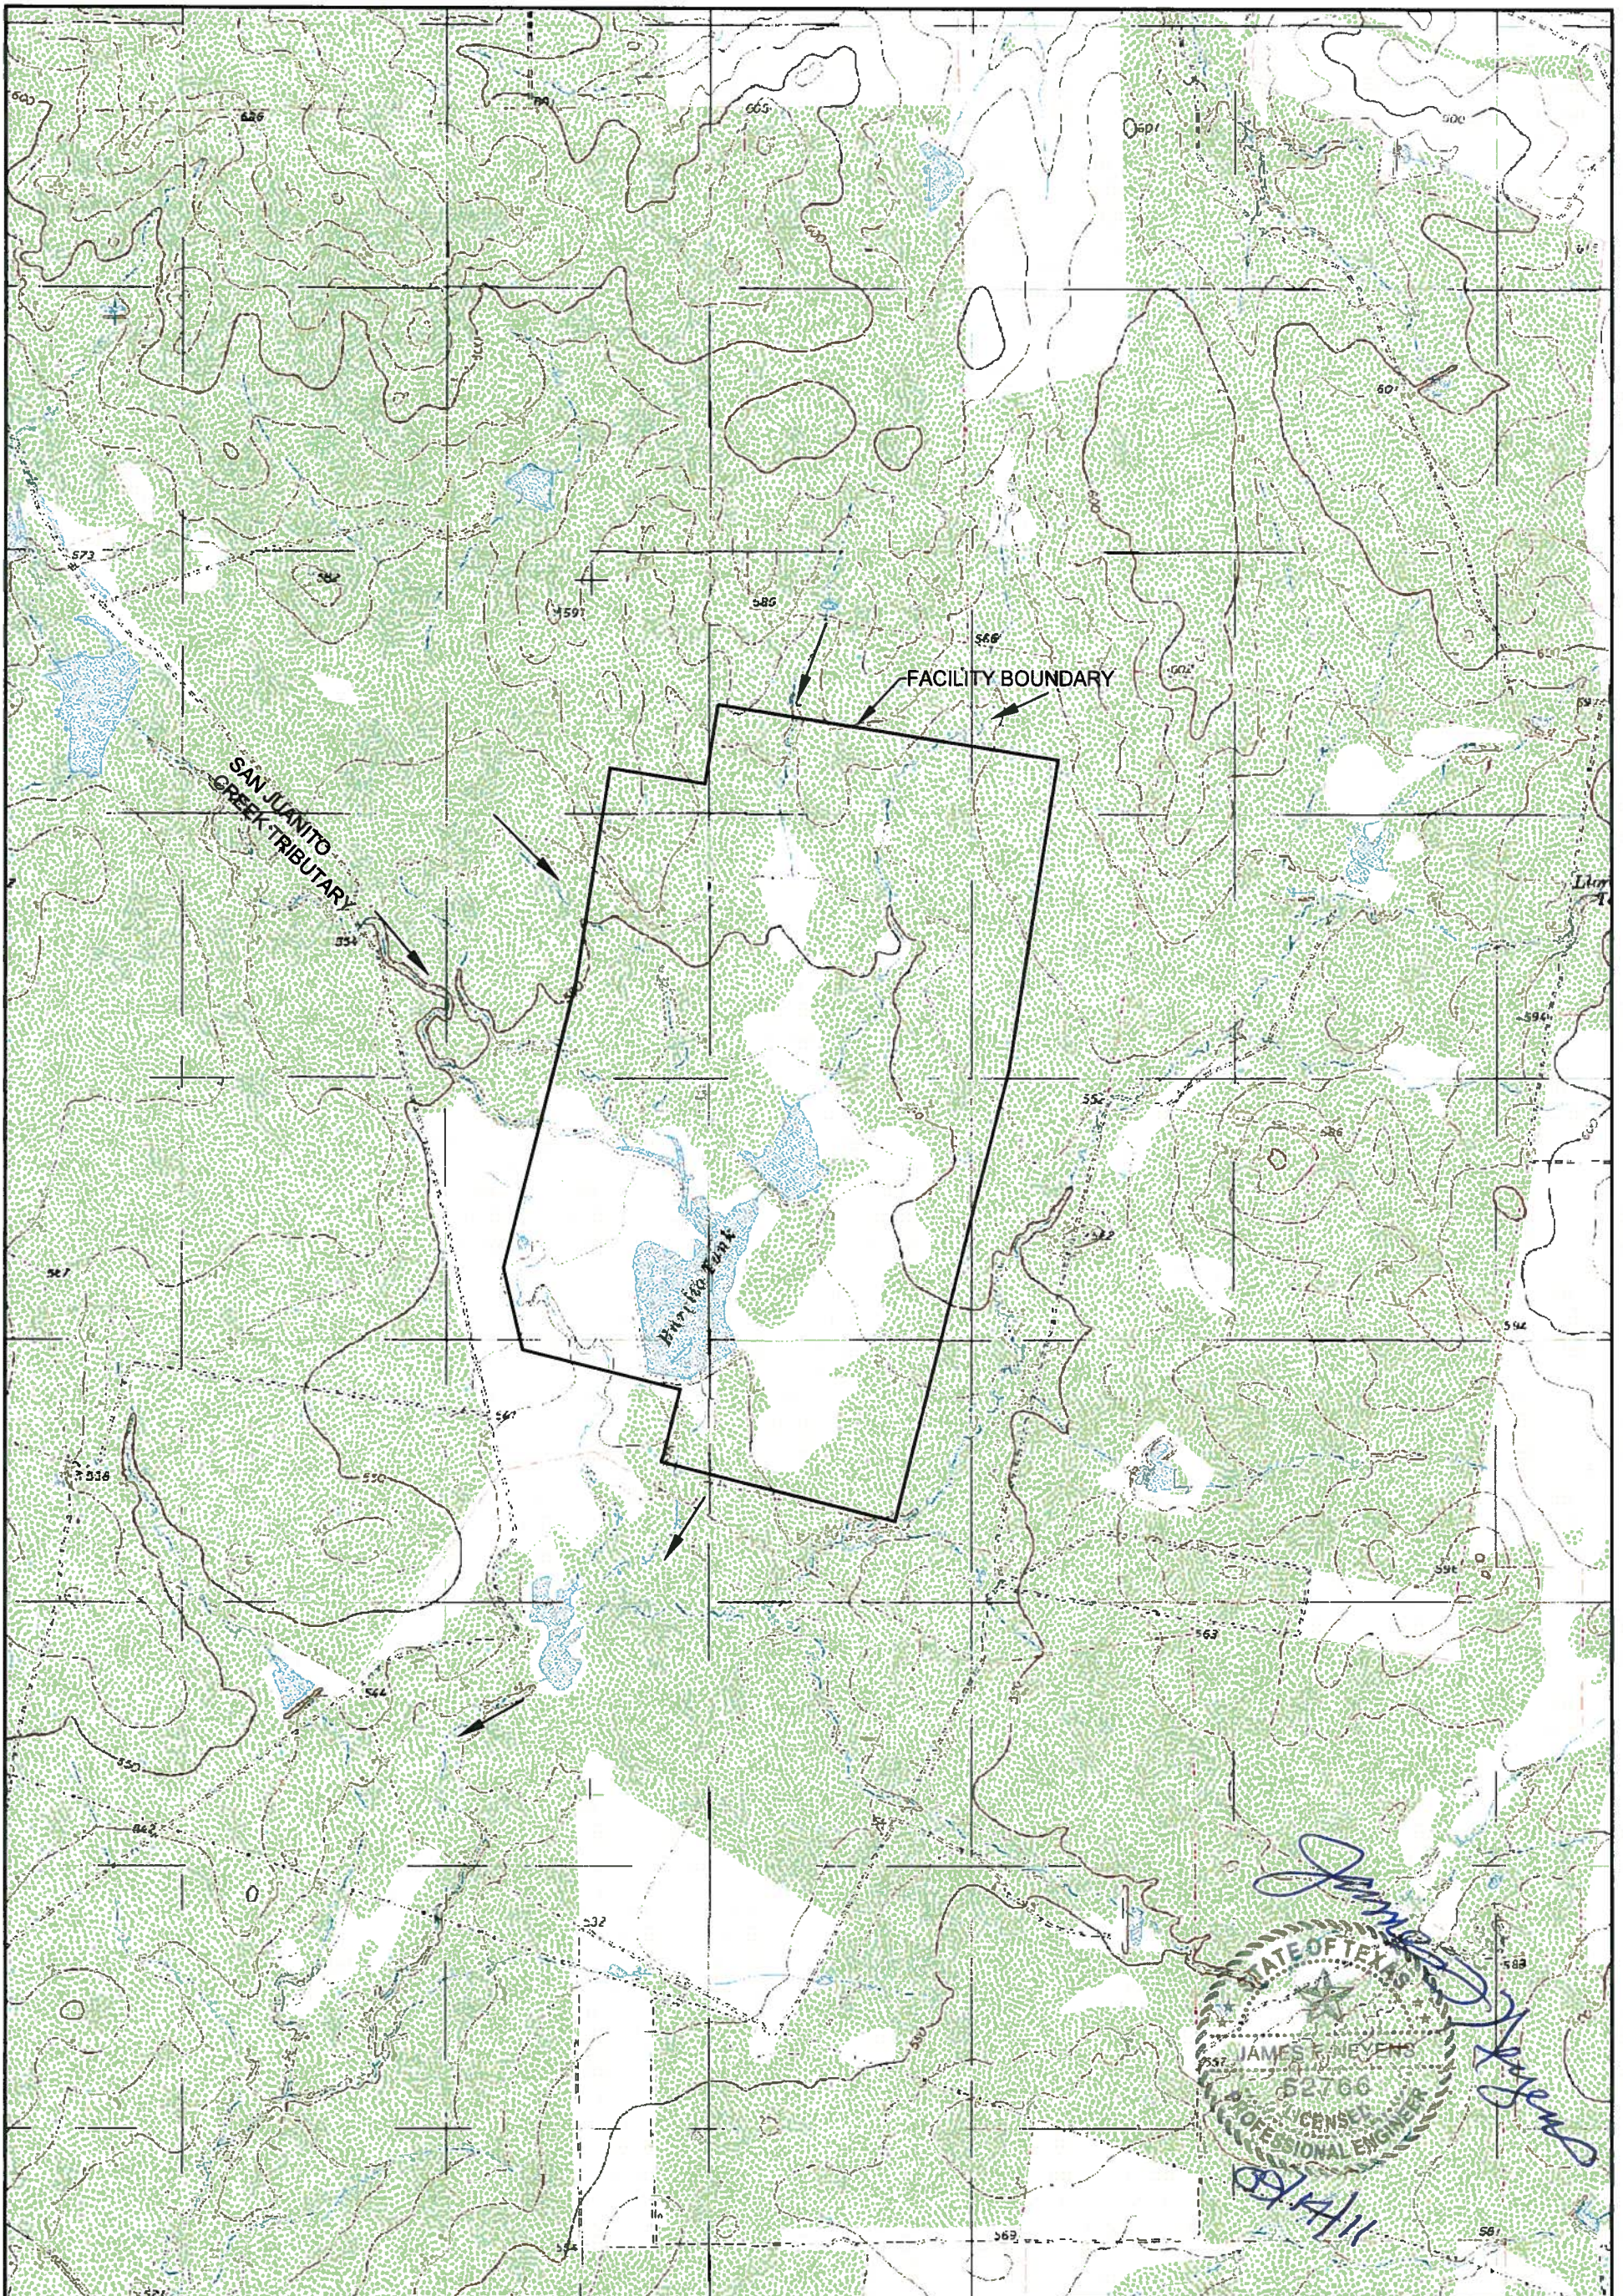
NOTES:
 1. FLOW DIRECTION INDICATED BY ARROWS.
 2. NO NAMED STREAMS SHOWN ON MAP.

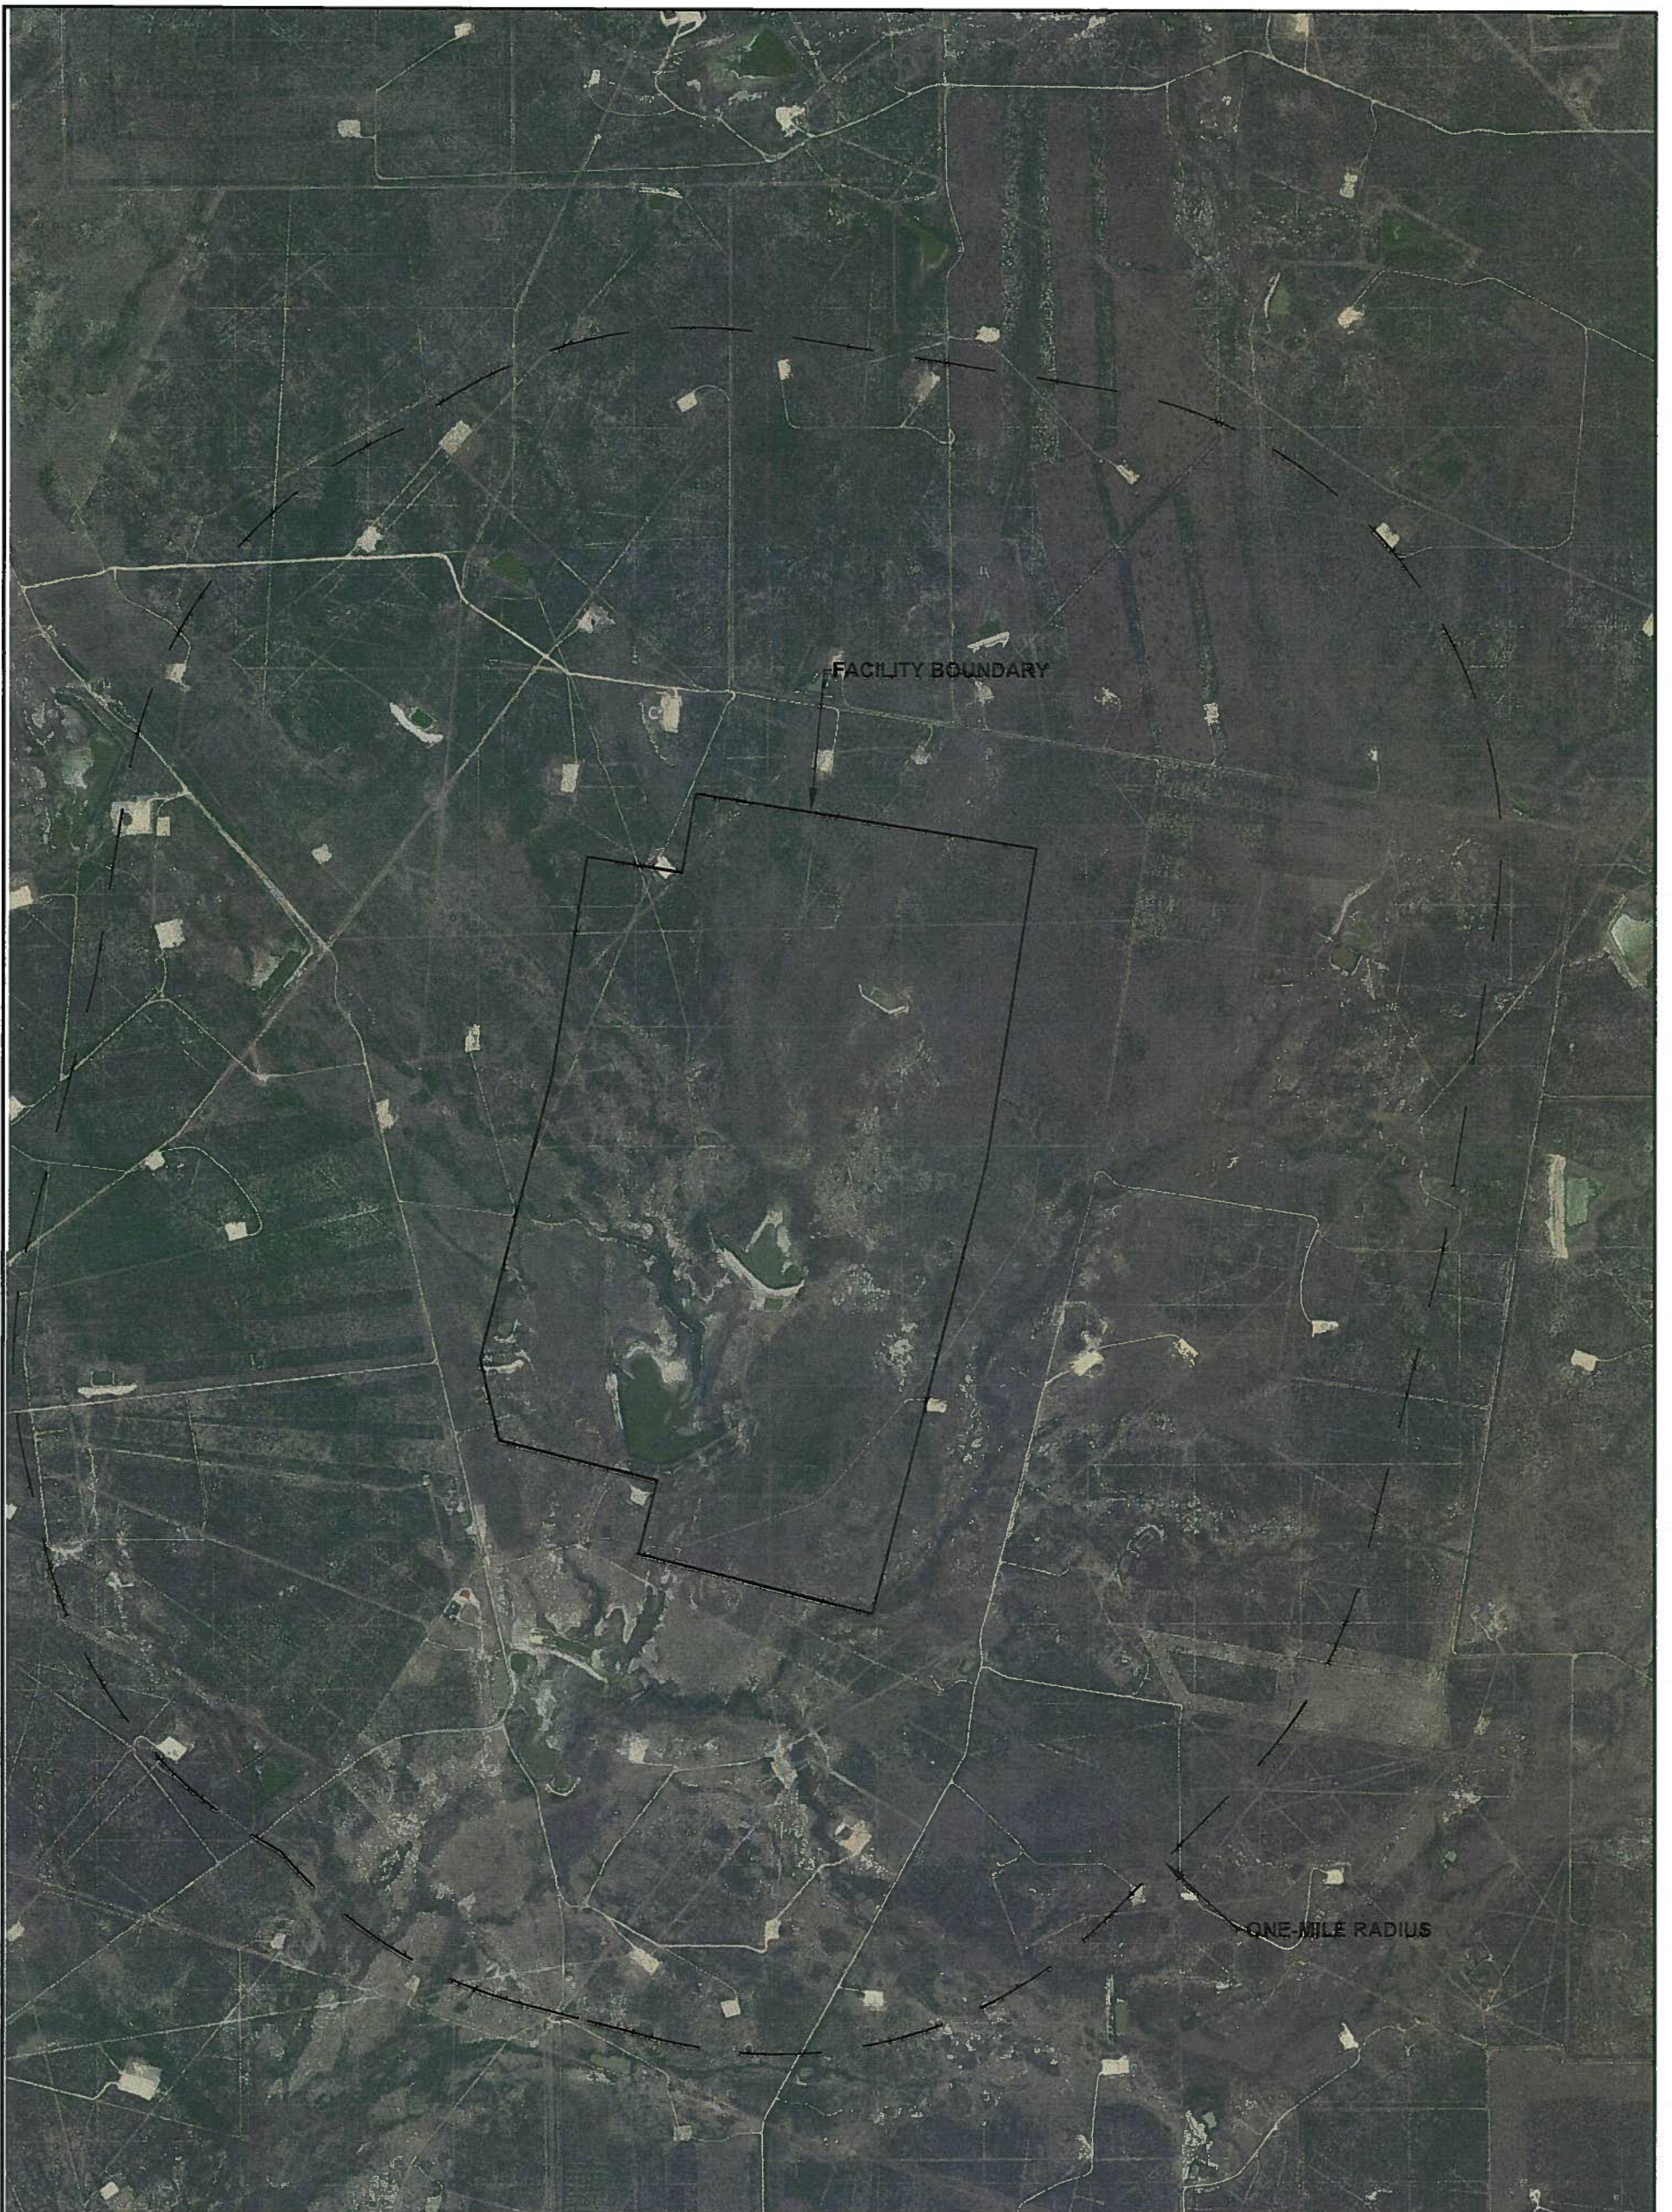
505 EAST HUNTLAND DRIVE SUITE 250 AUSTIN, TEXAS 78752 (512) 329-6080			FIGURE 7 PART II PAGE XX

An aerial photograph of the required size and scale is provided as Figure 7, Part II. The facility boundary is marked and an area within at least a one-mile radius beyond that boundary is shown. The scale of the aerial photograph is one inch equals 2,000 feet, which is within the required range. This photo shows the facility (or site) boundaries and the area within a one-mile radius of the boundary. No actual fill areas exist, so none can be shown or marked. There has been no growth for many years in the area covered by the aerial photograph, so a series of photographs to show growth trends is not needed because there are no growth trends to show.

Air Mode - The two nearby houses and one mobile home in the facility area are located to the southwest of the landfill, as shown on the Aerial Photograph, Figure 7. The prevailing wind direction, as shown by the Wind Rose in Figure 2, is not in this direction. In fact, Figure 2 shows that wind blows from the facility towards these two residences only about 5 percent of the time. The three factors of low incidence of wind blowing towards these residences, lack of etiological agents or vectors, and the separation distance of over 2,100 feet, combine to produce a negligible chance of adverse health effects to these residents due to the facility.

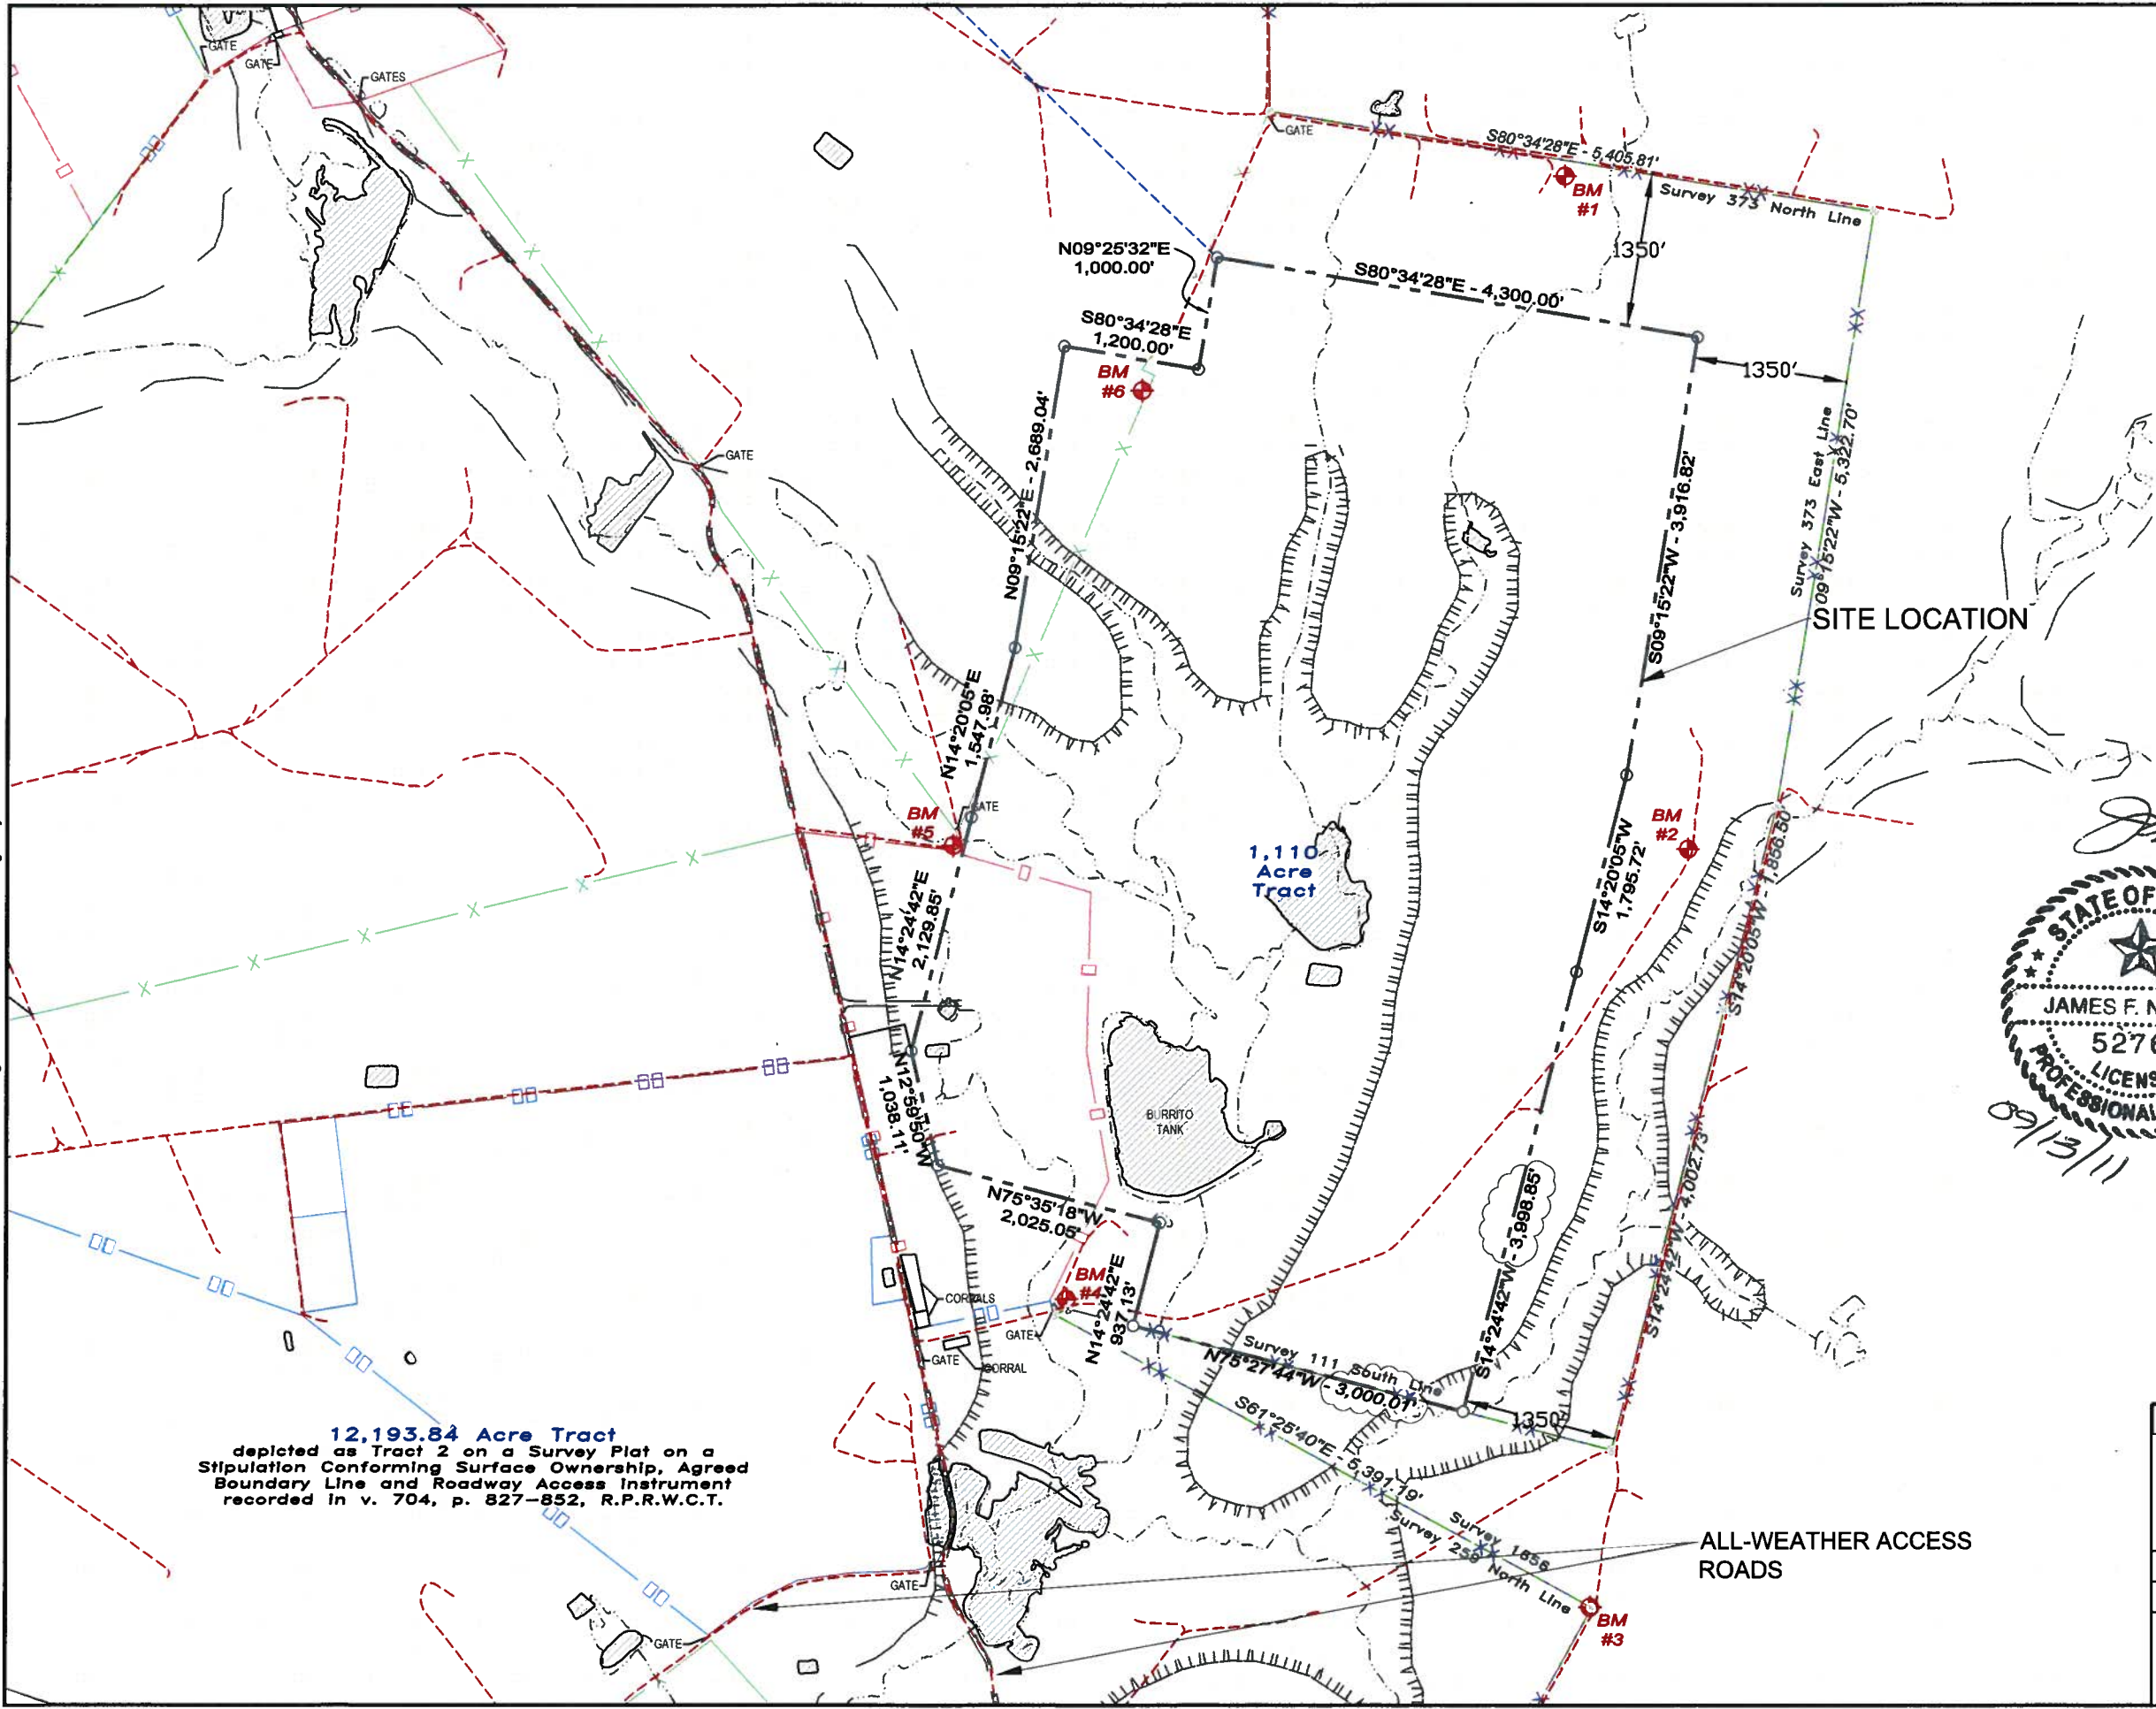
- NOTES:**
- SOURCE: BOUNDARY AND IMPROVEMENT SURVEY, MEJIA ENGINEERING COMPANY (8/15/2011).
 - BY GRAPHICAL PLOTTING ONLY, PARTS OF THIS TRACT ARE LOCATED WITHIN ZONE A AS DEFINED BY THE FEMA FLOOD INSURANCE RATE MAP, COMMUNITY PANEL NO. 48479C1275C WITH AN EFFECTIVE DATE OF APRIL 2, 2008.
 - TRC ENVIRONMENTAL CORP. TBPE FIRM F-3775.

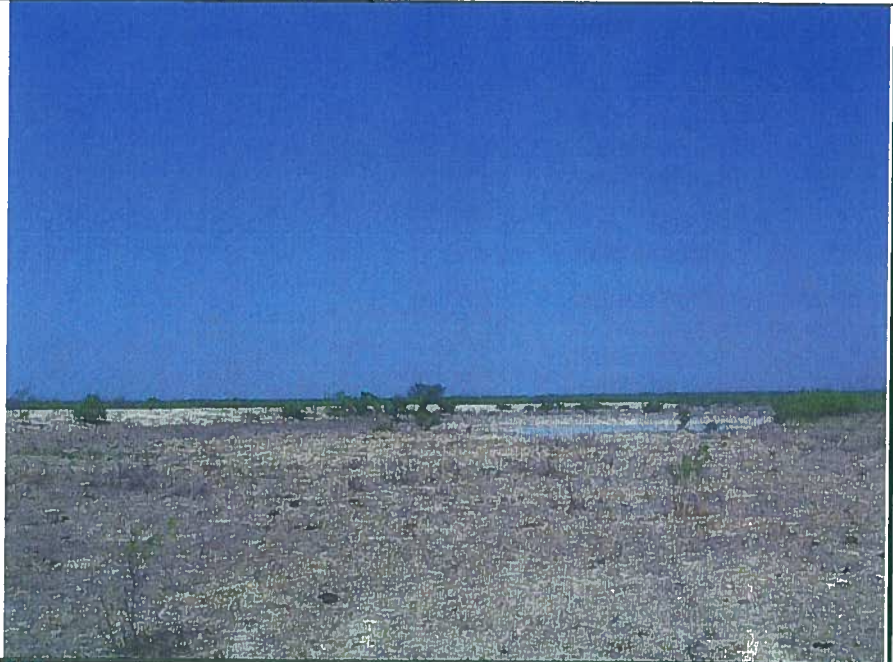
Feature: Stock Tank WB101		
Date: 4/19/2011		
Comments: Stock tank WB101 in northeastern portion of project area. Facing north.		
Photograph ID: 2

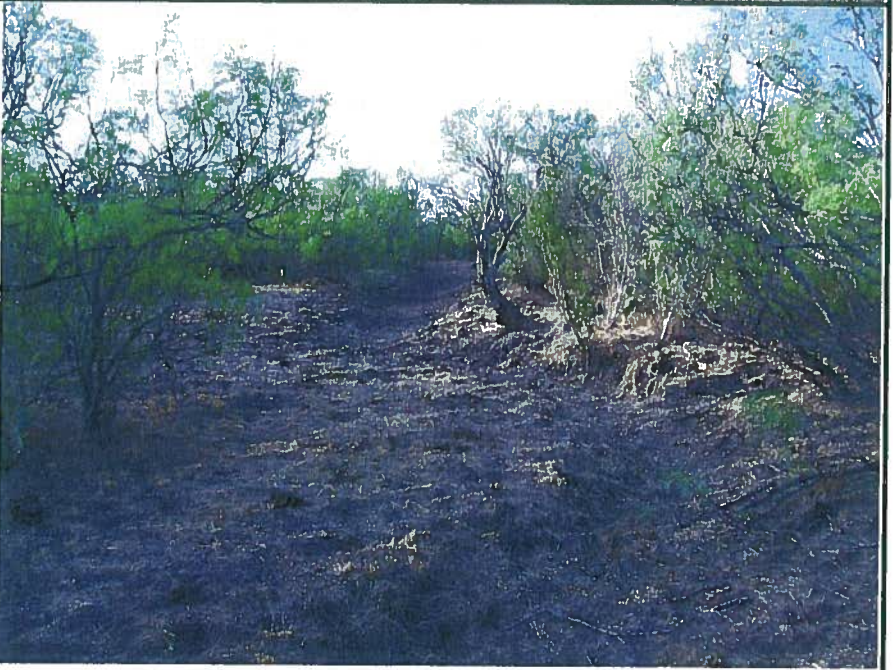
Feature: Stream S123		
Date: 4/21/2011		
Comments: Ephemeral stream S123 in northwestern portion of project area. Facing downstream (south).

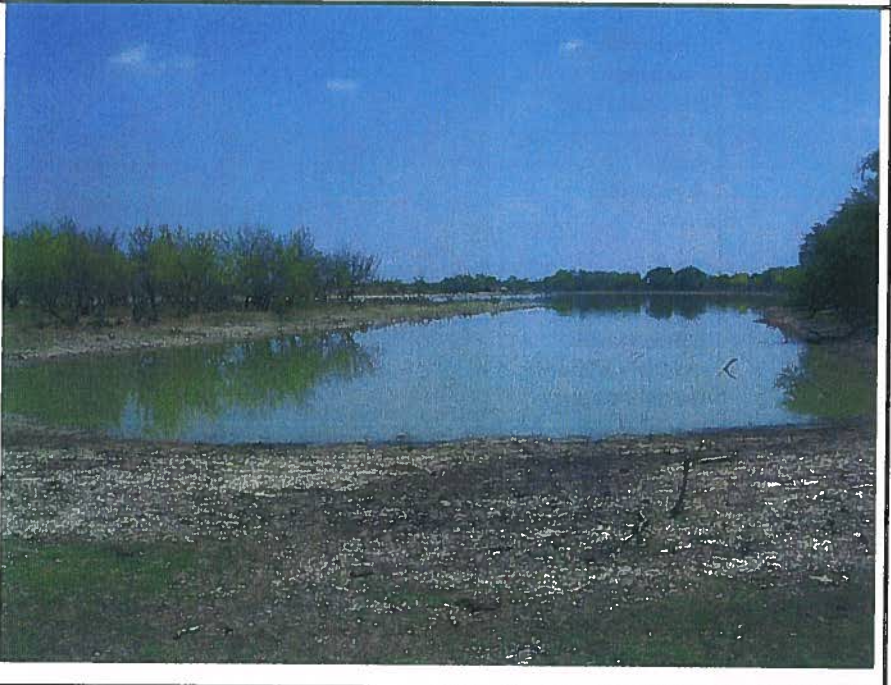
Feature: Stock Tank WB104	
Date: 4/19/2011	
Comments: Large stock tank in central portion of project area. Facing south.

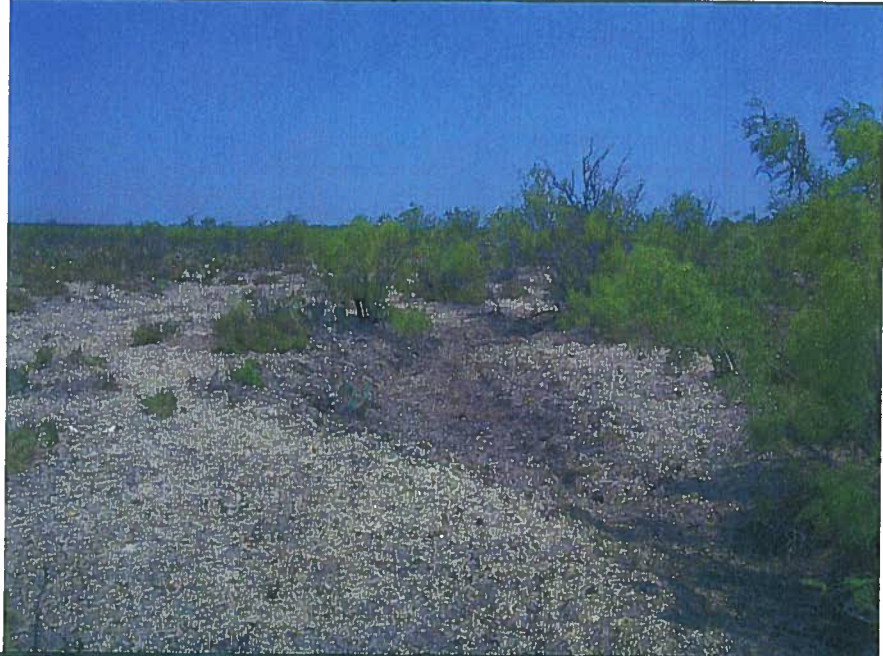
Feature: Stream S103		
Date: 4/19/2011		
Comments: Ephemeral stream S103 in central portion of the project area. Facing north (upstream).		
Photograph ID: 6

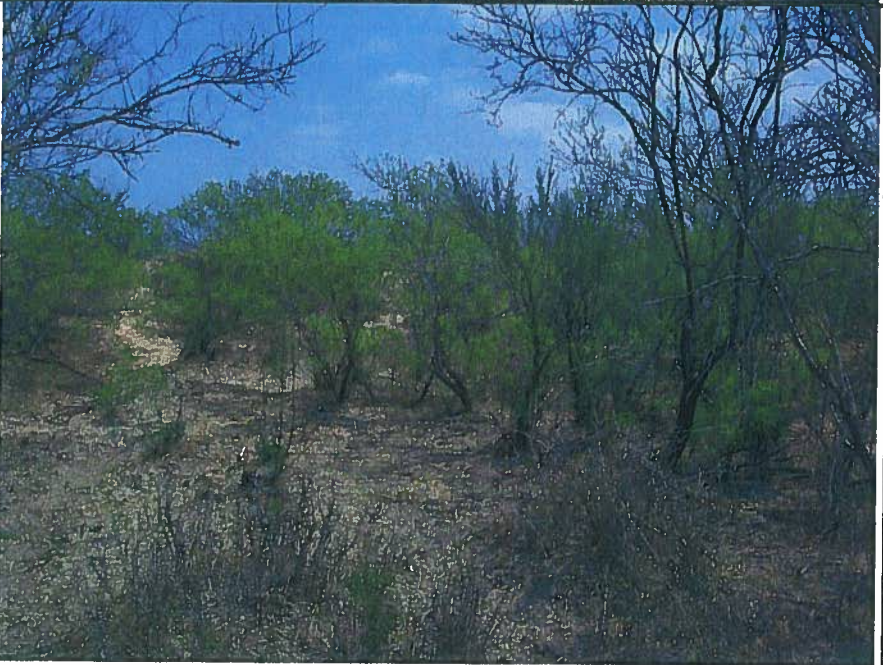
Feature: Stream S120		
Date: 4/20/2011		
Comments: Ephemeral stream S120 (left of photo) in west-central portion of project area. Facing east (downstream).

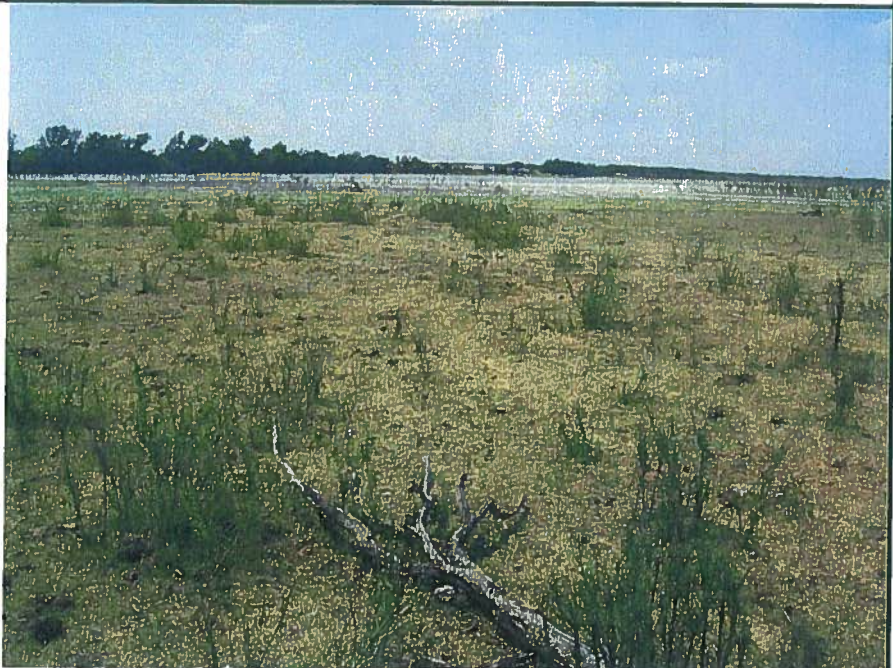
Feature: Wetland and Stock Tank WB128			
Date: 4/21/2011			
Comments: Fringe area of wetland W127 near large stock tank in southern portion of project area. Stock tank in background. Facing southwest.

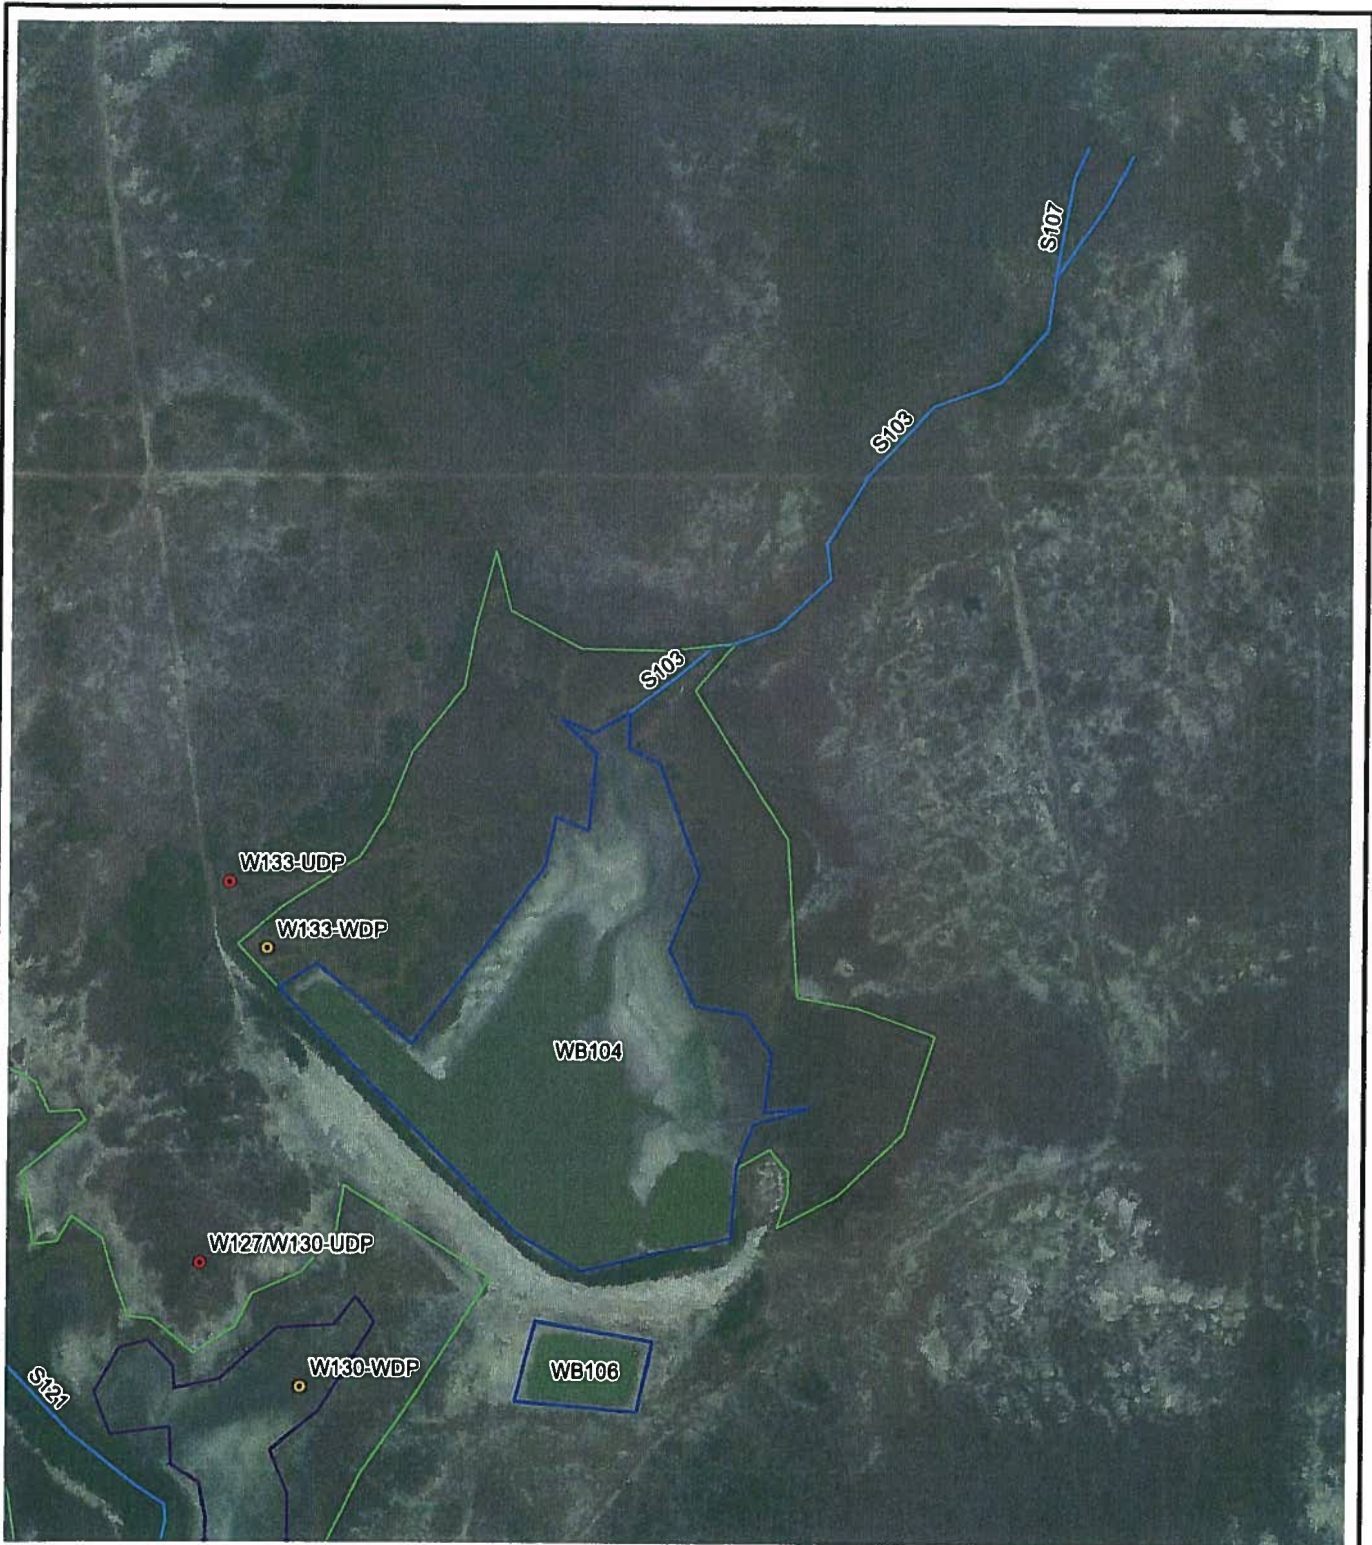
FIGURE
A-3

- Survey Area
- Streams
- Stock Tanks
- Palustrine Emergent (PEM) Wetland Boundary
- Palustrine Scrub Shrub (PSS) Wetland Boundary
- Wetland Data Point (WDP)
- Upland Data Point (UDP)

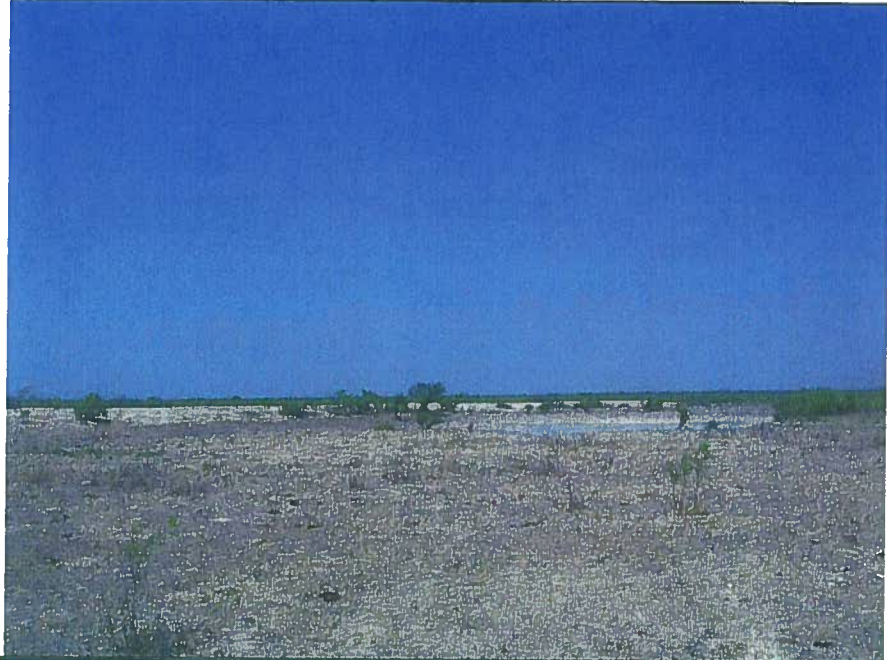
Feature: Stock Tank WB101		
Date: 4/19/2011		
Comments: Stock tank WB101. Facing north.		
Photograph ID: 2

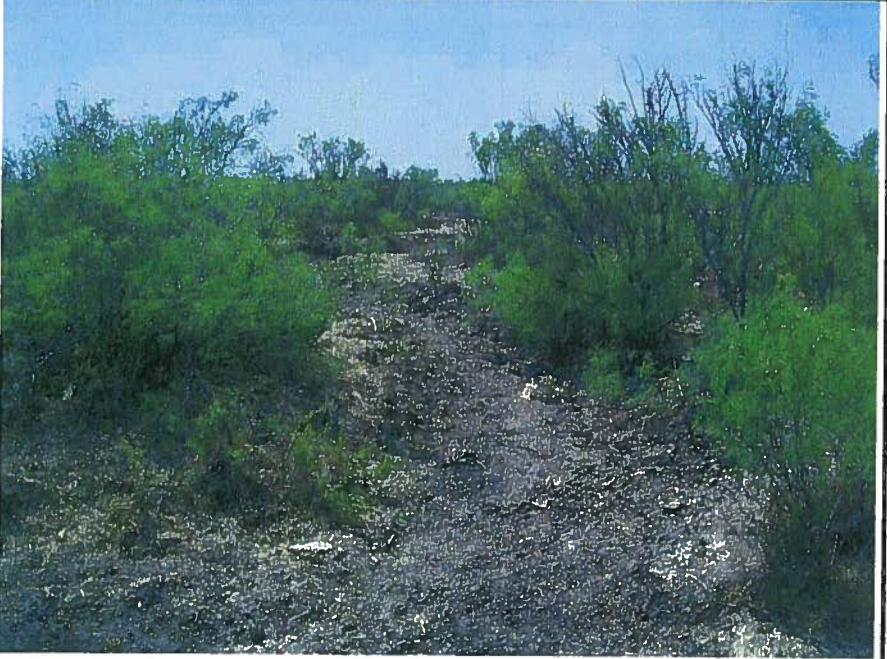
Feature: Stream S103		
Date: 4/19/2011		
Comments: Ephemeral stream S103. Facing south (downstream).
