APPLICATION FOR PERMIT
TYPE I MUNICIPAL SOLID WASTE FACILITY
MSW PERMIT NO. 2374
PESCADITO ENVIRONMENTAL
RESOURCE CENTER
RANCHO VIEJO WASTE MANAGEMENT, LLC
SOLID WASTE DISPOSAL FACILITY
LAREDO, WEBB COUNTY, TEXAS

March 28, 2011
Revised September 14, 2011

**Reference: Pescadito Environmental Resource Center – Webb County
Municipal Solid Waste (MSW) – Proposed Permit No. 2374
Response to First Notice of Deficiency (NOD)
Tracking No. 14710139; CN603835489/RN106119639**

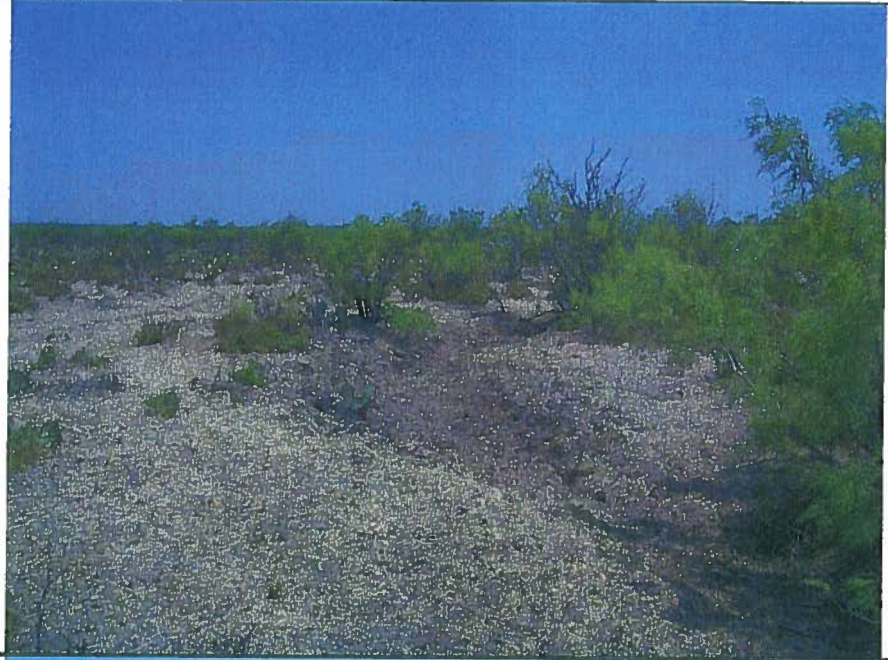
Client: Rancho Viejo Waste Management, LLC		Project Number: 182277	
Project Name: Pescadito Environmental Resource Center		County, State: Webb County, Texas	
Photograph ID: 3

Feature: Stream S103			
Date: 4/19/2011			
Comments: Ephemeral stream S103. Facing north (upstream).			
Photograph ID: 4

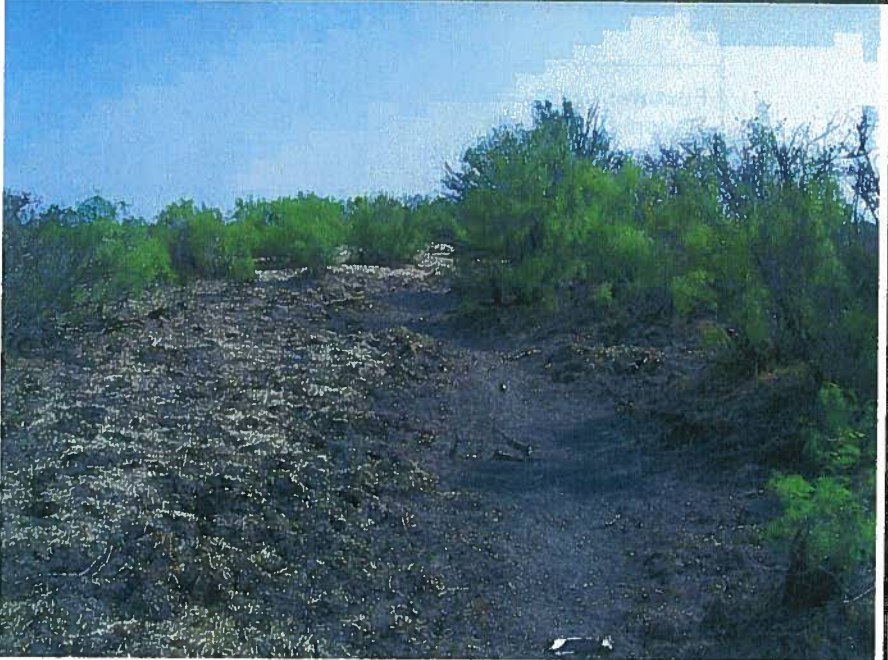
Feature: Ephemeral stream S107			
Date: 4/19/2011			
Comments: Ephemeral stream S107, a short tributary of S103. Facing north (upstream).

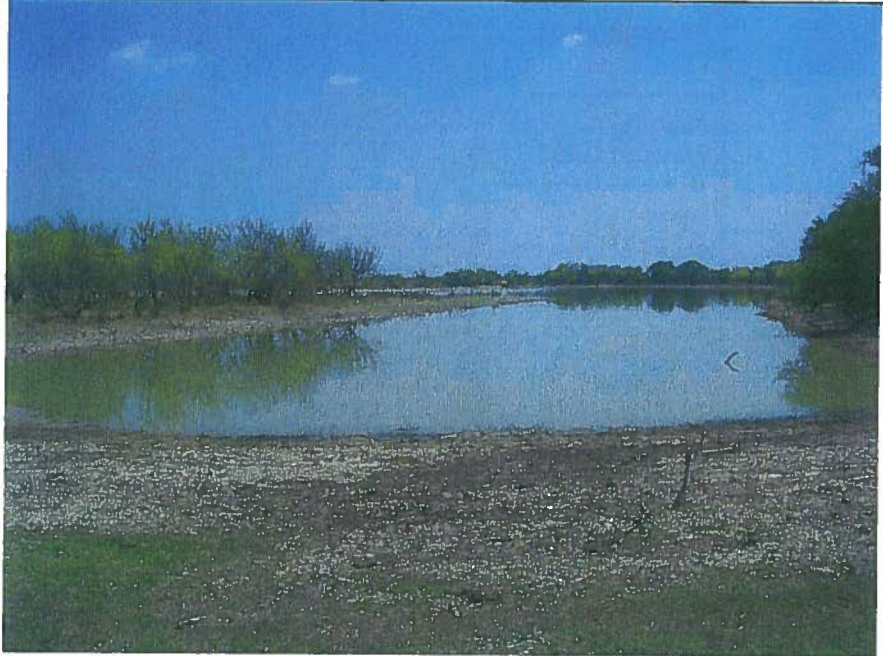
Client: Rancho Viejo Waste Management, LLC		Project Number: 182277	
Project Name: Pescadito Environmental Resource Center		County, State: Webb County, Texas	
Photograph ID: 5

Feature: Stock Tank WB104 and Wetland W133			
Date: 4/19/2011			
Comments: Stock tank SB104 and wetland W133 (left of photo). Facing south.			
Photograph ID: 6

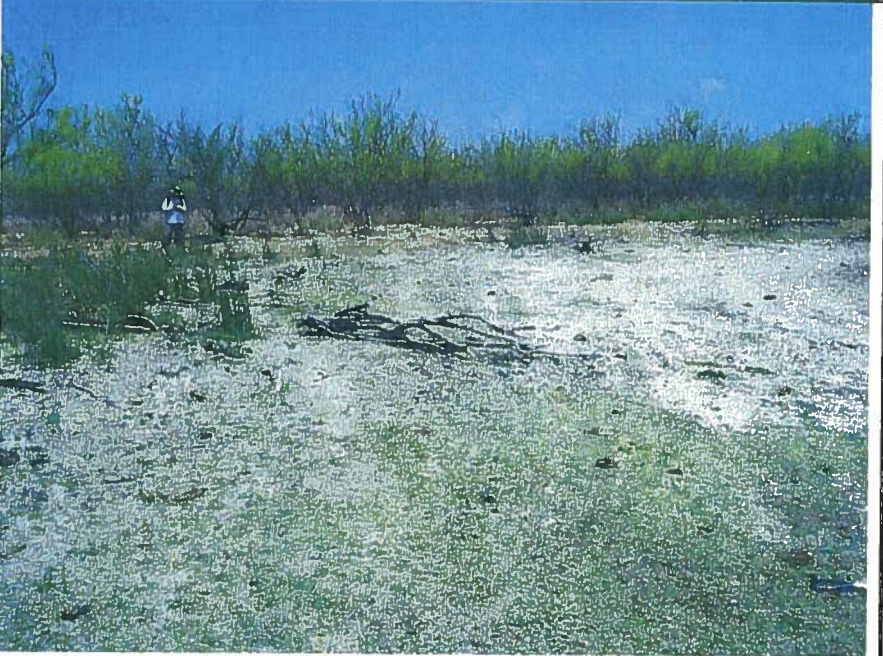
Feature: Wetland W133 and Stock Tank W1B104			
Date: 4/21/2011			
Comments: Wetland W133 (background) at the edge of stock tank WB104 (foreground). Facing north.

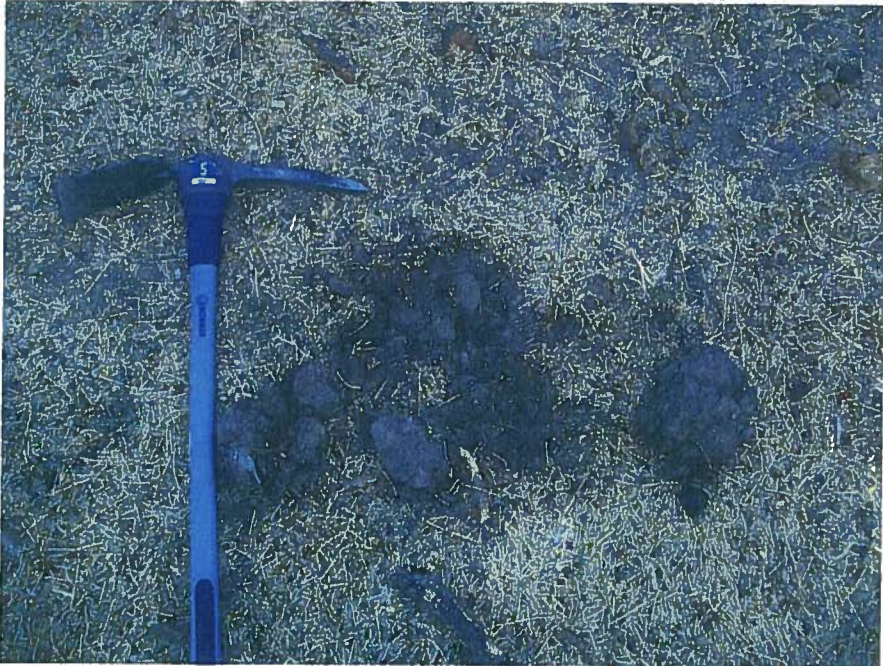
Feature: Soil at W133-WDP			
Date: 4/19/2011			
Comments: Soil at W133-WDP wetland data point.

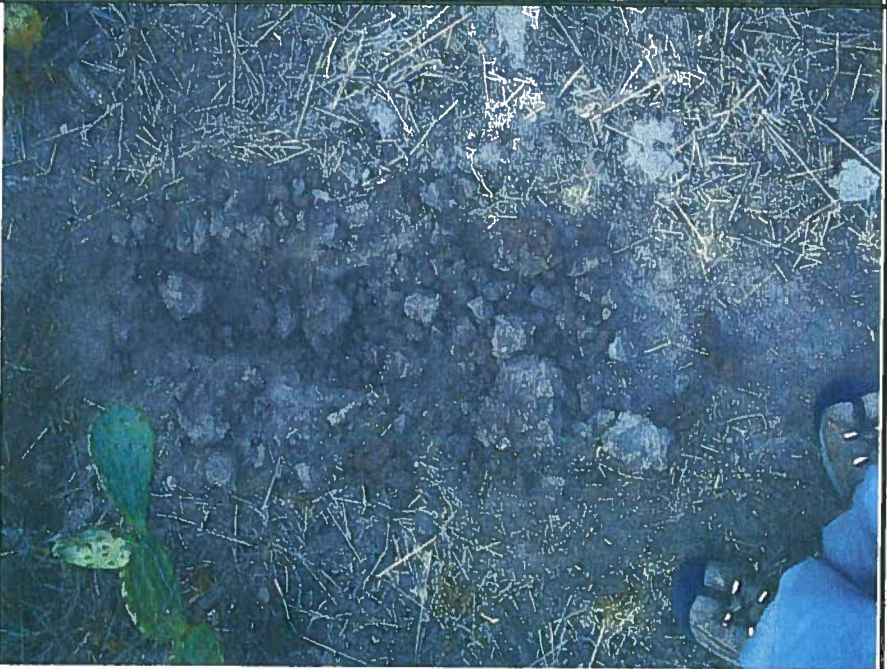
Feature: Soil at W133-UDP			
Date: 4/20/2011			
Comments: Soil at W133-UDP upland data point.

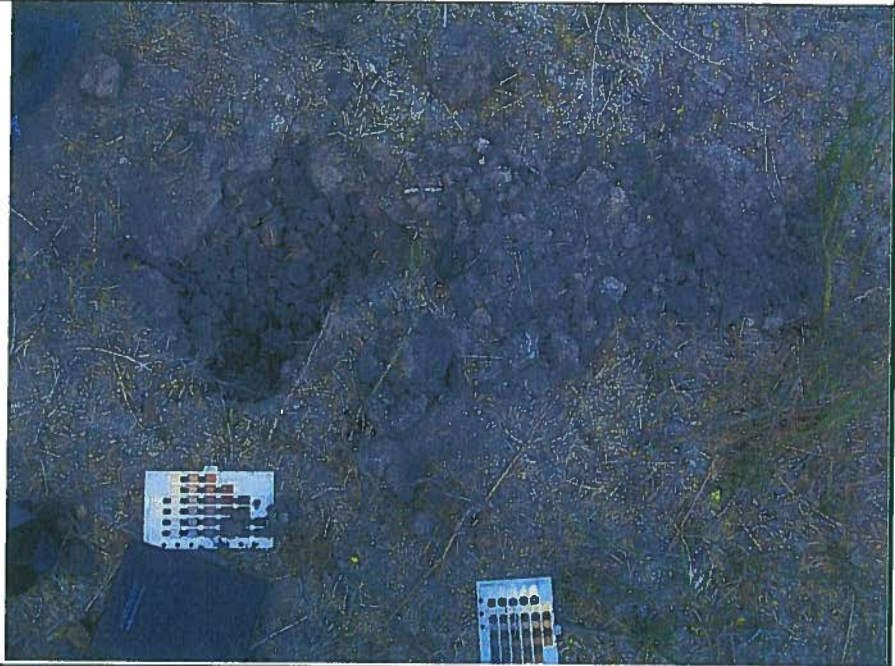
Client: Rancho Viejo Waste Management, LLC		Project Number: 182277	
Project Name: Pescadito Environmental Resource Center		County, State: Webb County, Texas	
Photograph ID: 13

Feature: Soil at W109-WDP			
Date: 4/20/2011			
Comments: Soil profile at W109-WDP wetland data point.			
Photograph ID: 14

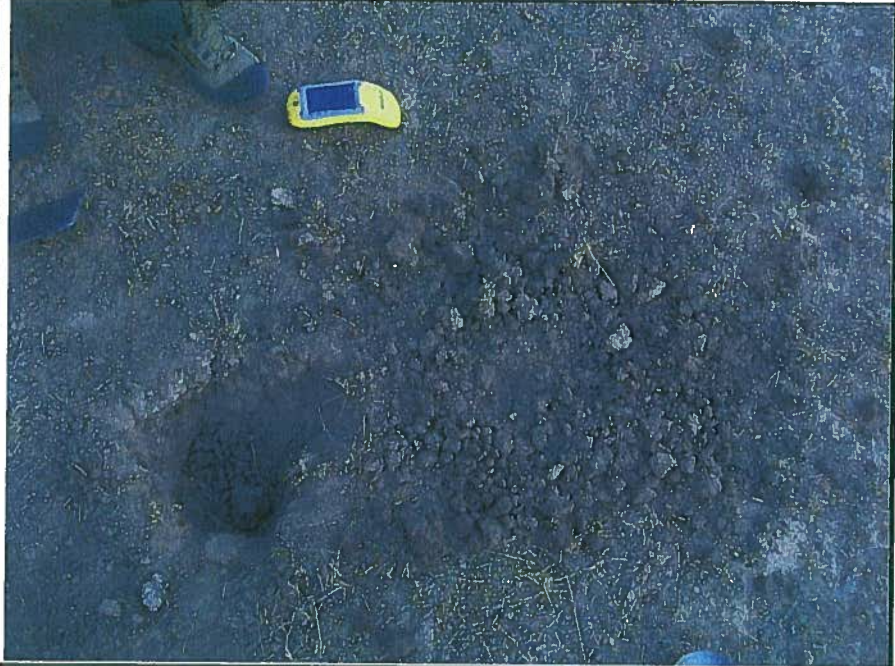
Client: Rancho Viejo Waste Management, LLC		Project Number: 182277	
Project Name: Pescadito Environmental Resource Center		County, State: Webb County, Texas	
Photograph ID: 15

Feature: Soil at W109-UDP			
Date: 4/20/2011			
Comments: Soil profile at W109-UDP upland data point.			
Photograph ID: 16

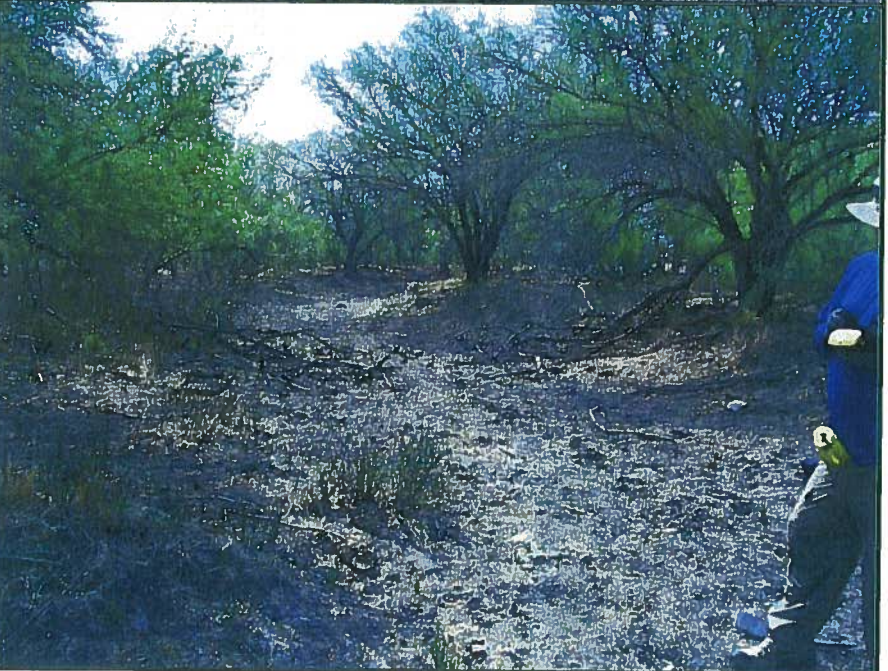
Feature: Wetland W115 and Stream S114			
Date: 4/20/2011			
Comments: Wetland W115 (left of photo), located adjacent to ephemeral stream S114 (background). Facing north (upstream).

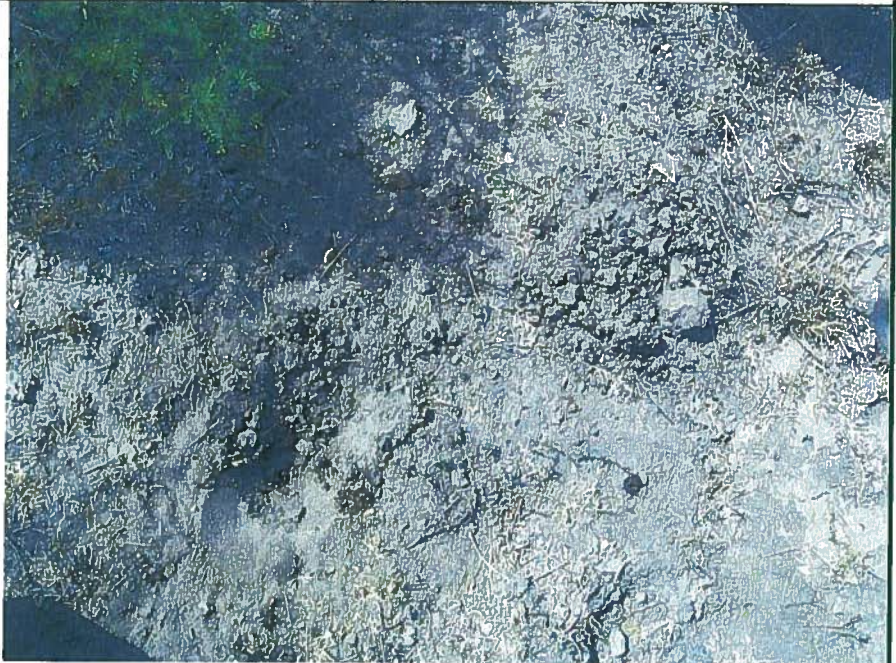
Client: Rancho Viejo Waste Management, LLC		Project Number: 182277	
Project Name: Pescadito Environmental Resource Center		County, State: Webb County, Texas	
Photograph ID: 23

Feature: Soil at W115/W118- UDP			
Date: 4/20/2011			
Comments: Soil at W115/W118- UDP upland data point.			
Photograph ID: 24

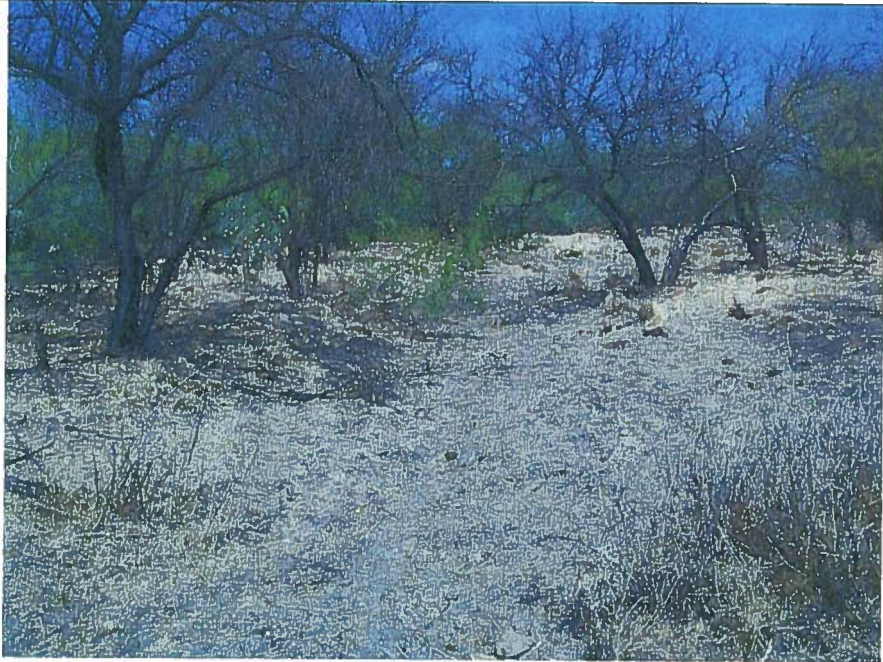
Client: Rancho Viejo Waste Management, LLC		Project Number: 182277	
Project Name: Pescadito Environmental Resource Center		County, State: Webb County, Texas	
Photograph ID: 25

Feature: Wetland W118			
Date: 4/20/2011			
Comments: Wetland W118, located within an abandoned drainage channel created by stock tank construction. Facing north.			
Photograph ID: 26

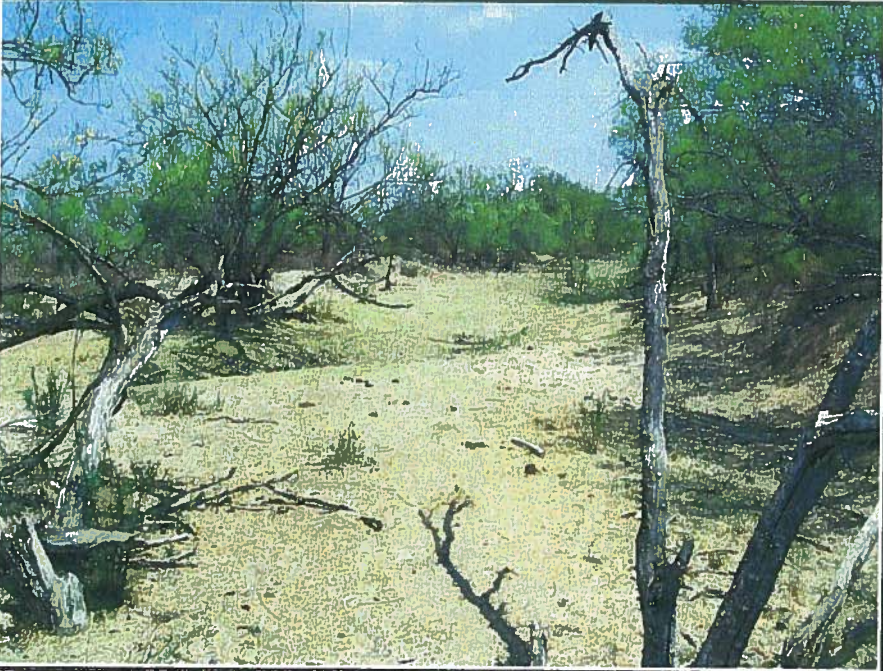
Feature: Streams S120 and S121	
Date: 4/20/2011	
Comments: Confluence of ephemeral stream S120 (left of photo) and S121 (foreground and background). Facing east (downstream).

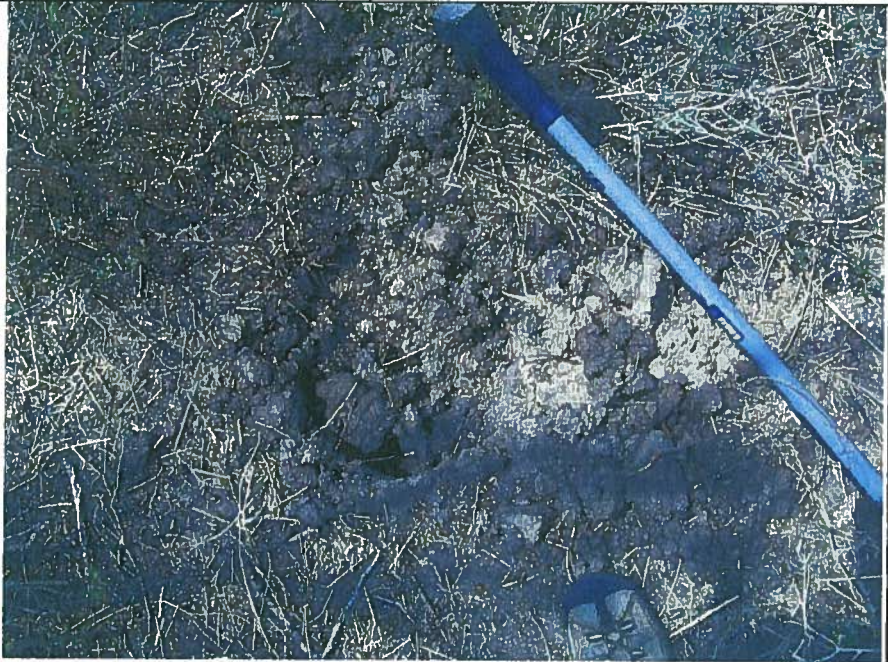
Client: Rancho Viejo Waste Management, LLC		Project Number: 182277
Project Name: Pescadito Environmental Resource Center		County, State: Webb County, Texas
Photograph ID: 33

Feature: Soil at W126-WDP		
Date: 4/21/2011		
Comments: Soil at W126-WDP wetland data point.		
Photograph ID: 34

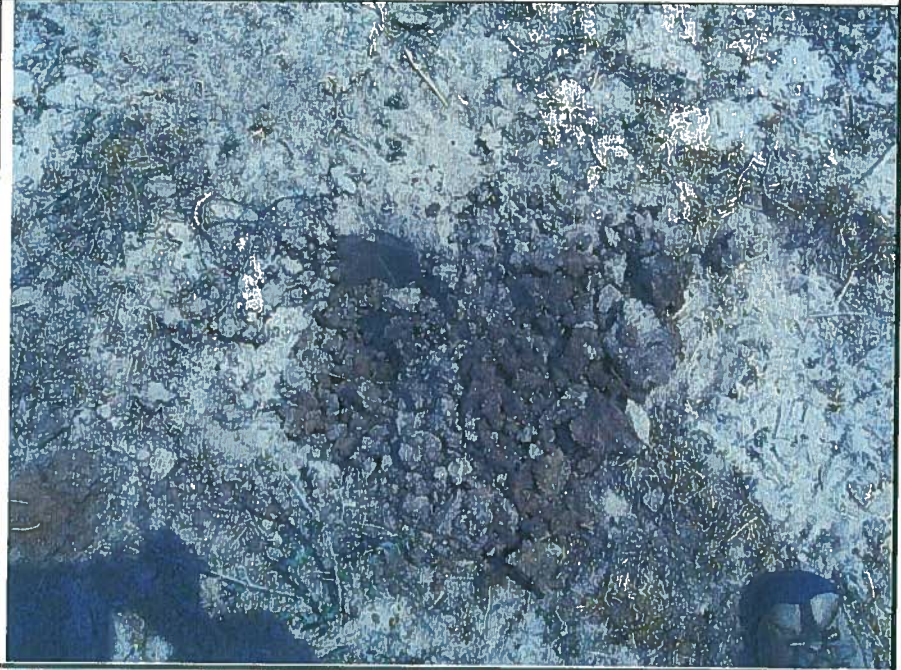
Client: Rancho Viejo Waste Management, LLC		Project Number: 182277	
Project Name: Pescadito Environmental Resource Center		County, State: Webb County, Texas	
Photograph ID: 35

Feature: Soil at W126-UDP			
Date: 4/21/2011			
Comments: Soil at W126-UDP upland data point.			
Photograph ID: 36

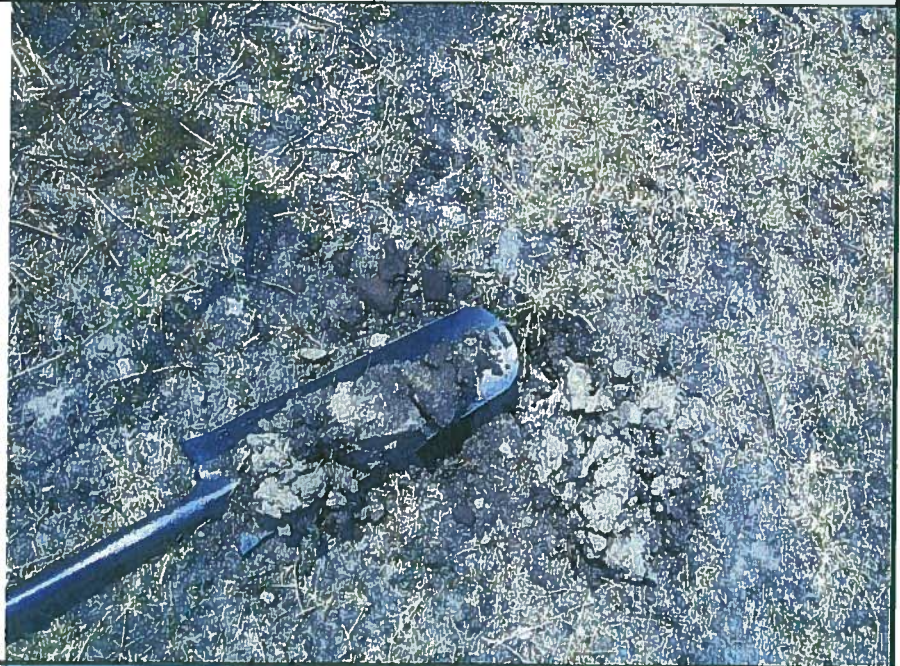
Client: Rancho Viejo Waste Management, LLC		Project Number: 182277
Project Name: Pescadito Environmental Resource Center		County, State: Webb County, Texas
Photograph ID: 37

Feature: Soil at W127-WDP1		
Date: 4/21/2011		
Comments: Soil at W127-WDP1 wetland data point.		
Photograph ID: 38

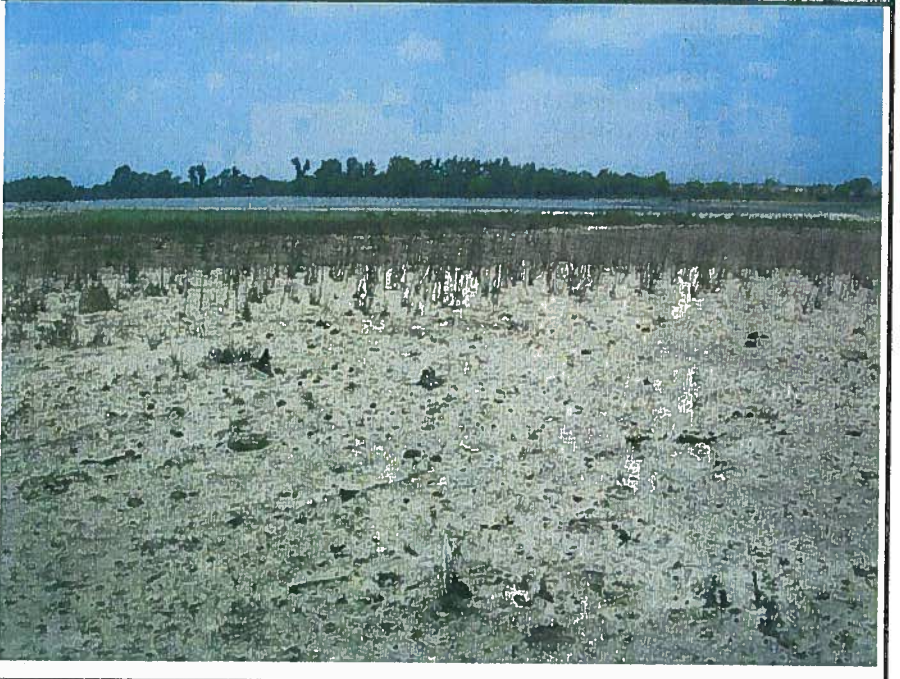
Feature: Sparse Vegetation at W127 and Stock Tank WB128		
Date: 4/21/2011		
Comments: Area of sparse vegetation at W127, a result of saline soils. Stock tank WB128 in background. Facing south.

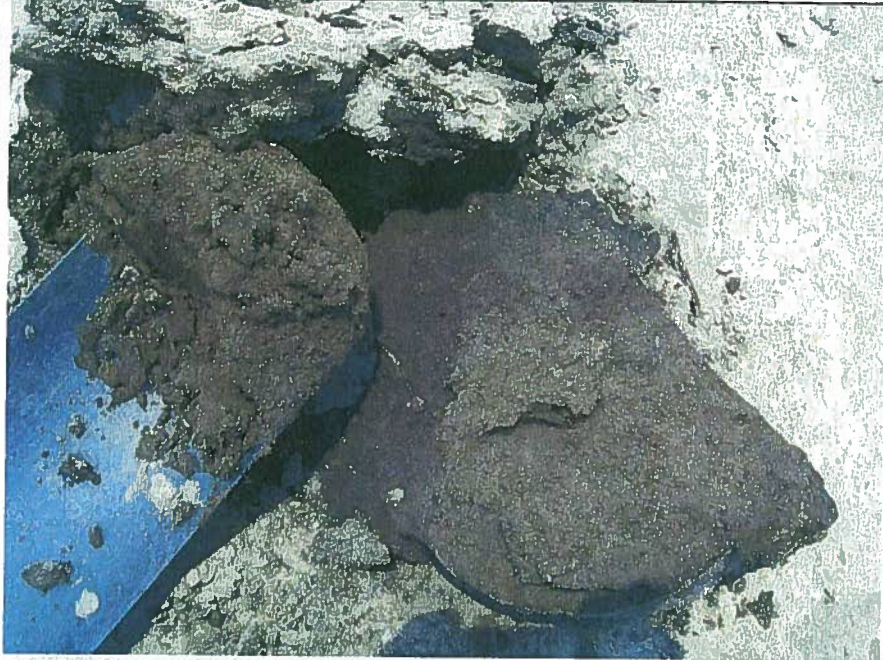
Client: Rancho Viejo Waste Management, LLC		Project Number: 182277	
Project Name: Pescadito Environmental Resource Center		County, State: Webb County, Texas	
Photograph ID: 39

Feature: Soil at W127			
Date: 4/21/2011			
Comments: Hydric soil at sparsely vegetated area of W127.			
Photograph ID: 40

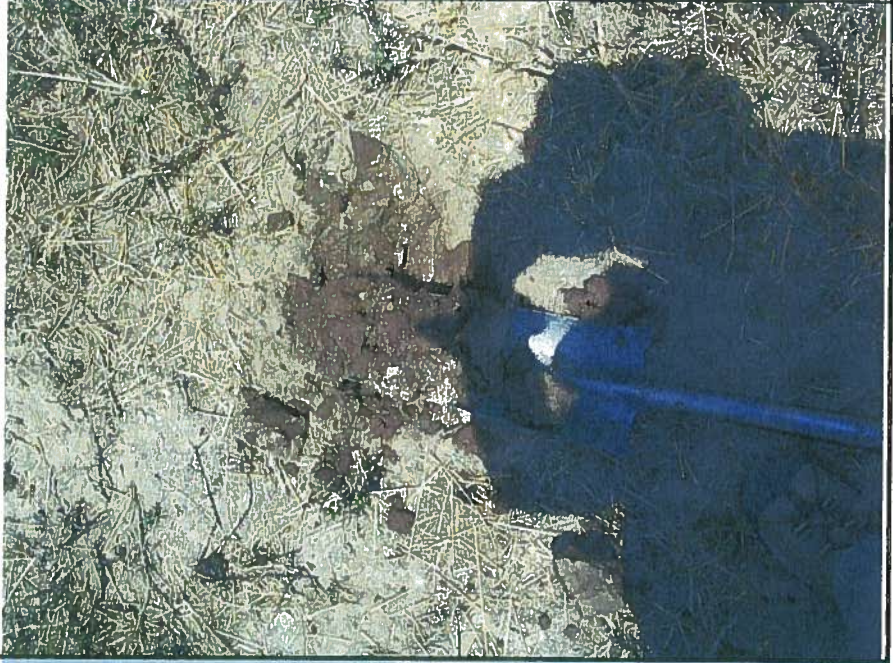
Client: Rancho Viejo Waste Management, LLC		Project Number: 182277	
Project Name: Pescadito Environmental Resource Center		County, State: Webb County, Texas	
Photograph ID: 41

Feature: Soil at W127-UDP1			
Date: 4/21/2011			
Comments: Soil profile at W127-UDP1 upland data point.			
Photograph ID: 42

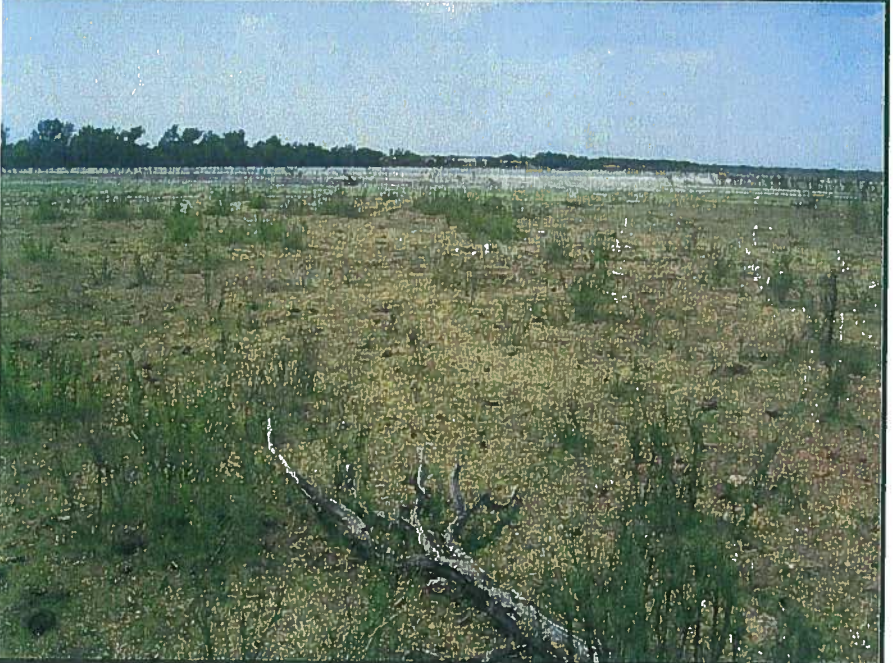
Feature: Wetland W127 at W127-WDP2 and Stock Tank WB128			
Date: 4/21/2011			
Comments: Fringe area of wetland W127, near W127-WDP2. Stock tank WB128 in background. Facing southwest.

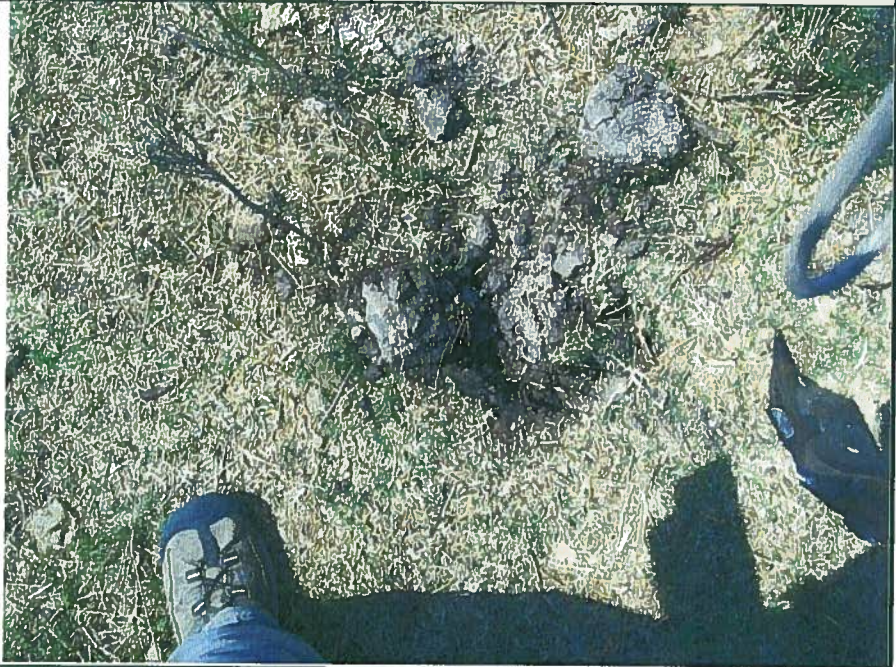
Client: Rancho Viejo Waste Management, LLC		Project Number: 182277
Project Name: Pescadito Environmental Resource Center		County, State: Webb County, Texas
Photograph ID: 43

Feature: Soil at W127- WDP2		
Date: 4/21/2011		
Comments: Soil at W127- WDP2 wetland data point.		
Photograph ID: 44

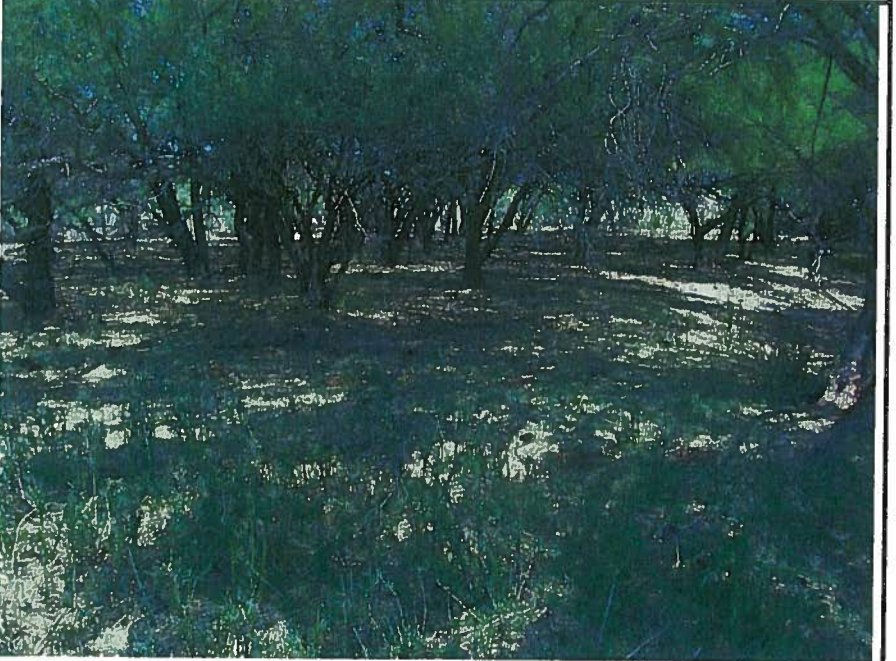
Feature: Upland habitat at W127-UDP2		
Date: 4/21/2011		
Comments: Upland habitat at W127-UDP2 upland data point. Facing southeast.

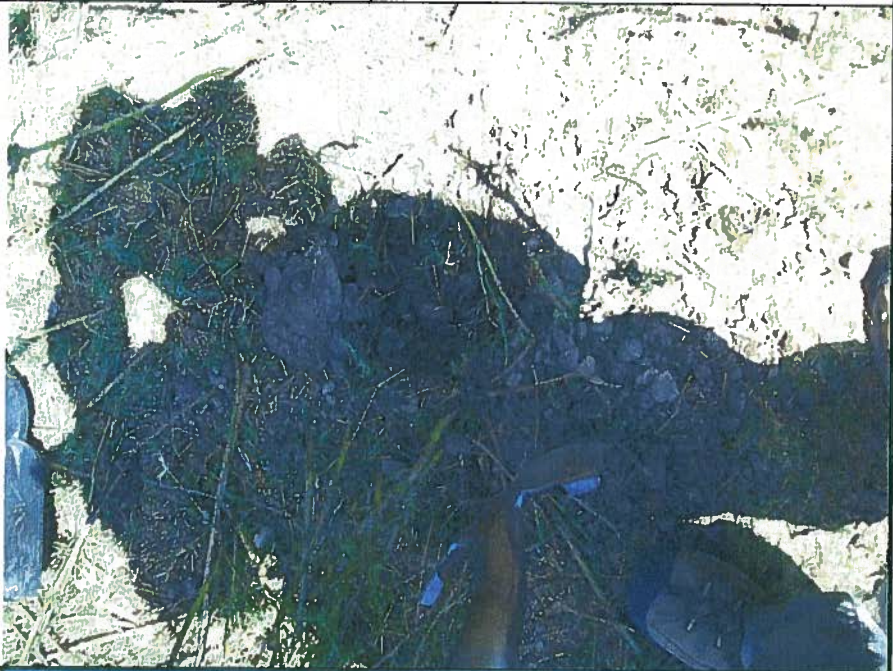
Client: Rancho Viejo Waste Management, LLC		Project Number: 182277	
Project Name: Pescadito Environmental Resource Center		County, State: Webb County, Texas	
Photograph ID: 45

Feature: Soil at W127-UDP2			
Date: 4/21/2011			
Comments: Soil profile at W127-UDP2 upland data point.			
Photograph ID: 46

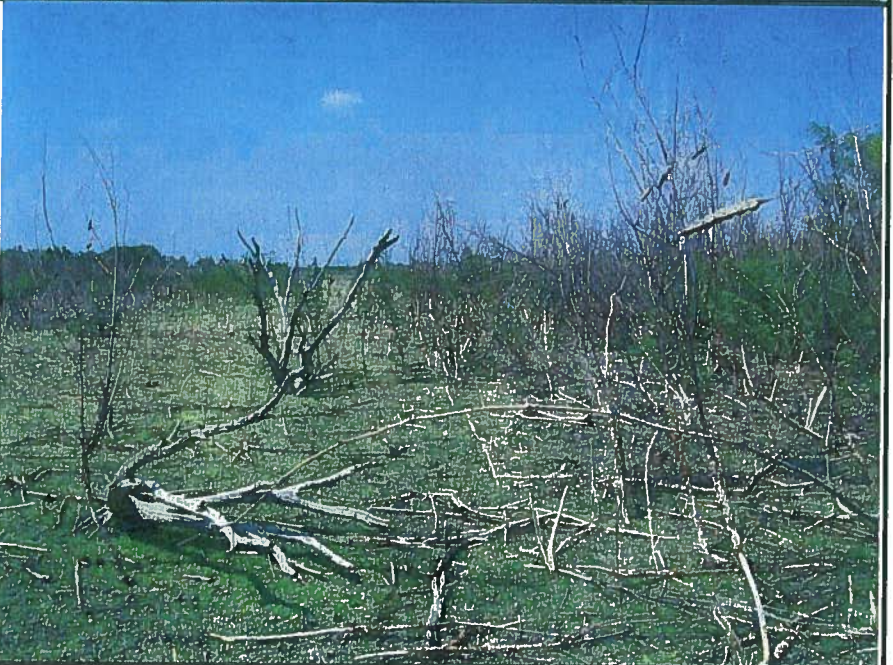
Feature: Wetland W127 at Stream S121			
Date: 4/21/2011			
Comments: Wetland W127 at ephemeral stream S121 (left of photo). Facing north.

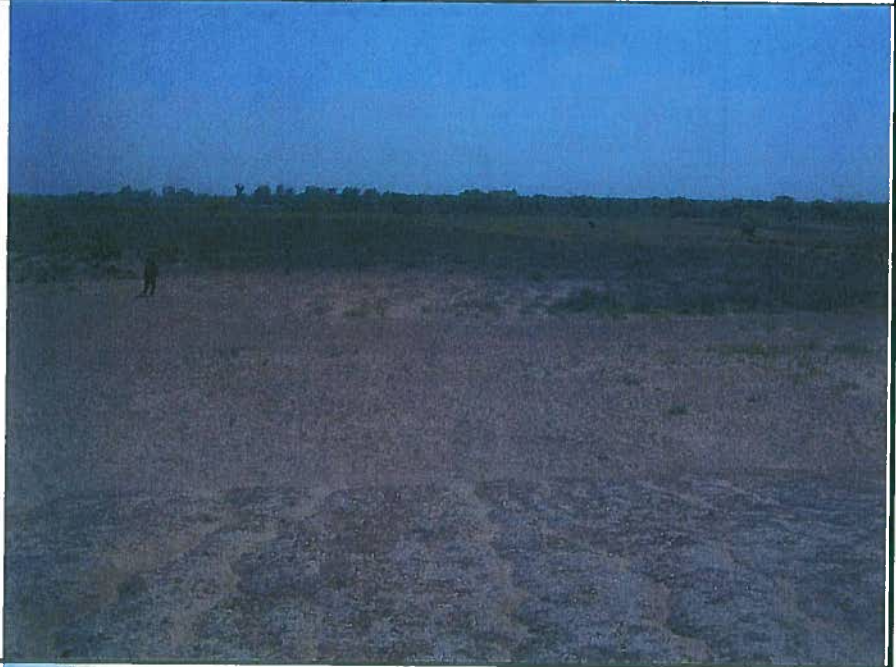
Client: Rancho Viejo Waste Management, LLC	Project Number: 182277
Project Name: Pescadito Environmental Resource Center	County, State: Webb County, Texas
Photograph ID: 47

Feature: Wetland W127 at W104 Impoundment	
Date: 4/21/2011	
Comments: Wetland W127 (background) at W104 impoundment (foreground). Facing south.	
Photograph ID: 48

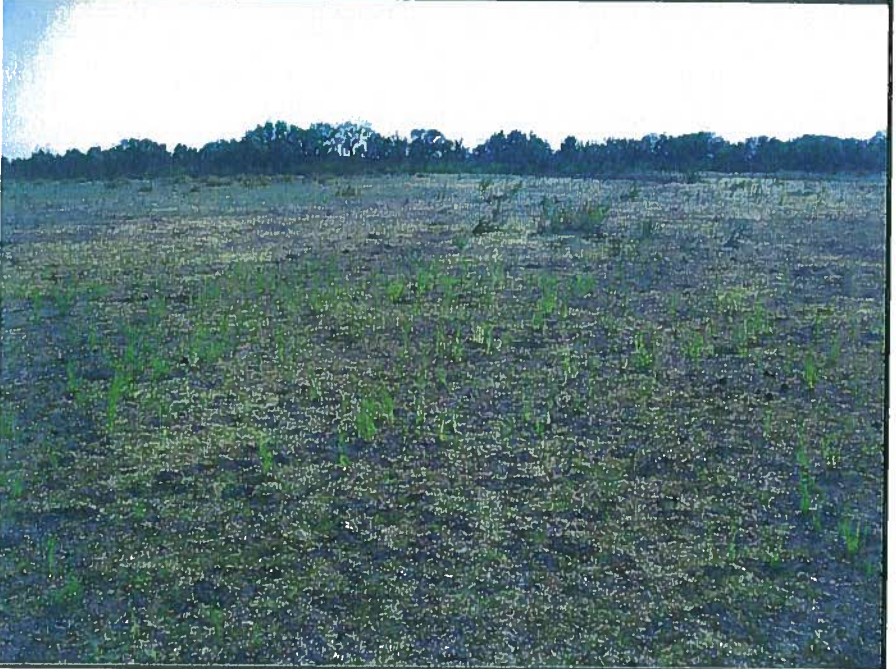
Feature: Wetland W130	
Date: 4/21/2011	
Comments: Wetland W130. Facing south.

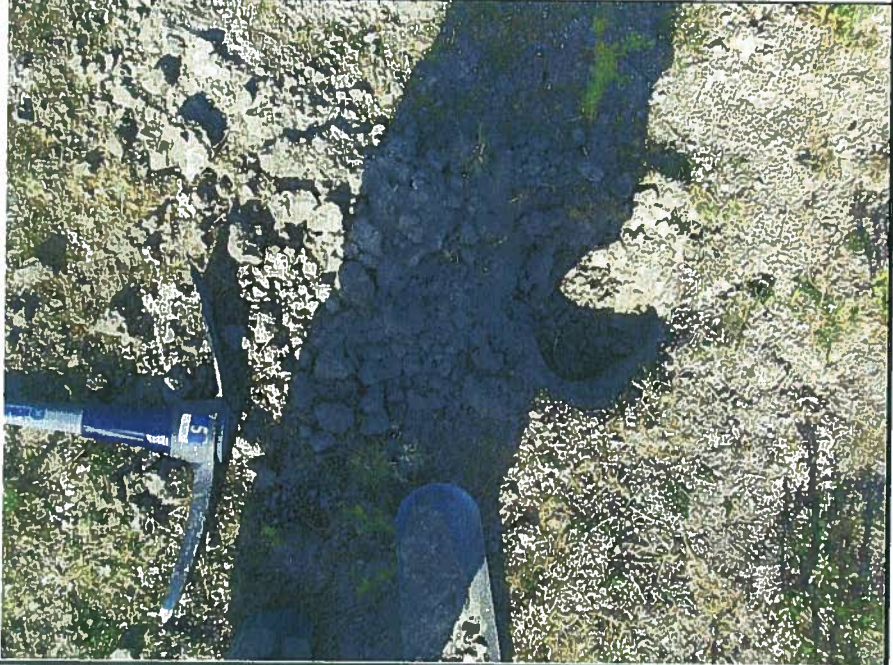
Client: Rancho Viejo Waste Management, LLC		Project Number: 182277	
Project Name: Pescadito Environmental Resource Center		County, State: Webb County, Texas	
Photograph ID: 49

Feature: Soil at W130-UDP1			
Date: 4/21/2011			
Comments: Soil at W130-WDP wetland data point.			
Photograph ID: 50

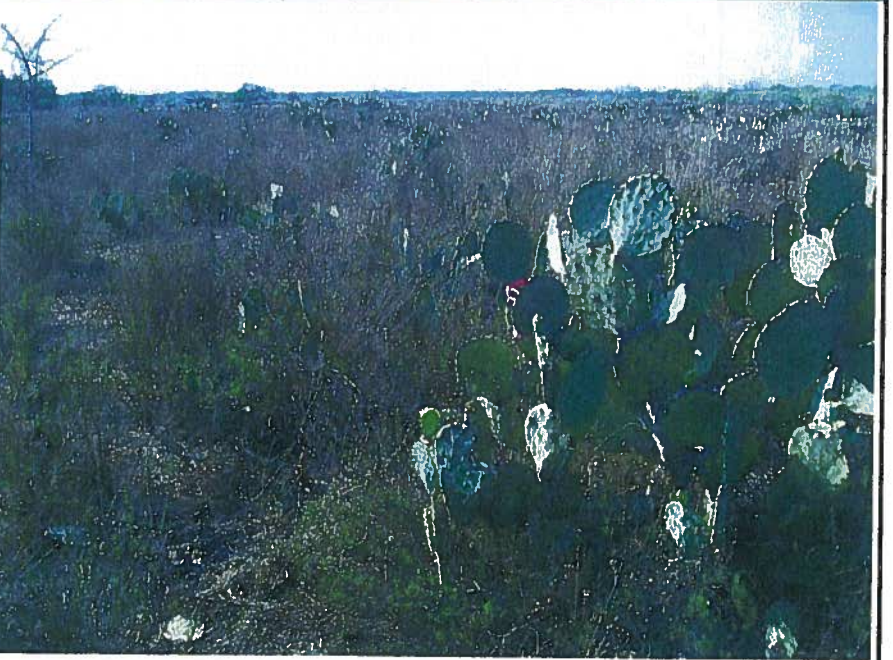
Feature: Upland habitat at W127/W130-UDP			
Date: 4/21/2011			
Comments: Upland habitat at W127/W130-UDP upland data point. Facing northwest.

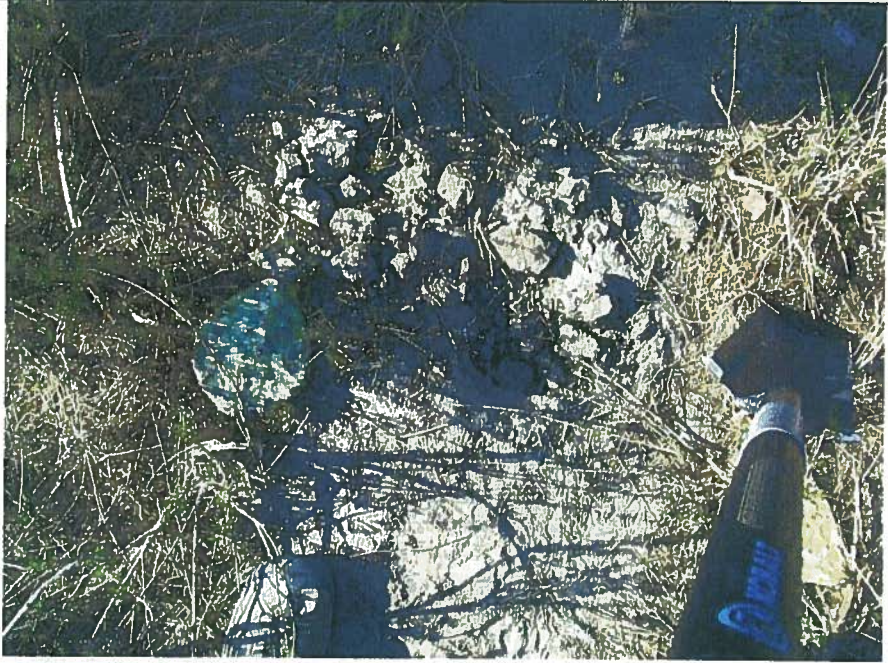
Client: Rancho Viejo Waste Management, LLC		Project Number: 182277	
Project Name: Pescadito Environmental Resource Center		County, State: Webb County, Texas	
Photograph ID: 51

Feature: Soil at W12/W130-UDP			
Date: 4/21/2011			
Comments: Soil at W127/W130- UDP upland data point.			
Photograph ID: 52

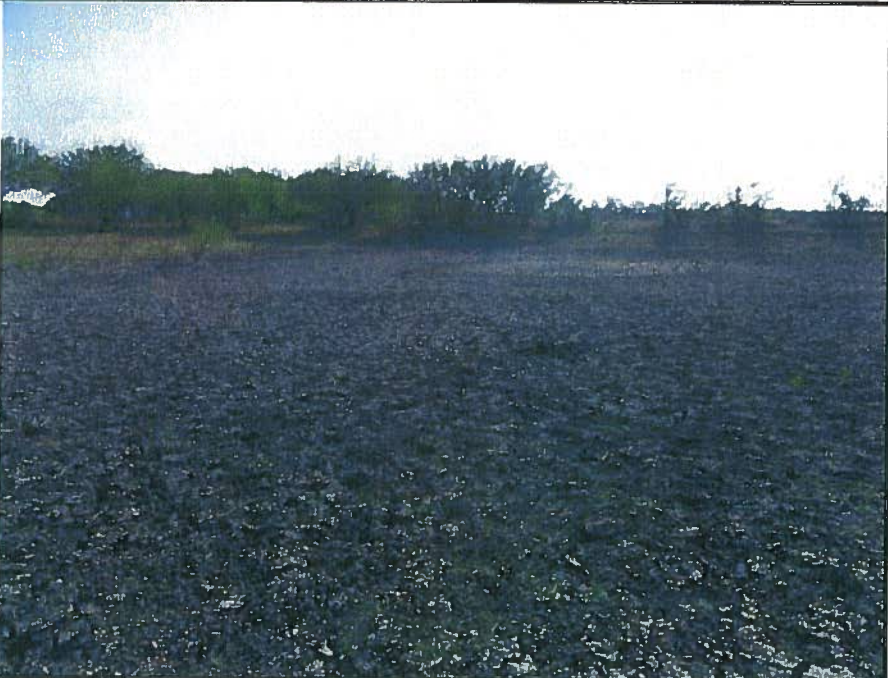
Feature: Stock Tank WB131			
Date: 4/21/2011			
Comments: Stock tank WB131. Facing west.

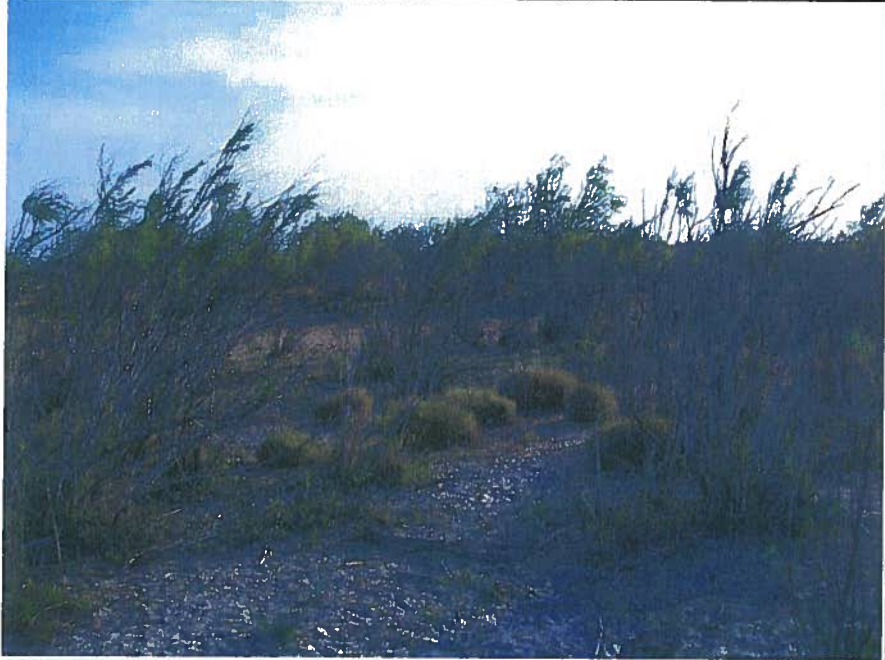
Client: Rancho Viejo Waste Management, LLC		Project Number: 182277	
Project Name: Pescadito Environmental Resource Center		County, State: Webb County, Texas	
Photograph ID: 53

Feature: Wetland W132			
Date: 4/21/2011			
Comments: Wetland W132. Facing southeast.			
Photograph ID: 54

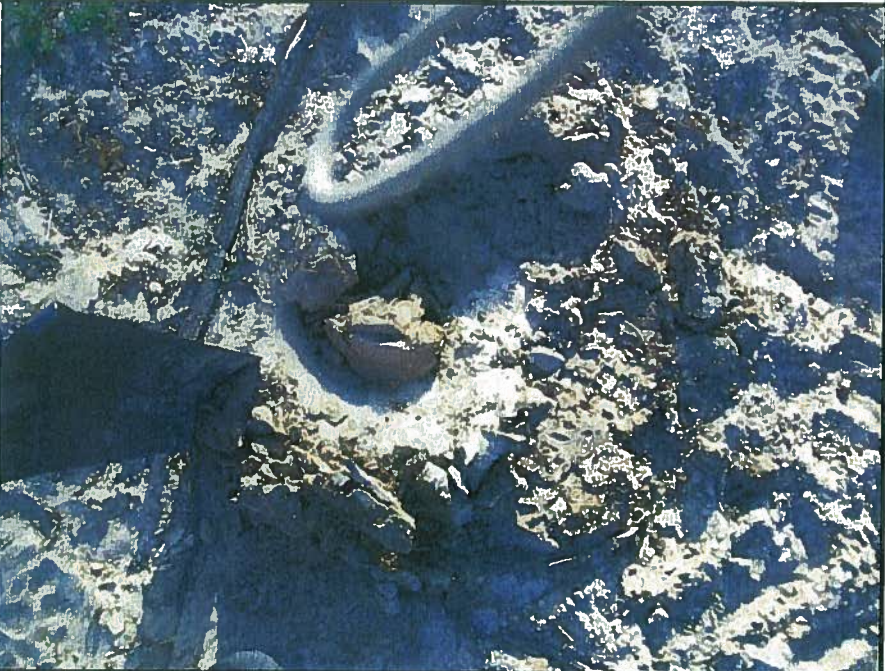
Feature: Soil at W132- WDP			
Date: 4/21/2011			
Comments: Soil at W132- WDP wetland data point.

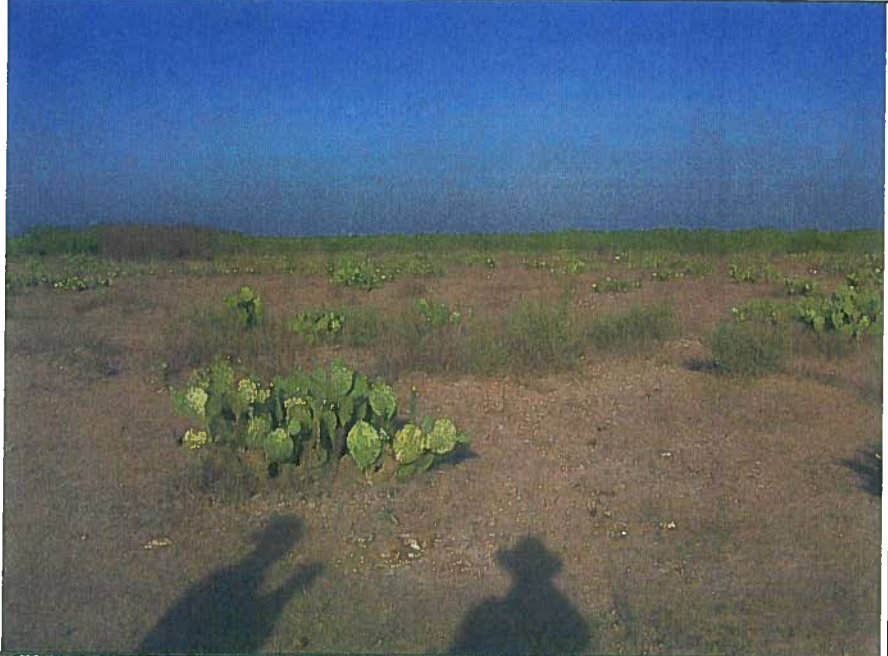
Client: Rancho Viejo Waste Management, LLC		Project Number: 182277	
Project Name: Pescadito Environmental Resource Center		County, State: Webb County, Texas	
Photograph ID: 55

Feature: Upland Habitat at W132-UDP			
Date: 4/21/2011			
Comments: Upland habitat at W132-UDP upland data point. Facing east.			
Photograph ID: 56

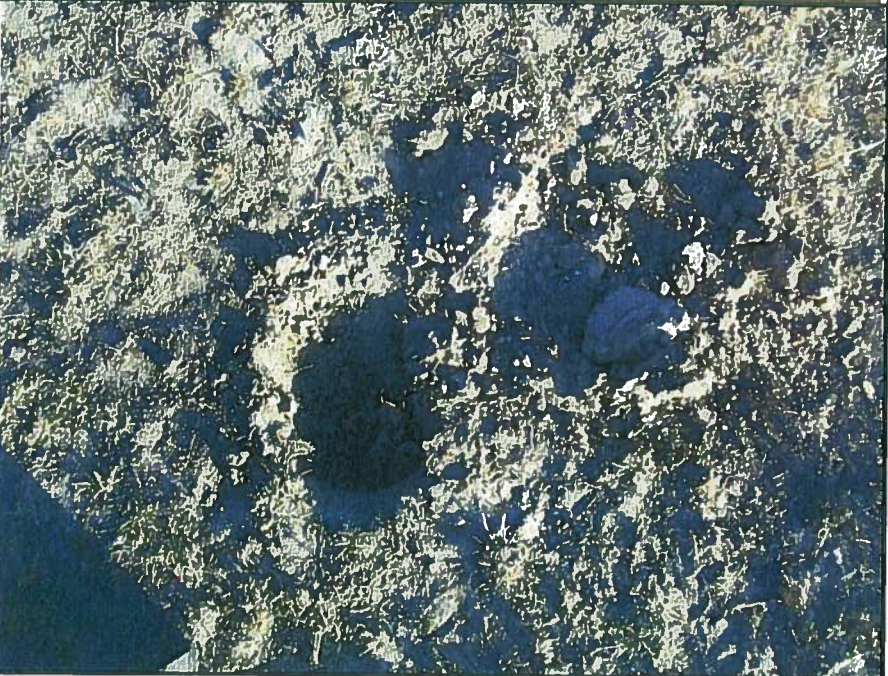
Feature: Soil at W132- UDP			
Date: 4/21/2011			
Comments: Soil at W132- UDP upland data point.

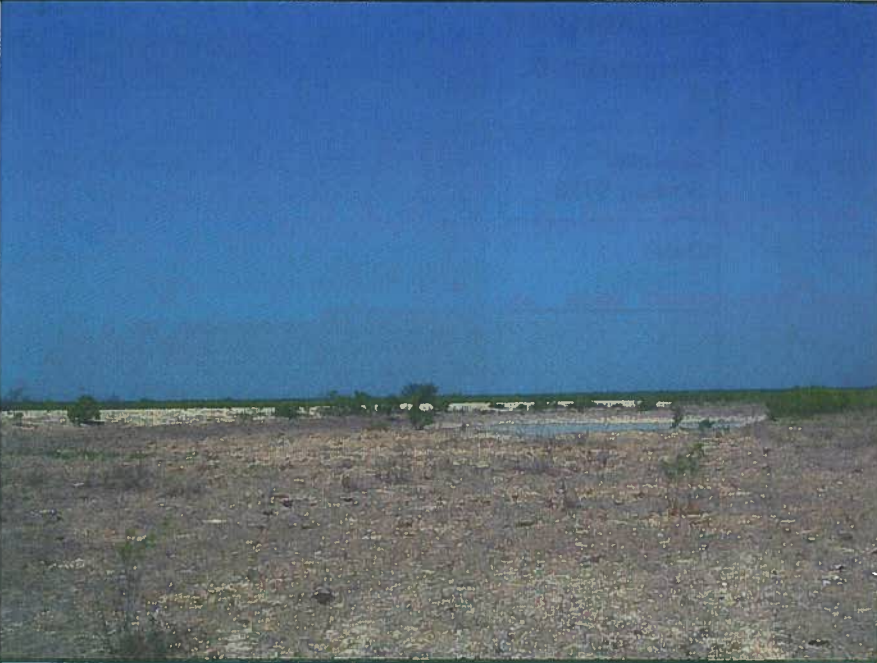
Client: Rancho Viejo Waste Management, LLC		Project Number: 182277	
Project Name: Pescadito Environmental Resource Center		County, State: Webb County, Texas	
Photograph ID: 1

Feature: Stock Tank WB101			
Date: 4/19/2011			
Comments: Stock tank WB101. Facing north.			
Photograph ID: 2

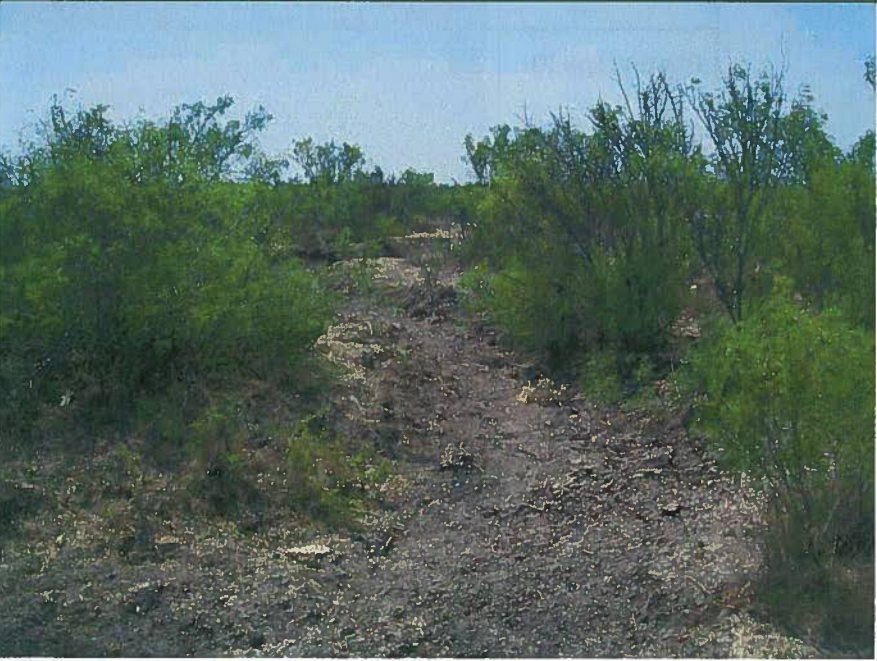
Feature: Stream S103			
Date: 4/19/2011			
Comments: Ephemeral stream S103. Facing south (downstream).
