APPLICATION FOR PERMIT
TYPE I MUNICIPAL SOLID WASTE FACILITY
MSW PERMIT NO. 2374
PESCADITO ENVIRONMENTAL
RESOURCE CENTER
RANCHO VIEJO WASTE MANAGEMENT, LLC
SOLID WASTE DISPOSAL FACILITY
LAREDO, WEBB COUNTY, TEXAS

March 28, 2011
Revised September 14, 2011

**Reference: Pescadito Environmental Resource Center – Webb County
Municipal Solid Waste (MSW) – Proposed Permit No. 2374
Response to First Notice of Deficiency (NOD)
Tracking No. 14710139; CN603835489/RN106119639**

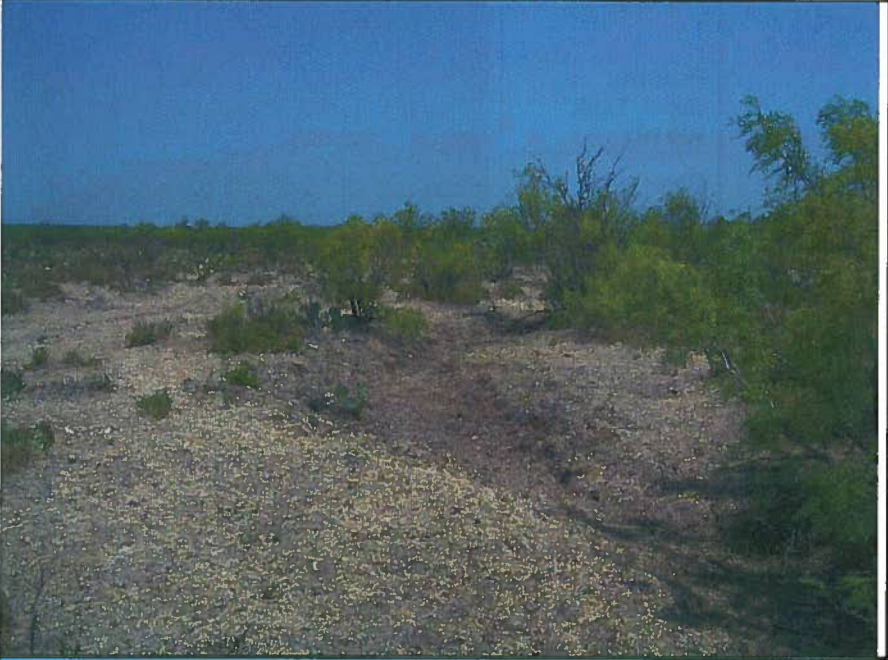
Client: Rancho Viejo Waste Management, LLC		Project Number: 182277	
Project Name: Pescadito Environmental Resource Center		County, State: Webb County, Texas	
Photograph ID: 3

Feature: Stream S103			
Date: 4/19/2011			
Comments: Ephemeral stream S103. Facing north (upstream).			
Photograph ID: 4

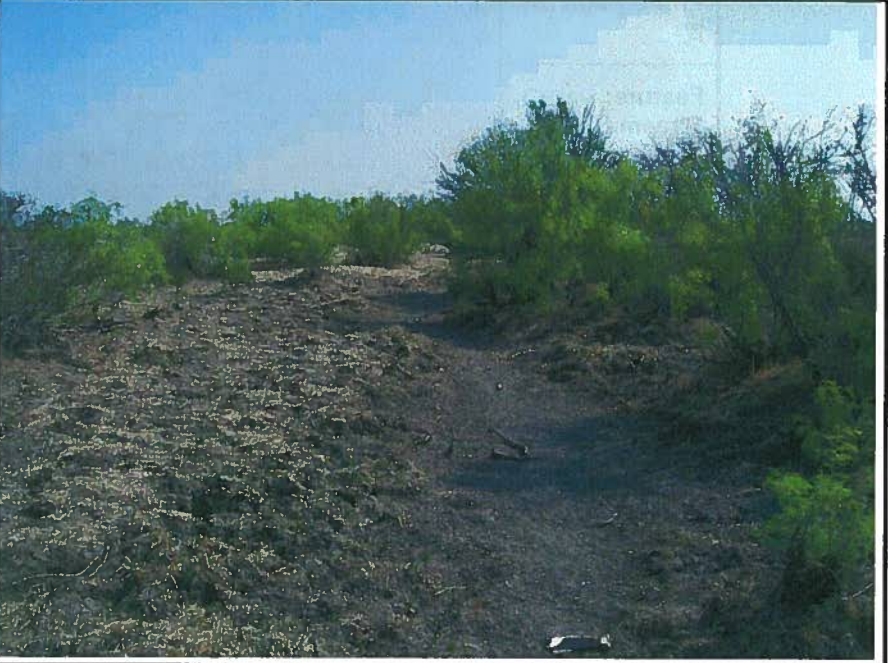
Feature: Ephemeral stream S107			
Date: 4/19/2011			
Comments: Ephemeral stream S107, a short tributary of S103. Facing north (upstream).

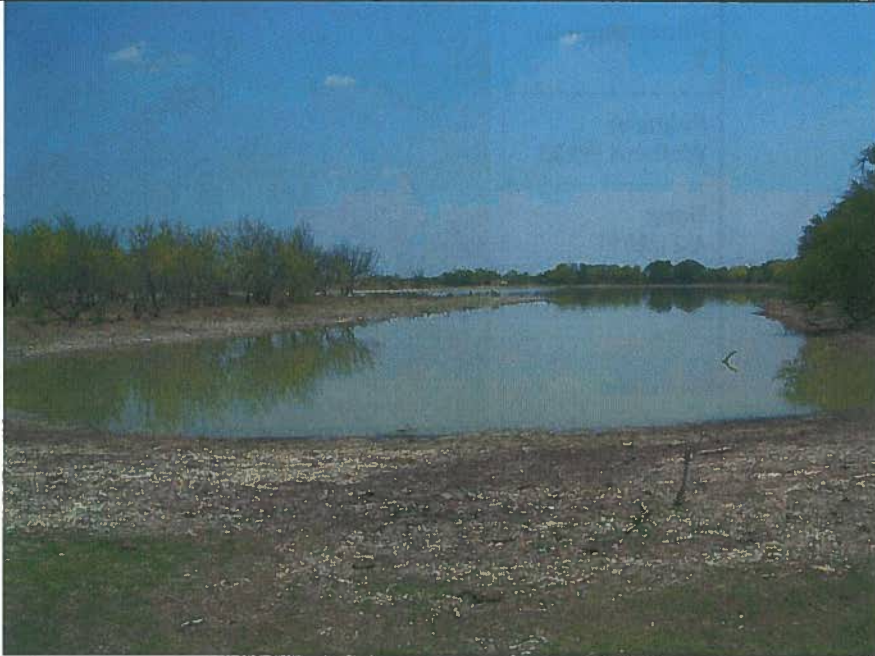
Client: Rancho Viejo Waste Management, LLC		Project Number: 182277
Project Name: Pescadito Environmental Resource Center		County, State: Webb County, Texas
Photograph ID: 5

Feature: Stock Tank WB104 and Wetland W133		
Date: 4/19/2011		
Comments: Stock tank SB104 and wetland W133 (left of photo). Facing south.		
Photograph ID: 6

Wetland W133 is a relatively large (14.70 ac), scrub-shrub, fringe wetland adjacent to stock tank WB104 (13.58 ac), which receives surface water flow from two, small floodplains (Figure 5). Defined channels and/or ordinary high water mark (OHWM) indicators were observed along the eastern floodplain at ephemeral streams S103, S107, and S122. One stock tank (WB101; 0.49 ac) is located between S103/S107 and S122. The eastern floodplain from WB104 to the northern Project survey area boundary is presented as a dashed blue line on the USGS topographical map indicating an intermittent drainage system (Figure 1; USGS 1980). Defined channels and/or OHWM indicators were observed along the western floodplain at ephemeral streams S123, S134, and S135. The western floodplain is presented as a dashed blue line along S134, at the northern Project survey area boundary (Figure 1; USGS 1980). It is possible that the construction of stock tank WB101, roads, and/or pipeline right-of-ways has fragmented the two floodplain drainage systems associated with WB104, resulting in sheet water flow and no defined channel and/or OHWM indicators in some areas. A small stock tank (WB106; 1.01 ac) is also located south of the WB104 impoundment.

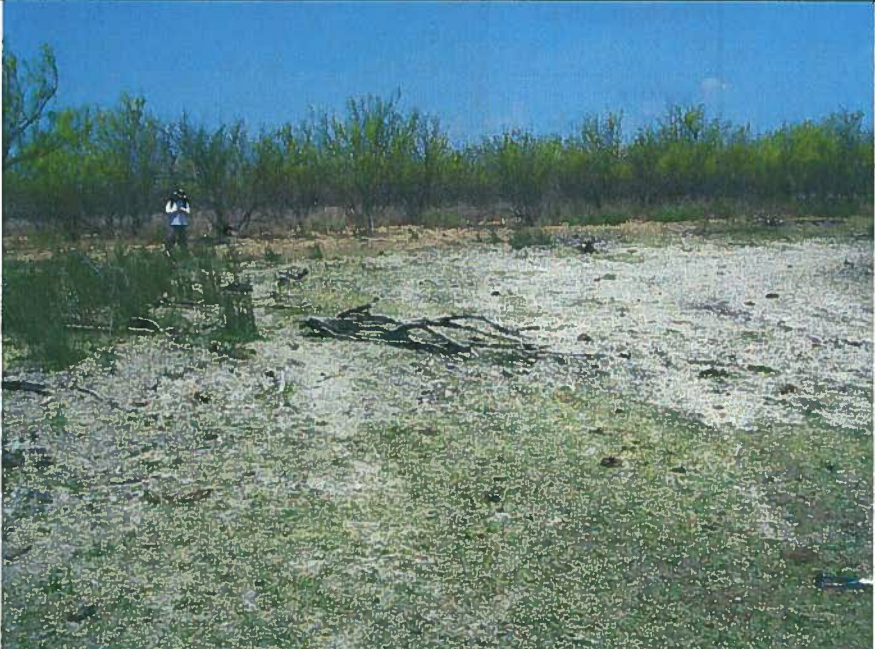
Feature: Wetland W133 and Stock Tank W1B104		
Date: 4/21/2011		
Comments: Wetland W133 (background) at the edge of stock tank WB104 (foreground). Facing north.

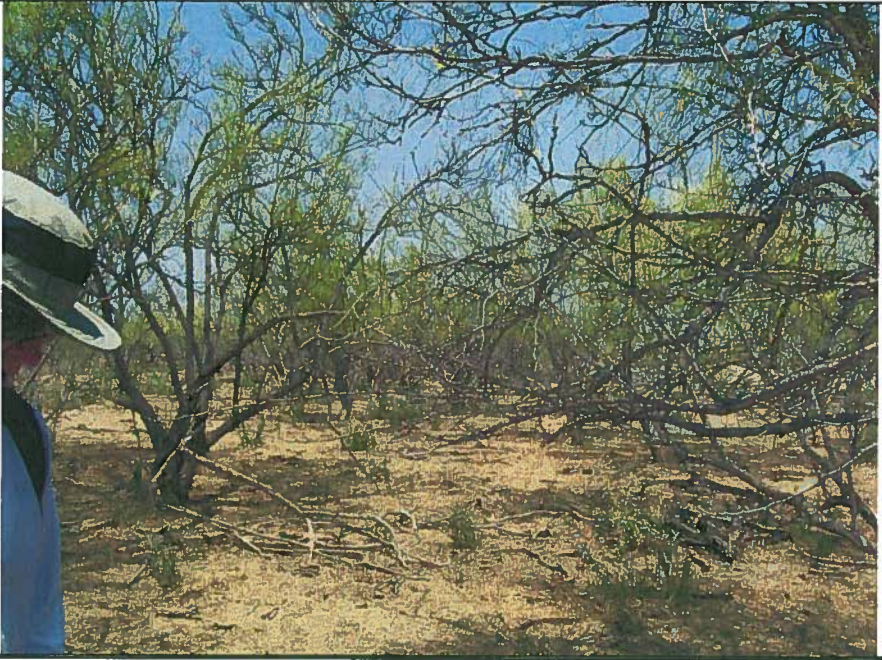
Client: Rancho Viejo Waste Management, LLC		Project Number: 182277	
Project Name: Pescadito Environmental Resource Center		County, State: Webb County, Texas	
Photograph ID: 7

Feature: Wetland W133			
Date: 4/21/2011			
Comments: Wetland W133. Facing north.			
Photograph ID: 8

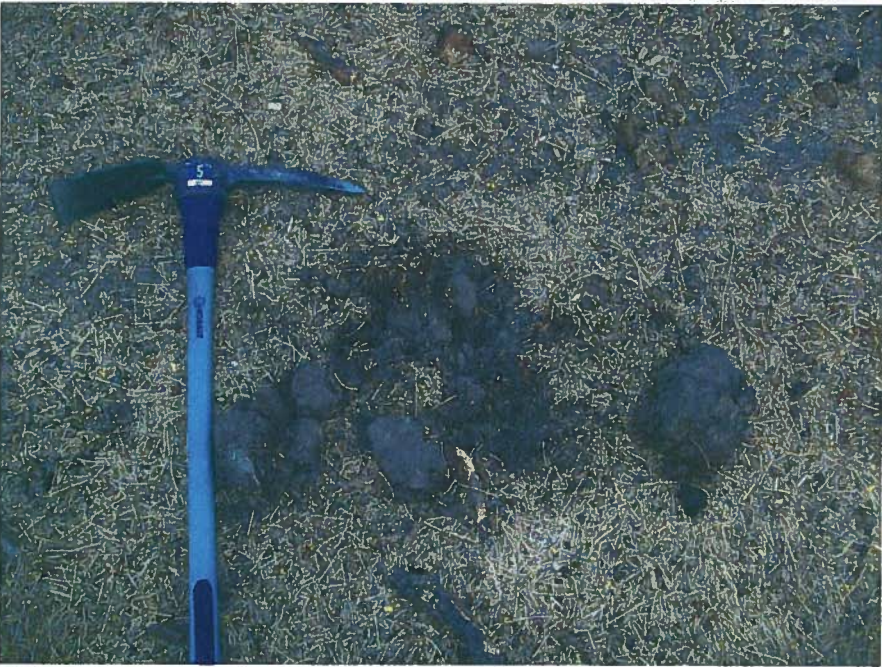
Feature: Soil at W133-WDP			
Date: 4/19/2011			
Comments: Soil at W133-WDP wetland data point.

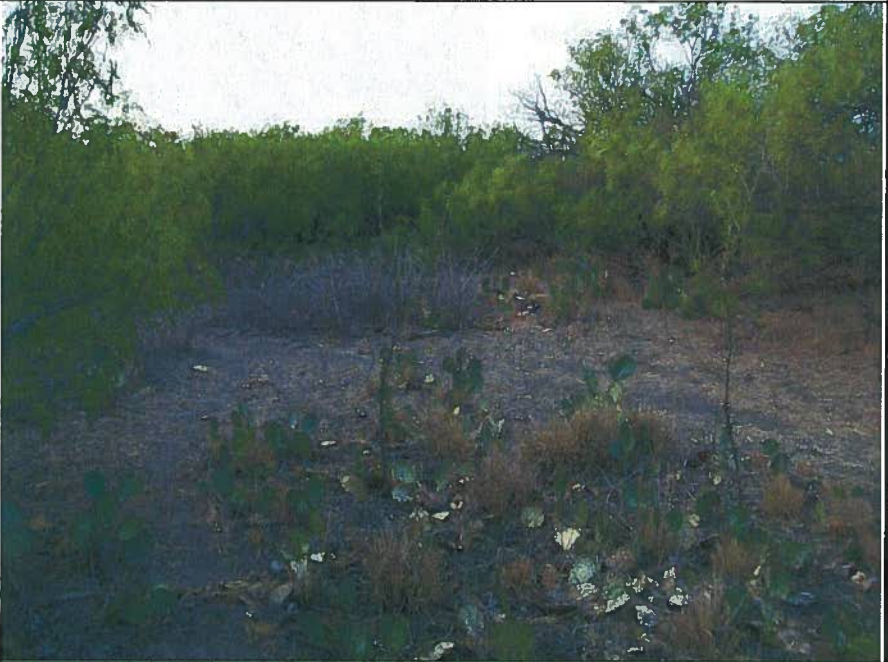
Client: Rancho Viejo Waste Management, LLC		Project Number: 182277
Project Name: Pescadito Environmental Resource Center		County, State: Webb County, Texas
Photograph ID: 9

Feature: Upland Habitat at W133-UDP		
Date: 4/19/2011		
Comments: Upland habitat at W133-UDP upland data point. Facing north.		
Photograph ID: 10

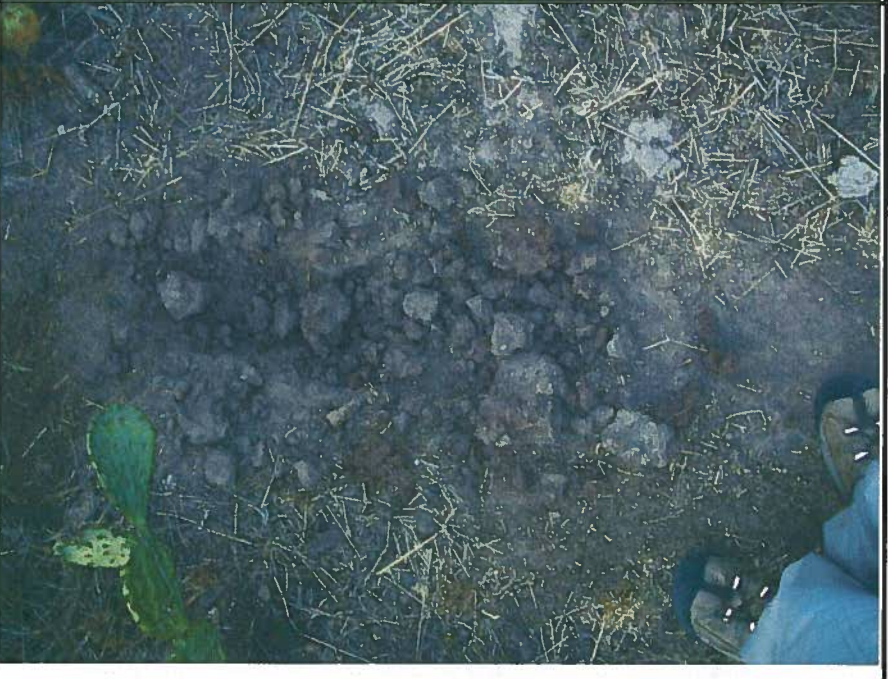
Feature: Soil at W133- UDP		
Date: 4/20/2011		
Comments: Soil at W133- UDP upland data point.

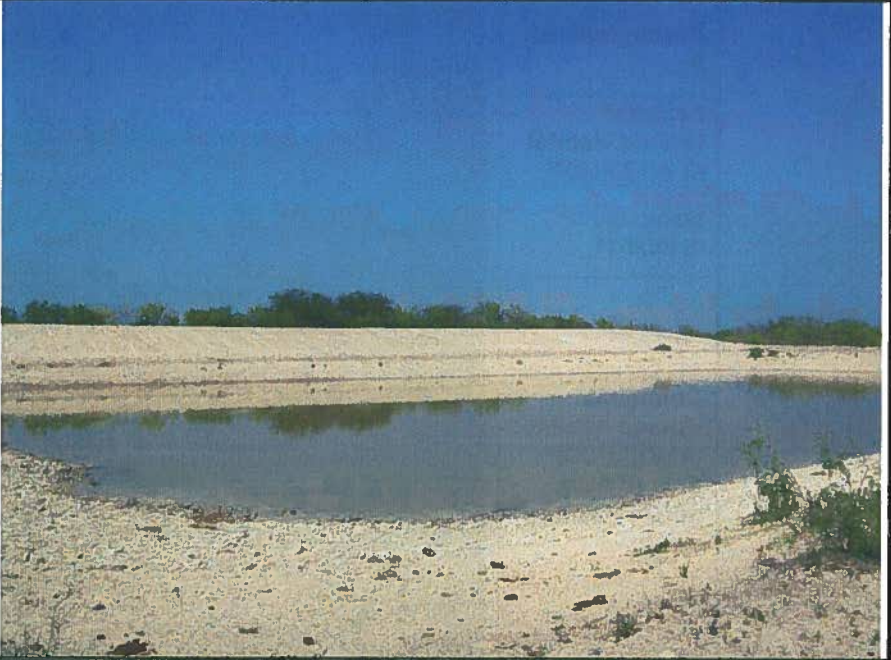
Client: Rancho Viejo Waste Management, LLC		Project Number: 182277
Project Name: Pescadito Environmental Resource Center		County, State: Webb County, Texas
Photograph ID: 11

Feature: Stock Tank WB106		
Date: 4/19/2011		
Comments: Stock tank WB106. Facing north.		
Photograph ID: 12

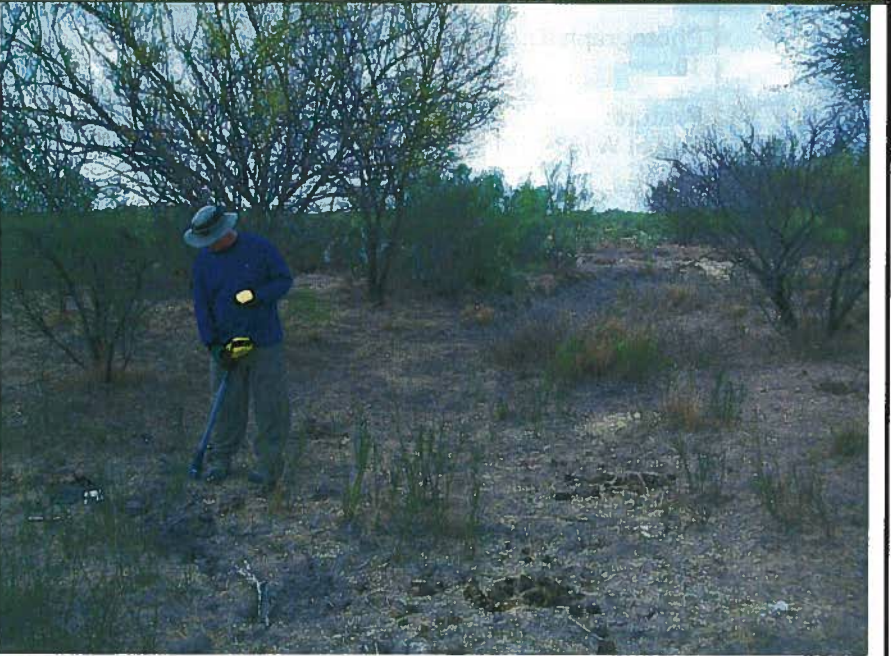
Feature: Wetland W109 (W109-WDP)		
Date: 4/20/2011		
Comments: Wetland W109 at W109-WDP. Facing south.

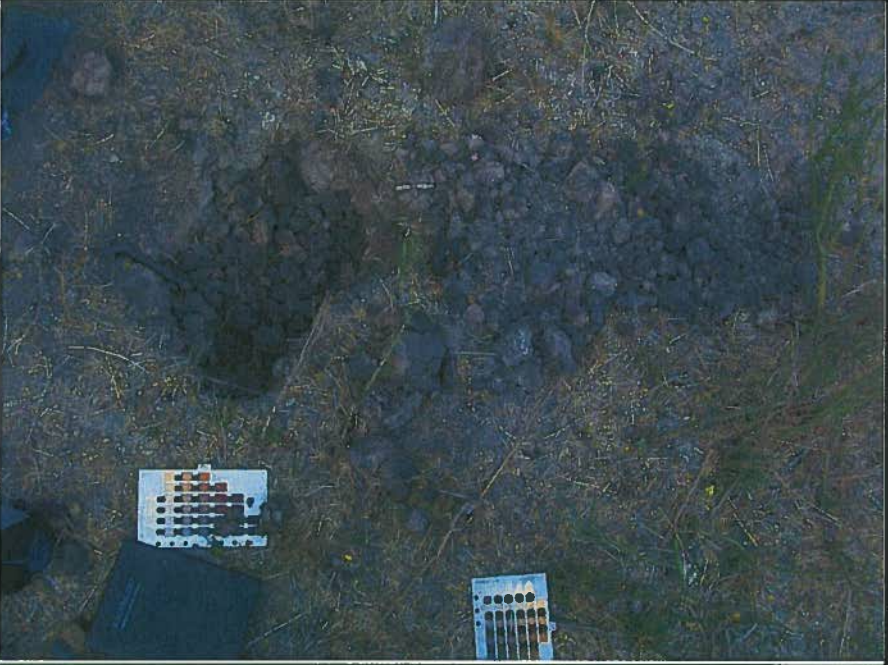
Client: Rancho Viejo Waste Management, LLC		Project Number: 182277	
Project Name: Pescadito Environmental Resource Center		County, State: Webb County, Texas	
Photograph ID: 13

Feature: Soil at W109-WDP			
Date: 4/20/2011			
Comments: Soil profile at W109-WDP wetland data point.			
Photograph ID: 14

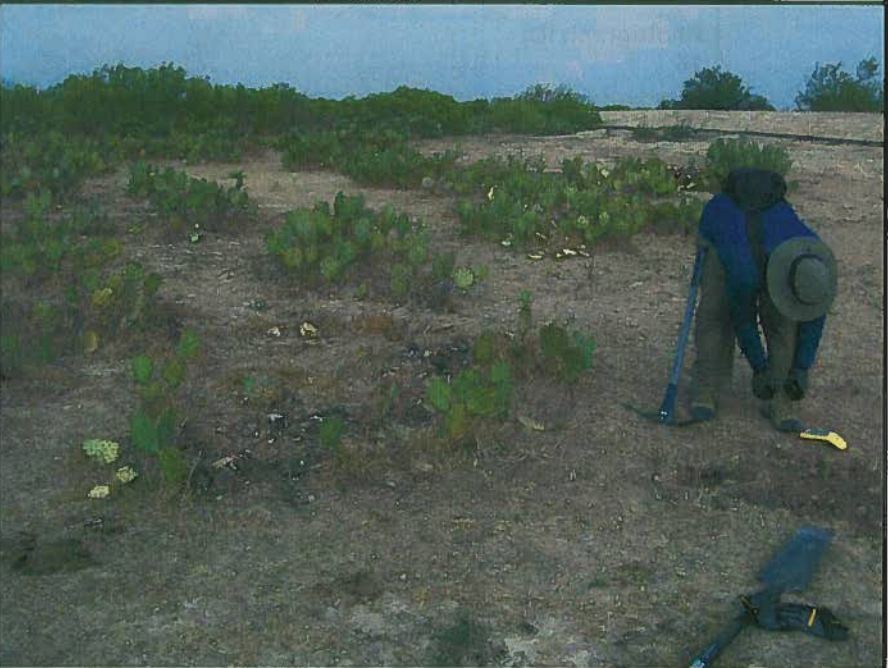
Feature: Upland habitat at W109-UDP			
Date: 4/20/2011			
Comments: Upland habitat at W109-UDP upland data point. Facing north.

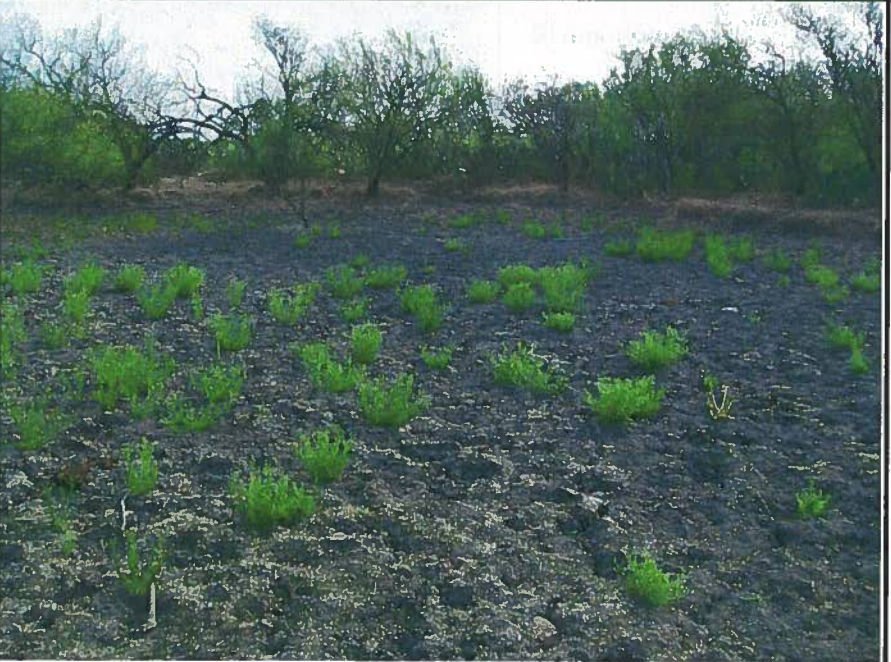
Feature: Stock Tank WB110		
Date: 4/20/2011		
Comments: Stock tank WB110. Facing north.

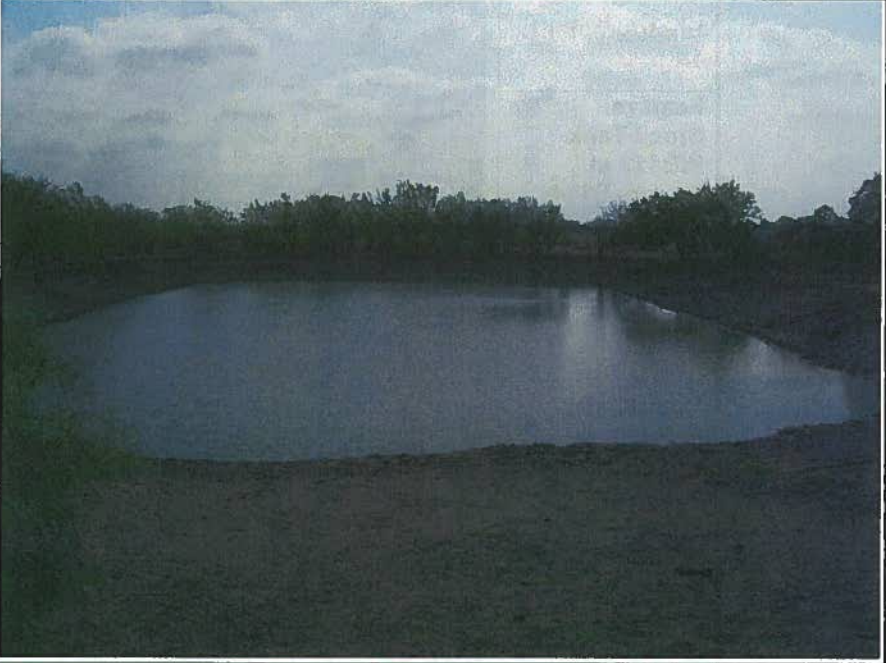
Client: Rancho Viejo Waste Management, LLC		Project Number: 182277
Project Name: Pescadito Environmental Resource Center		County, State: Webb County, Texas
Photograph ID: 17

Feature: Stock Tank WB111		
Date: 4/20/2011		
Comments: Stock Tank WB111. Facing east.		
Photograph ID: 18

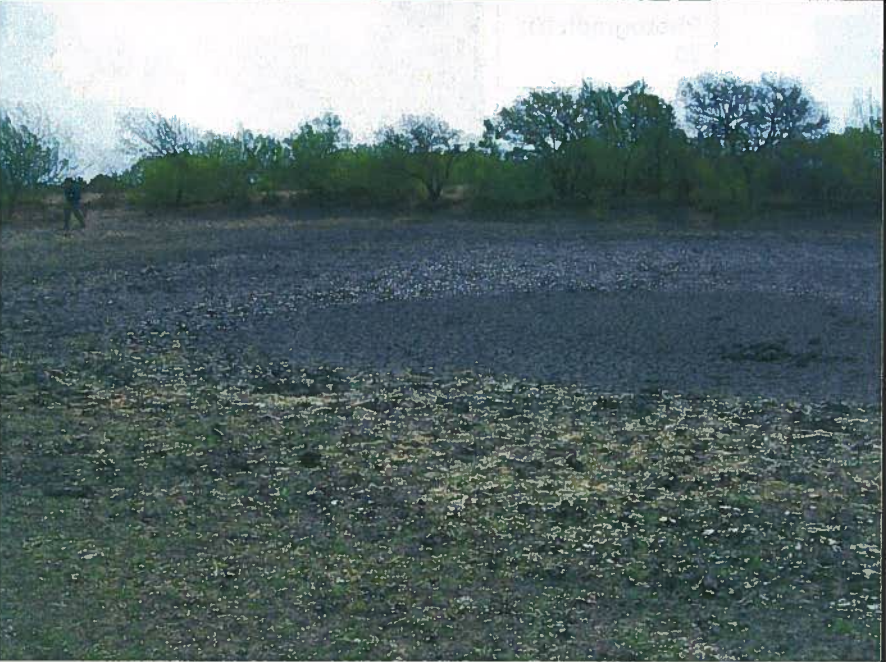
Feature: Stock Tank WB113		
Date: 4/20/2011		
Comments: Stock Tank WB113. Facing south.

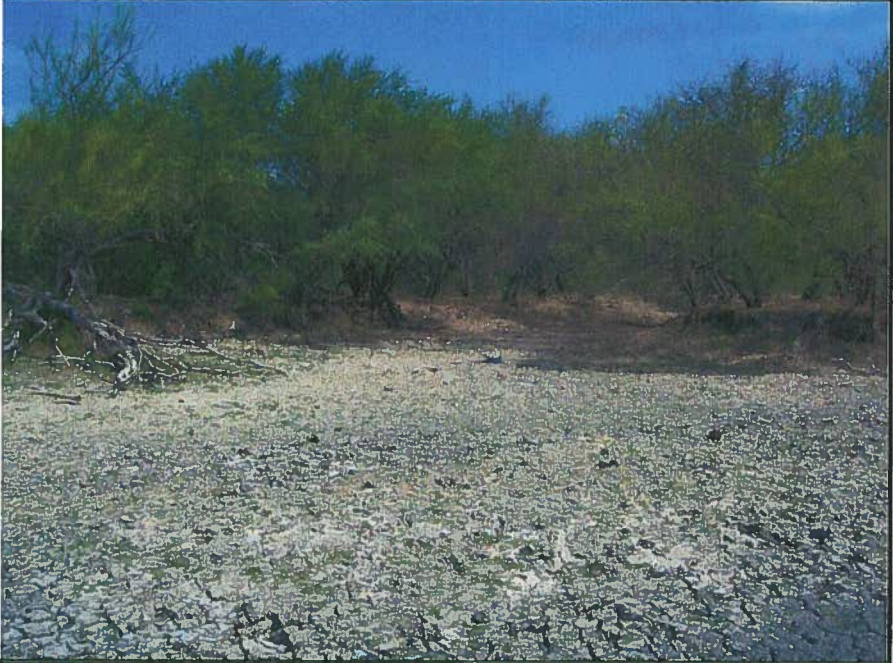
Client: Rancho Viejo Waste Management, LLC		Project Number: 182277
Project Name: Pescadito Environmental Resource Center		County, State: Webb County, Texas
Photograph ID: 19

Feature: Stock Tank WB113 at Stream S114		
Date: 4/20/2011		
Comments: Stock tank WB113 at ephemeral stream S114. Facing north.		
Photograph ID: 20

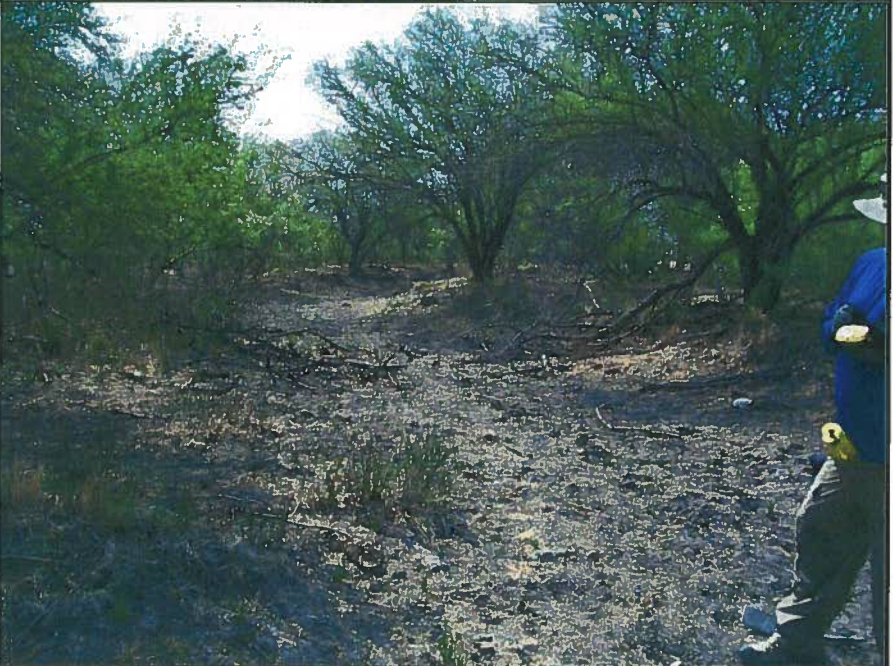
Feature: Wetland W115 and Stream S114		
Date: 4/20/2011		
Comments: Wetland W115 (left of photo), located adjacent to ephemeral stream S114 (background). Facing north (upstream).

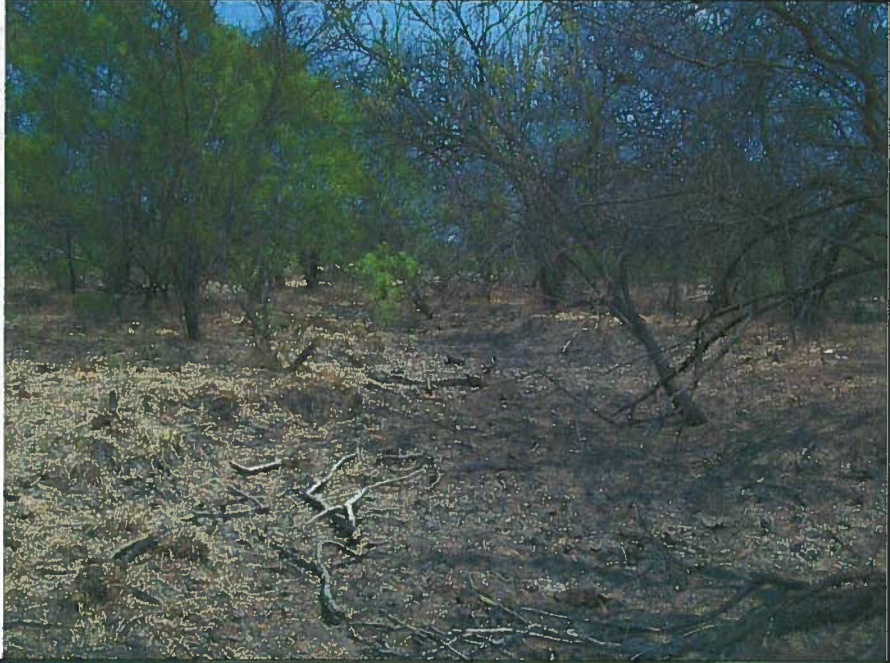
Client: Rancho Viejo Waste Management, LLC		Project Number: 182277	
Project Name: Pescadito Environmental Resource Center		County, State: Webb County, Texas	
Photograph ID: 21

Feature: Stream S114			
Date: 4/20/2011			
Comments: Ephemeral stream S114. Facing north (upstream).			
Photograph ID: 22

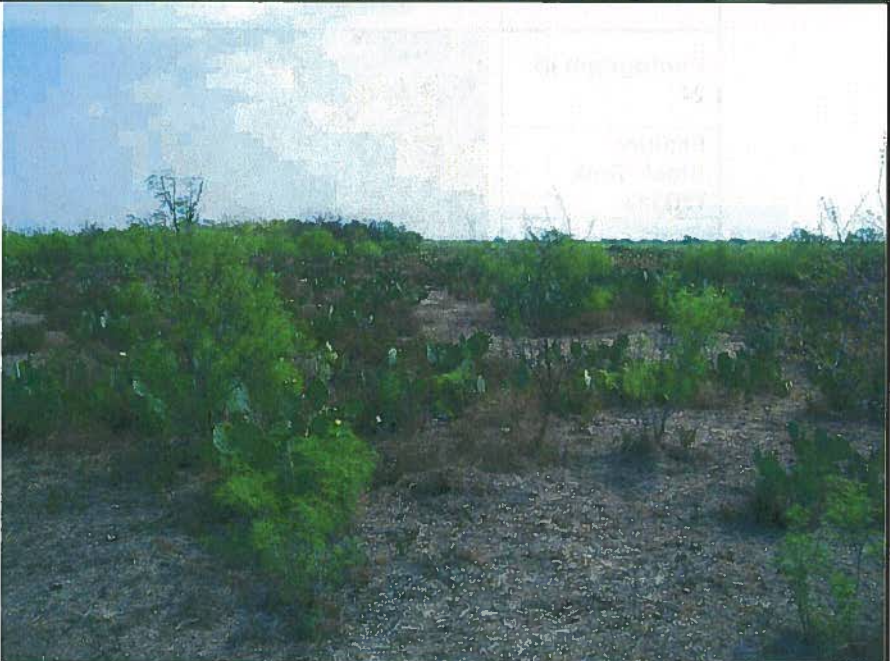
Feature: Upland Habitat at W115/W118-UDP			
Date: 4/20/2011			
Comments: Upland habitat at W115/W118-UDP upland data point. Facing east.

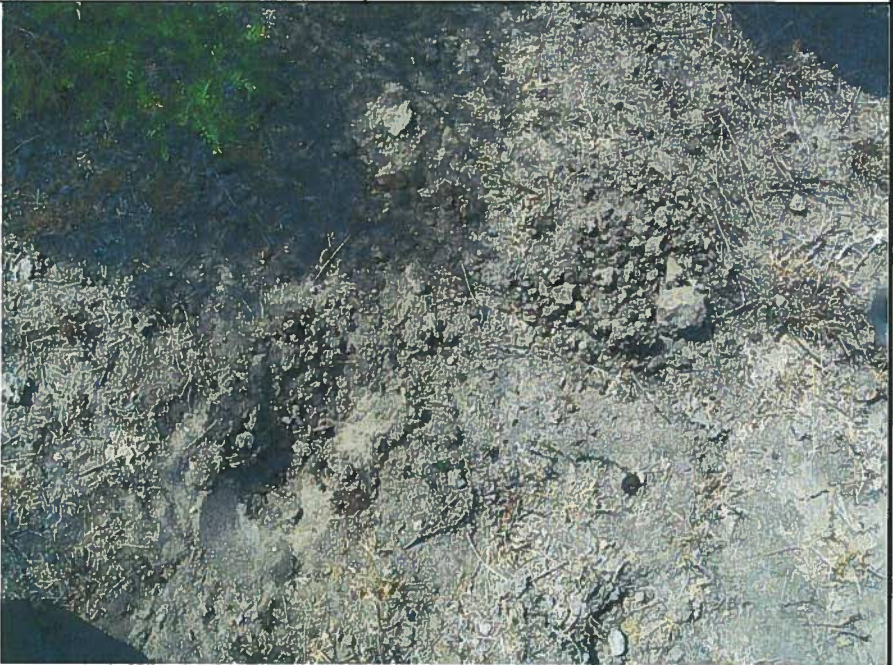
Client: Rancho Viejo Waste Management, LLC		Project Number: 182277	
Project Name: Pescadito Environmental Resource Center		County, State: Webb County, Texas	
Photograph ID: 23

Feature: Soil at W115/W118- UDP			
Date: 4/20/2011			
Comments: Soil at W115/W118- UDP upland data point.			
Photograph ID: 24

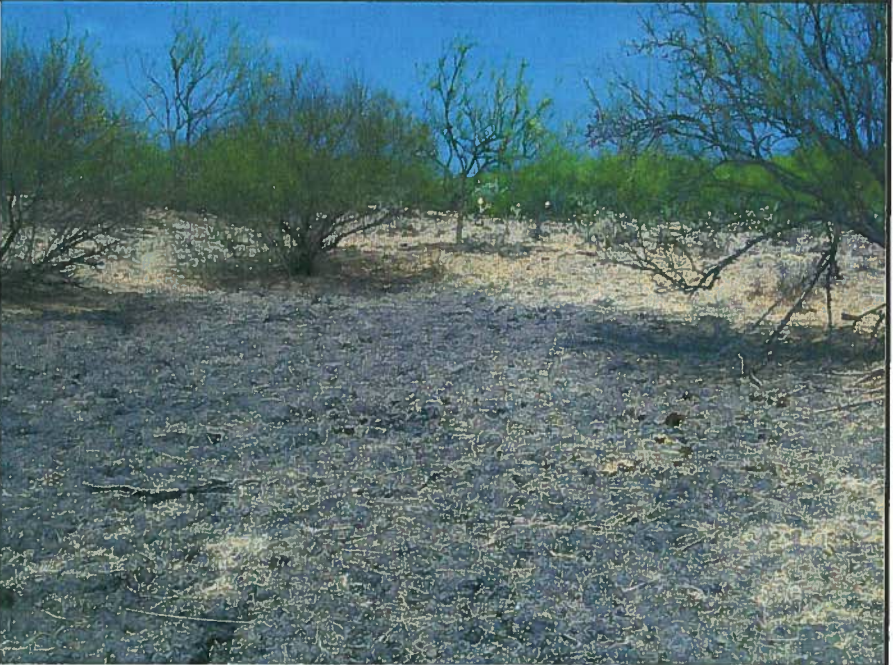
Feature: Stock Tank WB117			
Date: 4/20/2011			
Comments: Stock Tank WB117. Facing north.

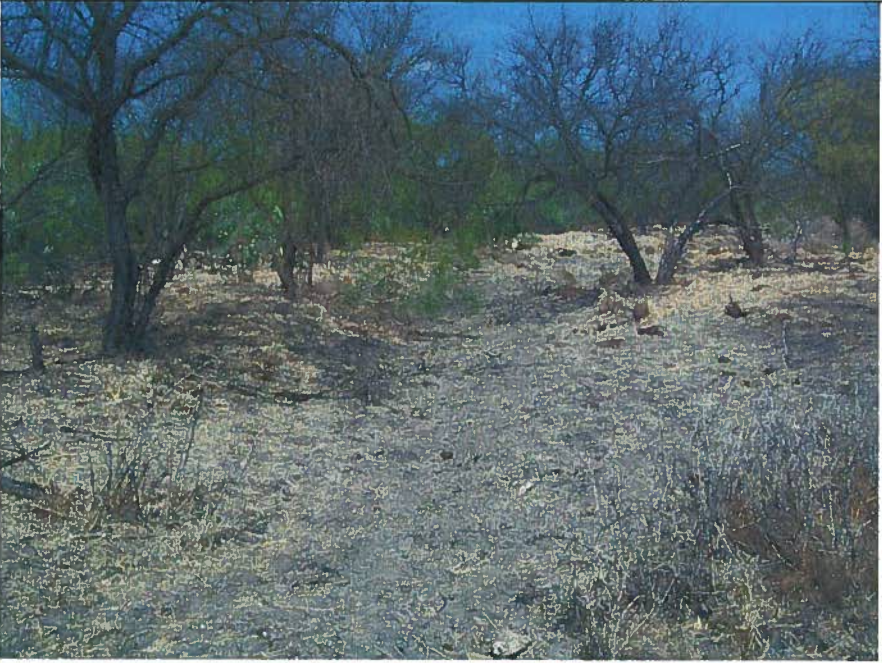
Client: Rancho Viejo Waste Management, LLC		Project Number: 182277	
Project Name: Pescadito Environmental Resource Center		County, State: Webb County, Texas	
Photograph ID: 25

Feature: Wetland W118			
Date: 4/20/2011			
Comments: Wetland W118, located within an abandoned drainage channel created by stock tank construction. Facing north.			
Photograph ID: 26

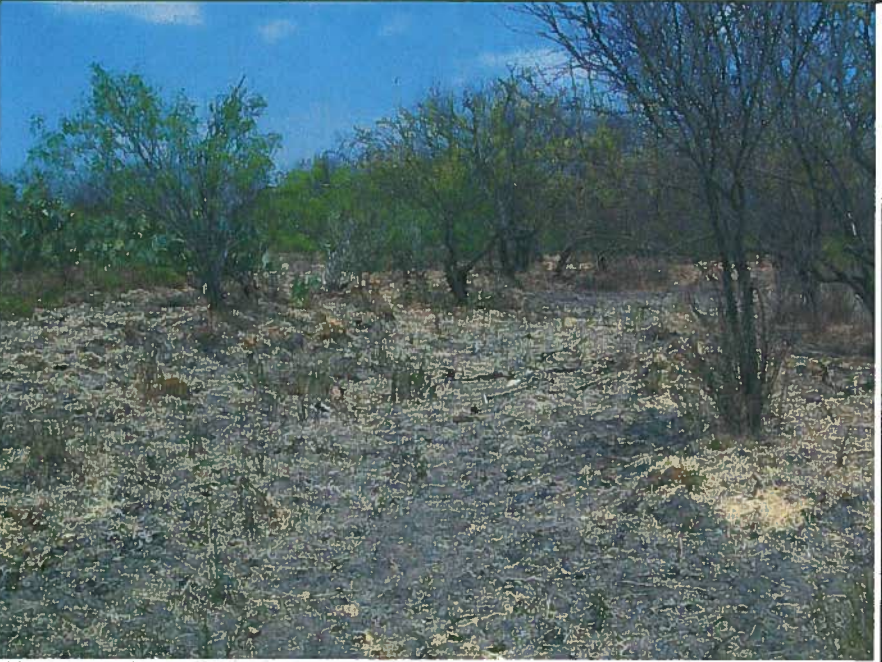
Feature: Stream S116			
Date: 4/20/2011			
Comments: Ephemeral stream S116. Facing north (upstream).

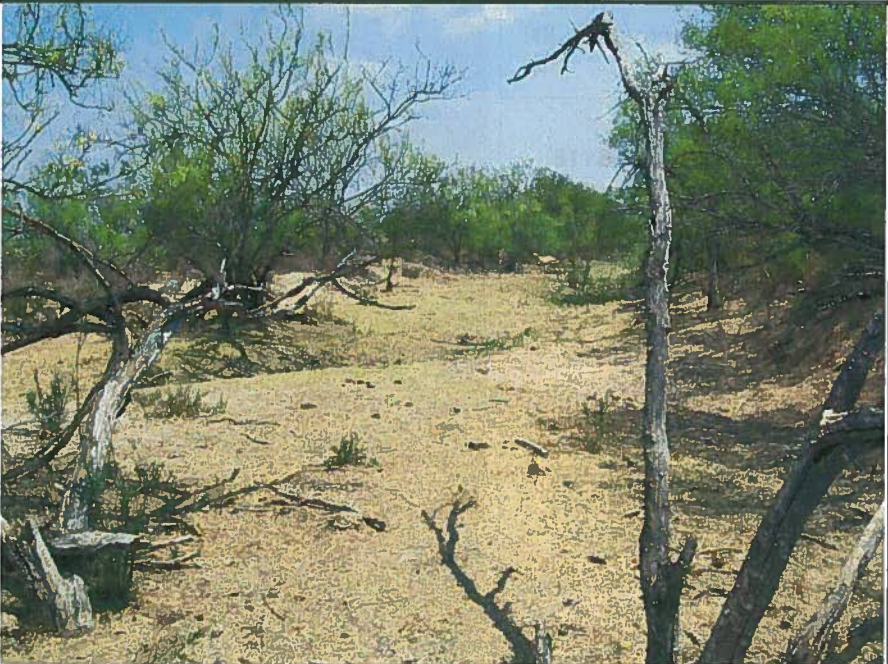
Feature: Streams S120 and S121			
Date: 4/20/2011			
Comments: Confluence of ephemeral stream S120 (left of photo) and S121 (foreground and background). Facing east (downstream).

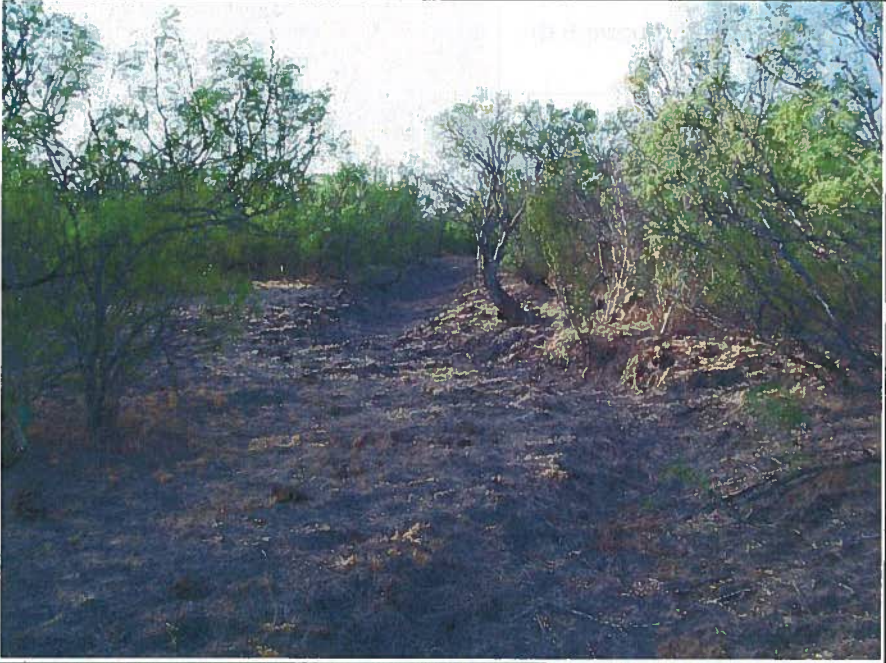
Client: Rancho Viejo Waste Management, LLC	Project Number: 182277
Project Name: Pescadito Environmental Resource Center	County, State: Webb County, Texas
Photograph ID: 29

Feature: Stream S123	
Date: 4/21/2011	
Comments: Ephemeral stream S123. Facing downstream (south).	
Photograph ID: 30

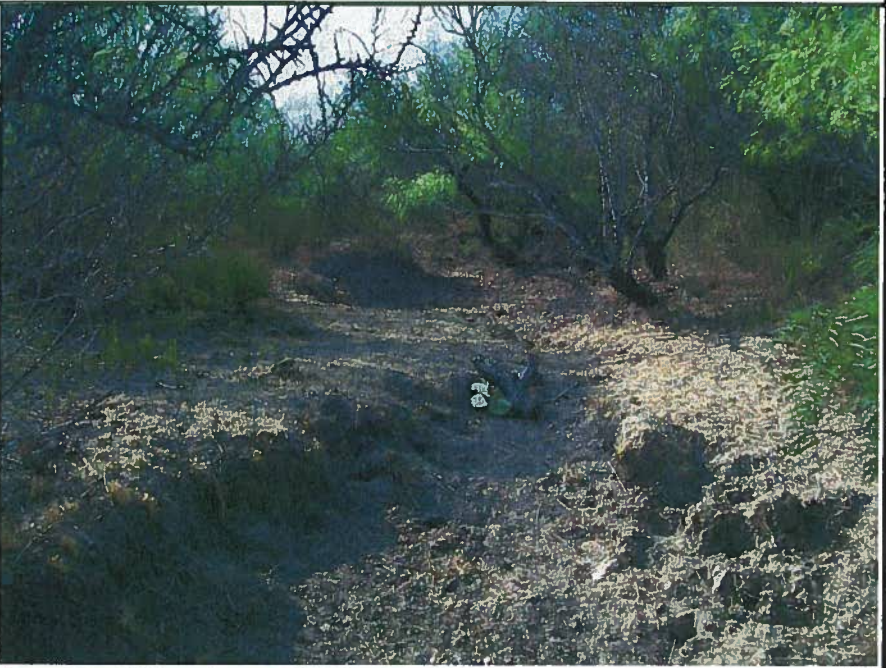
Feature: Stream S124	
Date: 4/21/2011	
Comments: Ephemeral stream S124. Facing south (downstream).

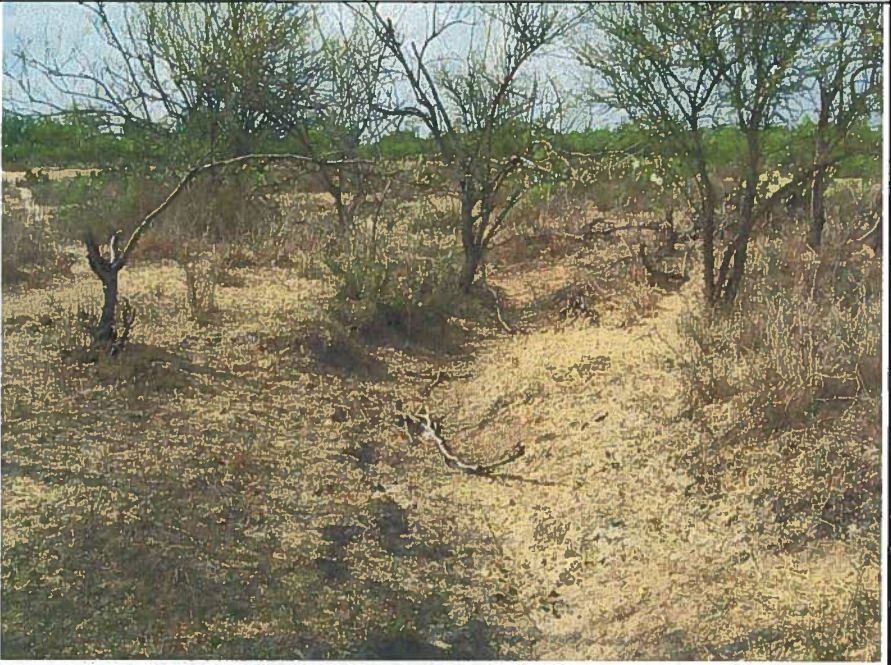
Client: Rancho Viejo Waste Management, LLC		Project Number: 182277
Project Name: Pescadito Environmental Resource Center		County, State: Webb County, Texas
Photograph ID: 31

Feature: Stream S125		
Date: 4/21/2011		
Comments: Ephemeral stream S125. Facing south (downstream).		
Photograph ID: 32

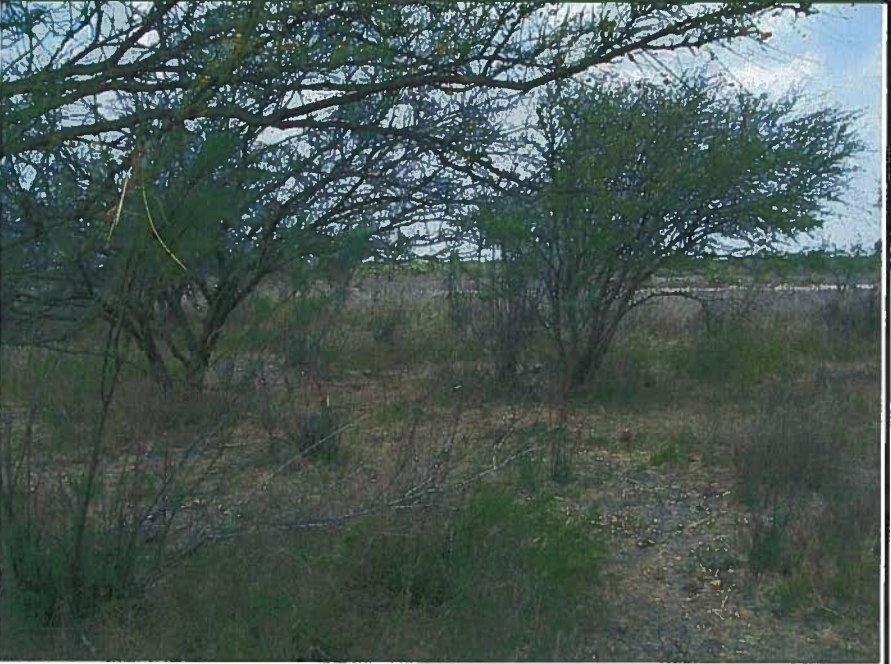
Feature: Wetland W126		
Date: 4/21/2011		
Comments: Wetland W126. Facing west.

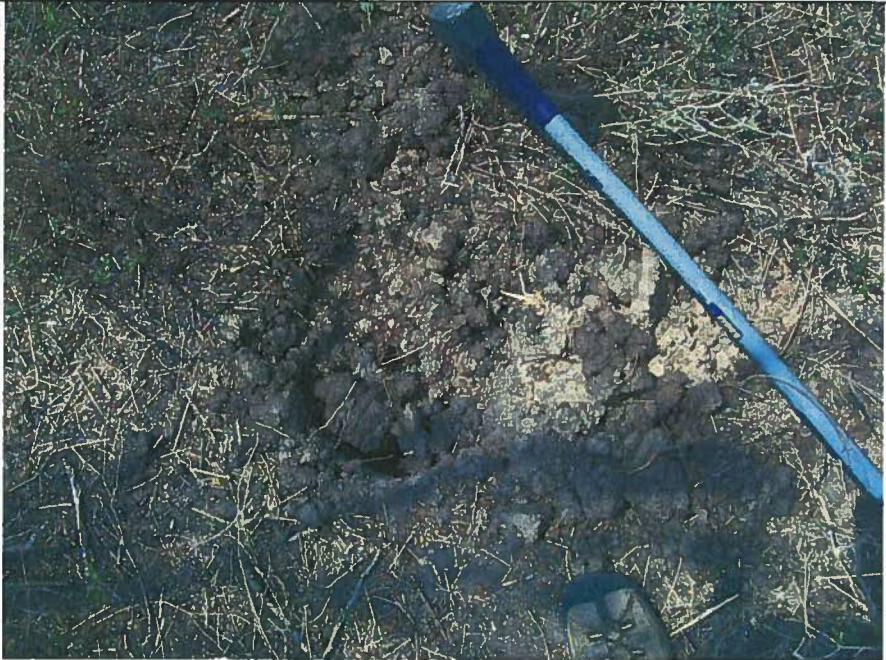
Client: Rancho Viejo Waste Management, LLC		Project Number: 182277	
Project Name: Pescadito Environmental Resource Center		County, State: Webb County, Texas	
Photograph ID: 33

Feature: Soil at W126-WDP			
Date: 4/21/2011			
Comments: Soil at W126-WDP wetland data point.			
Photograph ID: 34

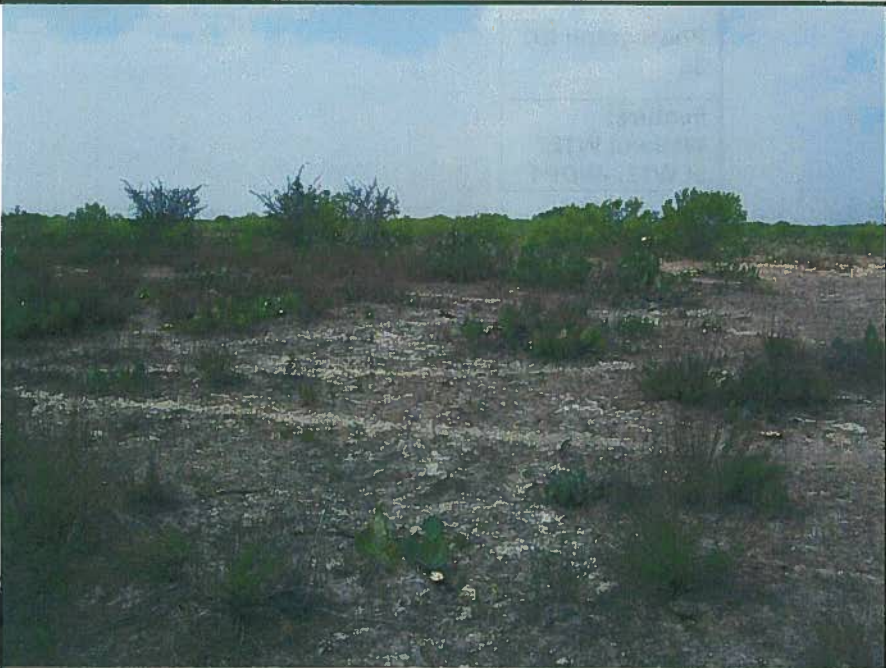
Feature: Upland habitat at W126-UDP			
Date: 4/21/2011			
Comments: Upland habitat at W126-UDP upland data point. Facing west.

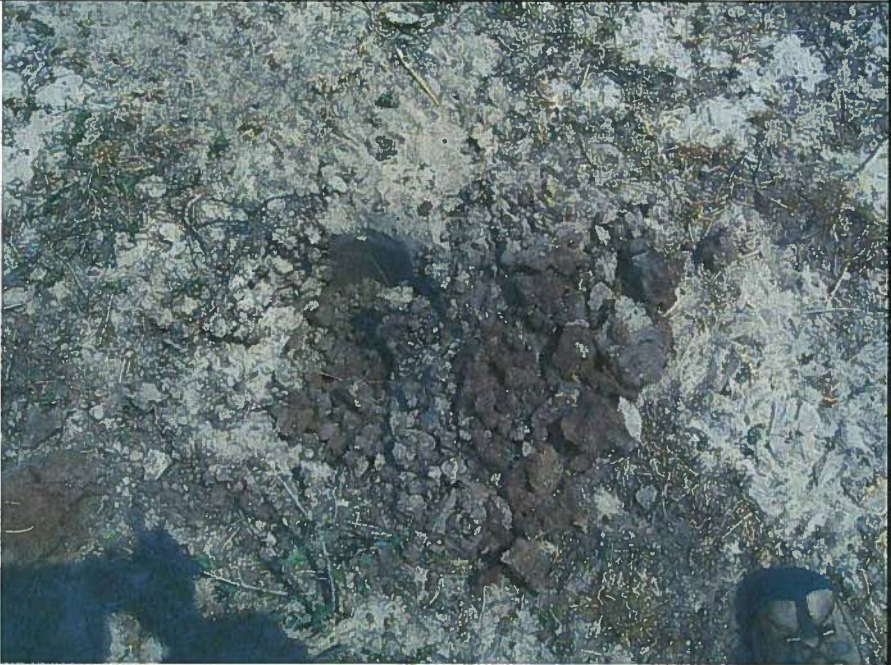
Client: Rancho Viejo Waste Management, LLC		Project Number: 182277	
Project Name: Pescadito Environmental Resource Center		County, State: Webb County, Texas	
Photograph ID: 35

Feature: Soil at W126-UDP			
Date: 4/21/2011			
Comments: Soil at W126-UDP upland data point.			
Photograph ID: 36

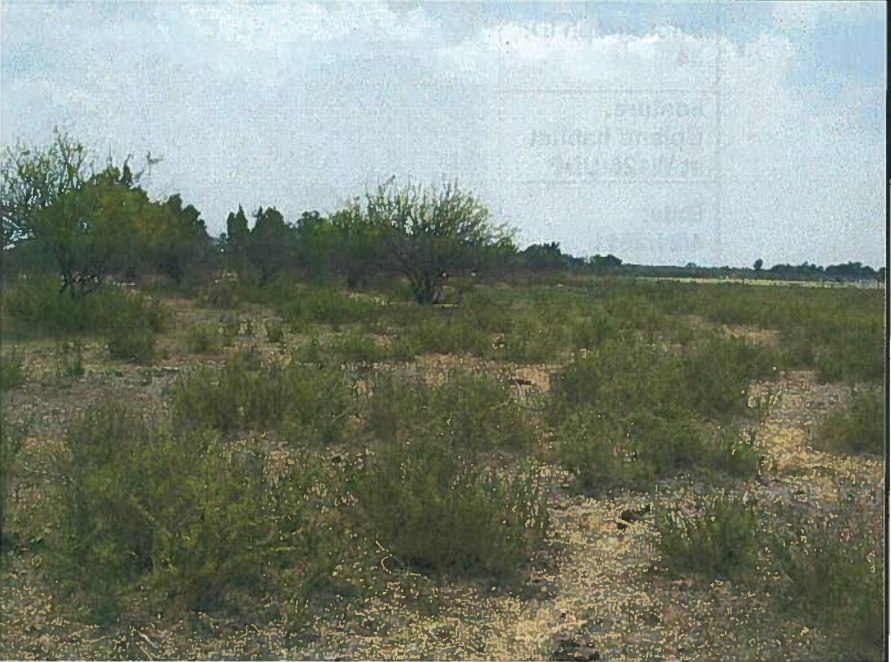
Feature: Wetland W127 at W127-WDP1			
Date: 4/21/2011			
Comments: Wetland W127 at W127-WDP1. Facing south.

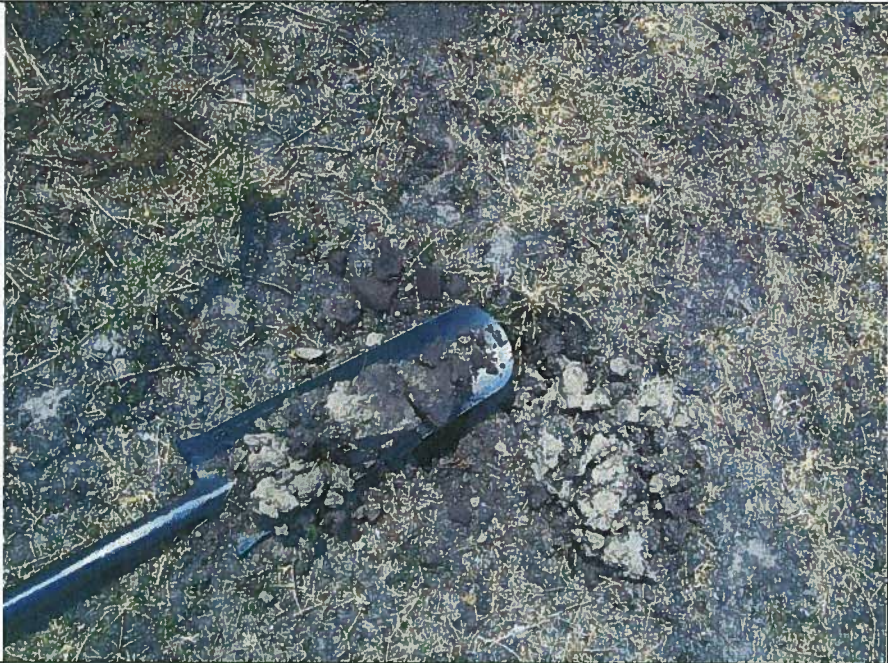
Client: Rancho Viejo Waste Management, LLC		Project Number: 182277	
Project Name: Pescadito Environmental Resource Center		County, State: Webb County, Texas	
Photograph ID: 37

Feature: Soil at W127-WDP1			
Date: 4/21/2011			
Comments: Soil at W127-WDP1 wetland data point.			
Photograph ID: 38

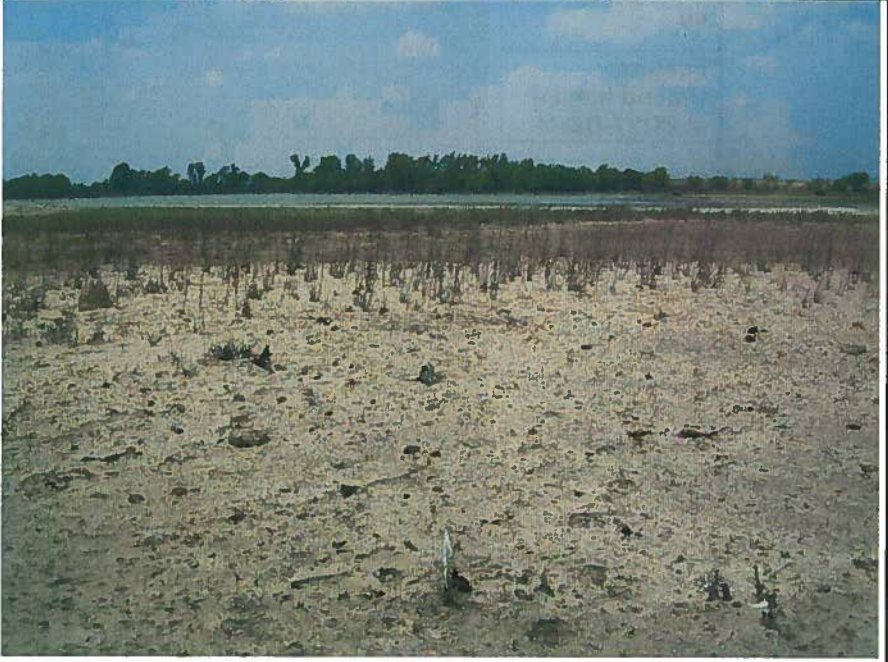
Feature: Sparse Vegetation at W127 and Stock Tank WB128			
Date: 4/21/2011			
Comments: Area of sparse vegetation at W127, a result of saline soils. Stock tank WB128 in background. Facing south.

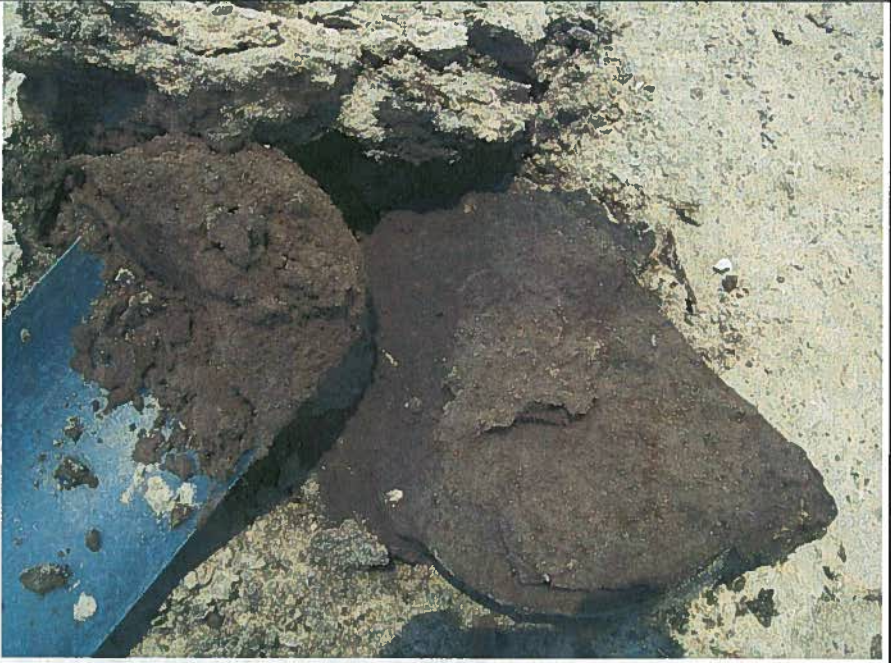
Client: Rancho Viejo Waste Management, LLC	Project Number: 182277
Project Name: Pescadito Environmental Resource Center	County, State: Webb County, Texas
Photograph ID: 39

Feature: Soil at W127	
Date: 4/21/2011	
Comments: Hydric soil at sparsely vegetated area of W127.	
Photograph ID: 40
