APPLICATION FOR PERMIT
TYPE I MUNICIPAL SOLID WASTE FACILITY
MSW PERMIT NO. 2374
PESCADITO ENVIRONMENTAL
RESOURCE CENTER
RANCHO VIEJO WASTE MANAGEMENT, LLC
SOLID WASTE DISPOSAL FACILITY
LAREDO, WEBB COUNTY, TEXAS

March 28, 2011
Revised September 14, 2011

**Reference: Pescadito Environmental Resource Center – Webb County
Municipal Solid Waste (MSW) – Proposed Permit No. 2374
Response to First Notice of Deficiency (NOD)
Tracking No. 14710139; CN603835489/RN106119639**

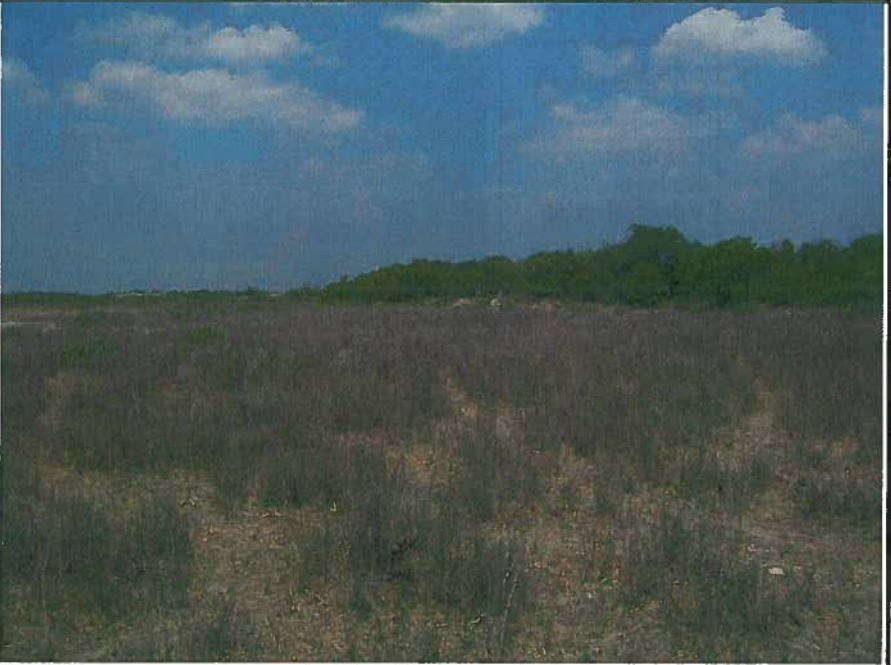
Feature: Upland habitat at W127-UDP1	
Date: 4/21/2011	
Comments: Upland habitat at W127-UDP1 upland data point. Facing north.

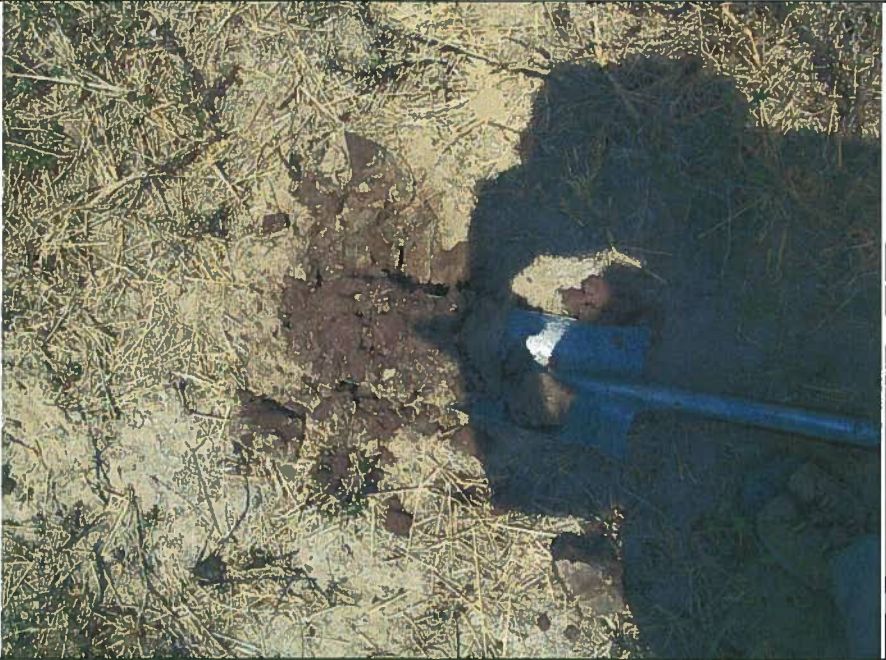
Client: Rancho Viejo Waste Management, LLC		Project Number: 182277	
Project Name: Pescadito Environmental Resource Center		County, State: Webb County, Texas	
Photograph ID: 41

Feature: Soil at W127-UDP1			
Date: 4/21/2011			
Comments: Soil profile at W127-UDP1 upland data point.			
Photograph ID: 42

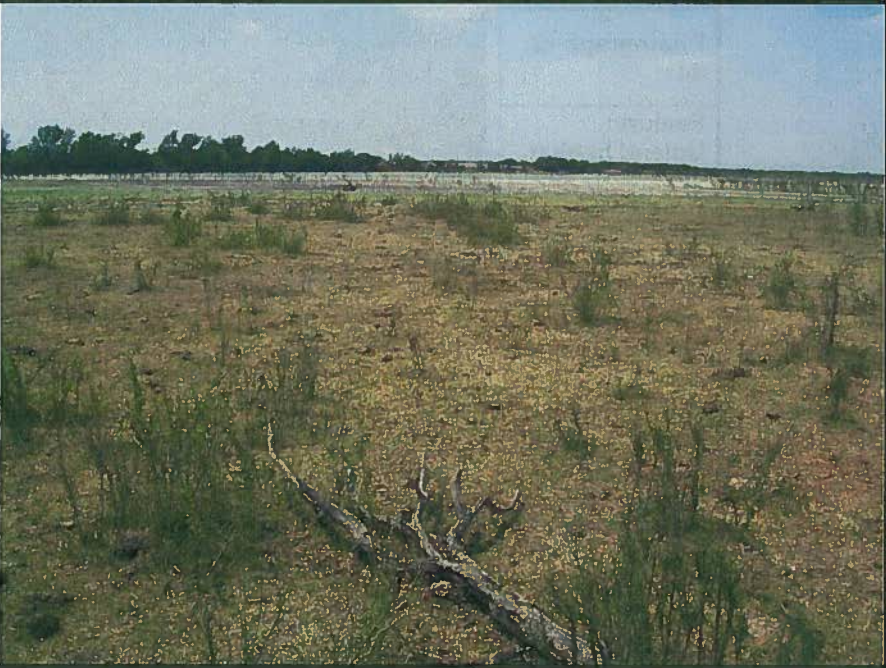
Feature: Wetland W127 at W127-WDP2 and Stock Tank WB128			
Date: 4/21/2011			
Comments: Fringe area of wetland W127, near W127-WDP2. Stock tank WB128 in background. Facing southwest.

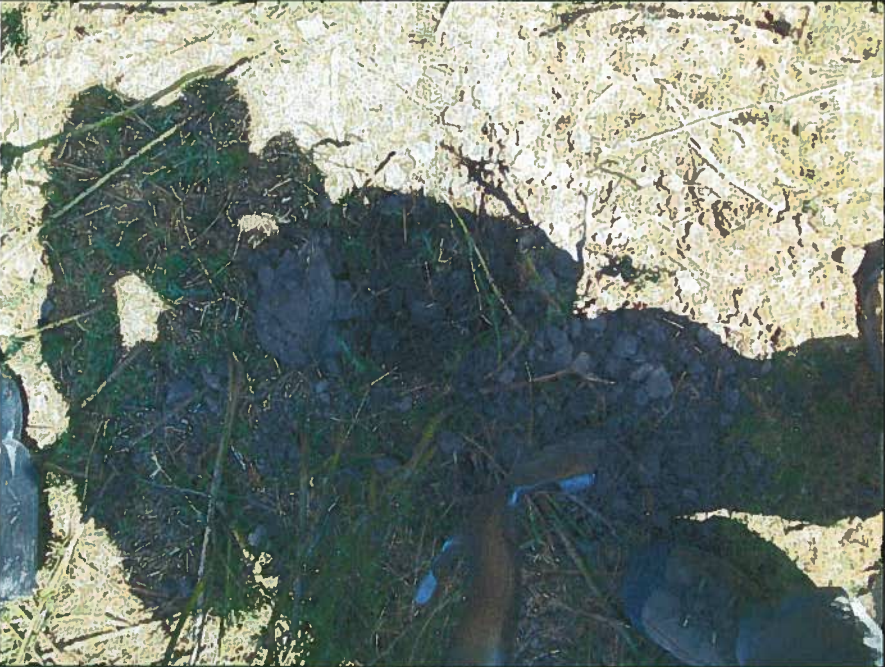
Client: Rancho Viejo Waste Management, LLC		Project Number: 182277	
Project Name: Pescadito Environmental Resource Center		County, State: Webb County, Texas	
Photograph ID: 45

Feature: Soil at W127-UDP2			
Date: 4/21/2011			
Comments: Soil profile at W127-UDP2 upland data point.			
Photograph ID: 46

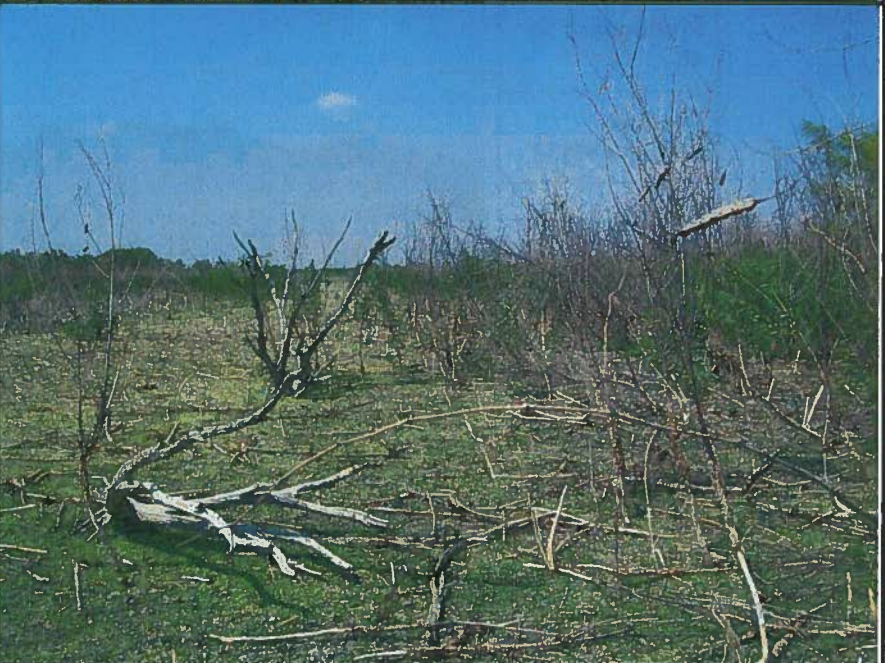
Feature: Wetland W127 at Stream S121			
Date: 4/21/2011			
Comments: Wetland W127 at ephemeral stream S121 (left of photo). Facing north.

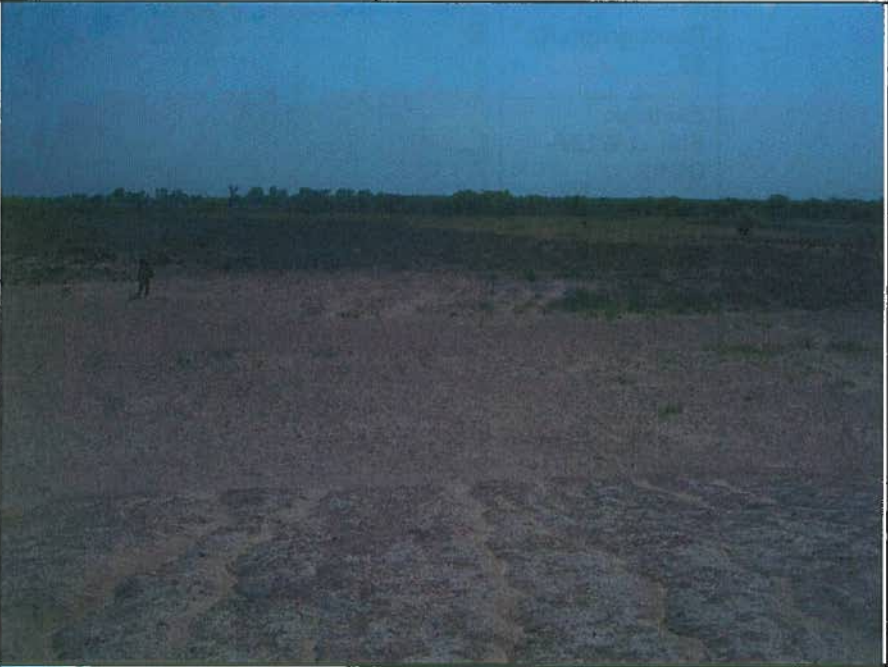
Client: Rancho Viejo Waste Management, LLC		Project Number: 182277
Project Name: Pescadito Environmental Resource Center		County, State: Webb County, Texas
Photograph ID: 47

Feature: Wetland W127 at W104 Impoundment		
Date: 4/21/2011		
Comments: Wetland W127 (background) at W104 impoundment (foreground). Facing south.		
Photograph ID: 48

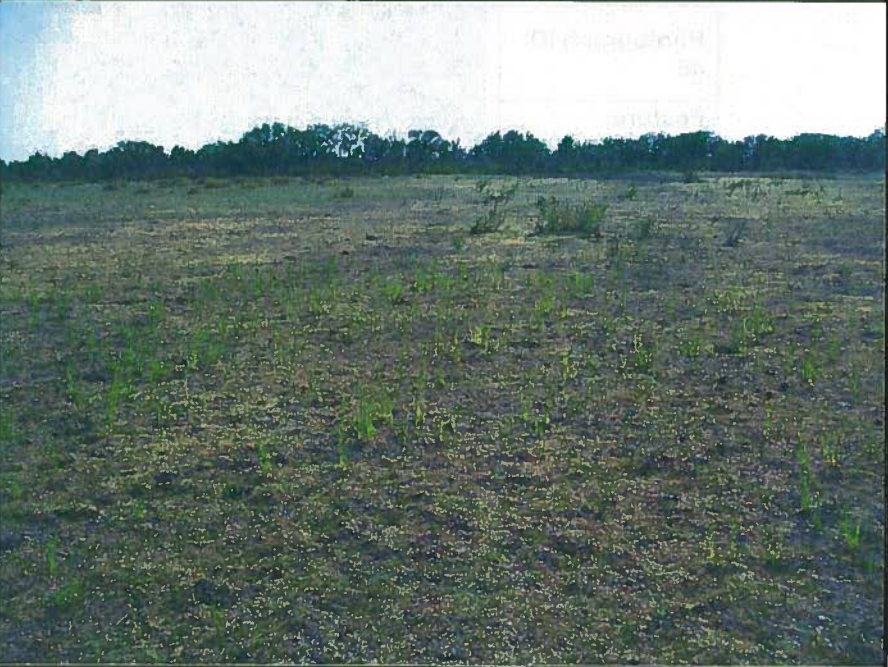
Feature: Wetland W130		
Date: 4/21/2011		
Comments: Wetland W130. Facing south.

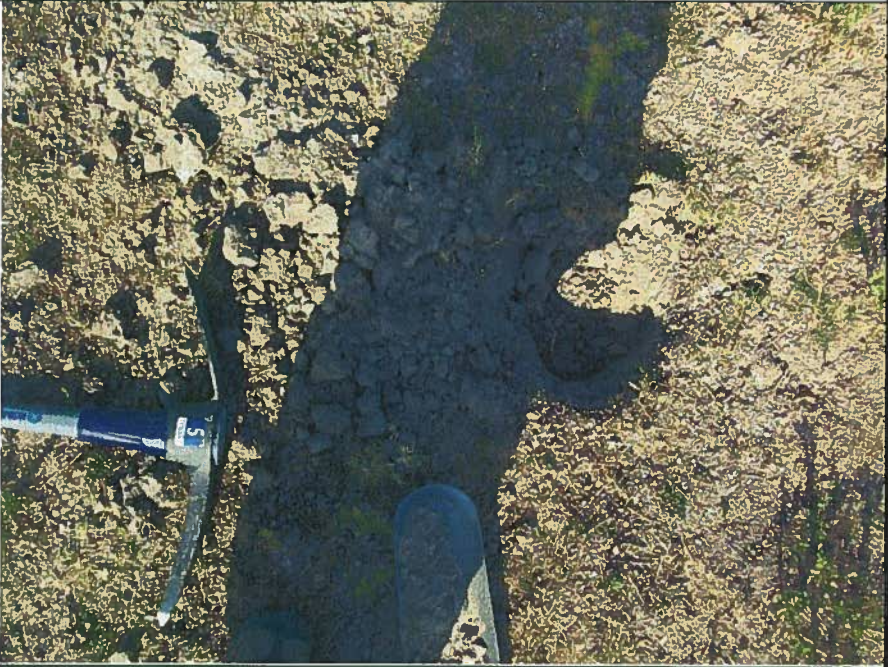
Client: Rancho Viejo Waste Management, LLC		Project Number: 182277	
Project Name: Pescadito Environmental Resource Center		County, State: Webb County, Texas	
Photograph ID: 49

Feature: Soil at W130-UDP1			
Date: 4/21/2011			
Comments: Soil at W130-WDP wetland data point.			
Photograph ID: 50

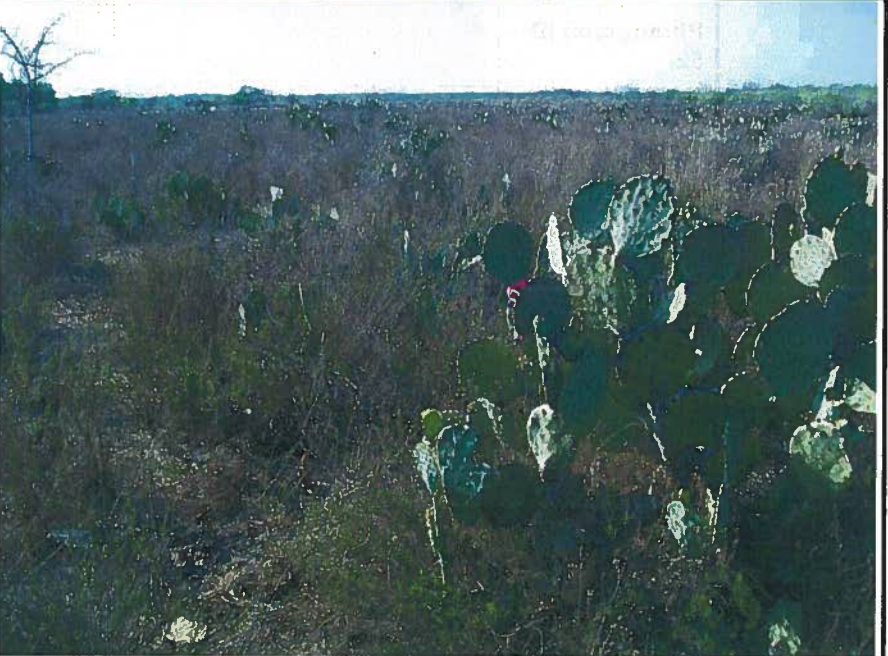
Feature: Upland habitat at W127/W130-UDP			
Date: 4/21/2011			
Comments: Upland habitat at W127/W130-UDP upland data point. Facing northwest.

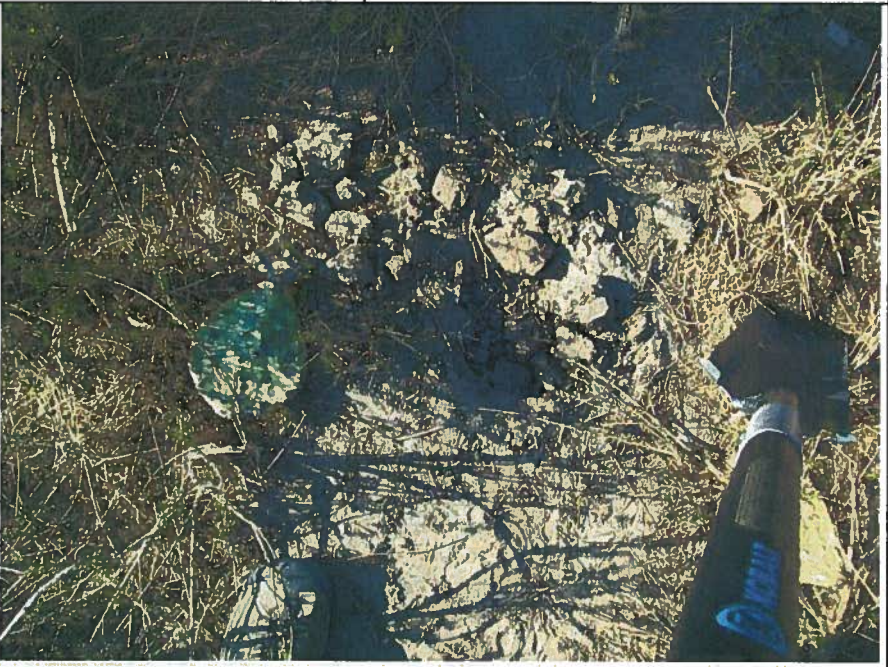
Client: Rancho Viejo Waste Management, LLC		Project Number: 182277	
Project Name: Pescadito Environmental Resource Center		County, State: Webb County, Texas	
Photograph ID: 51

Feature: Soil at W12/W130-UDP	
Date: 4/21/2011			
Comments: Soil at W127/W130- UDP upland data point.			
Photograph ID: 52

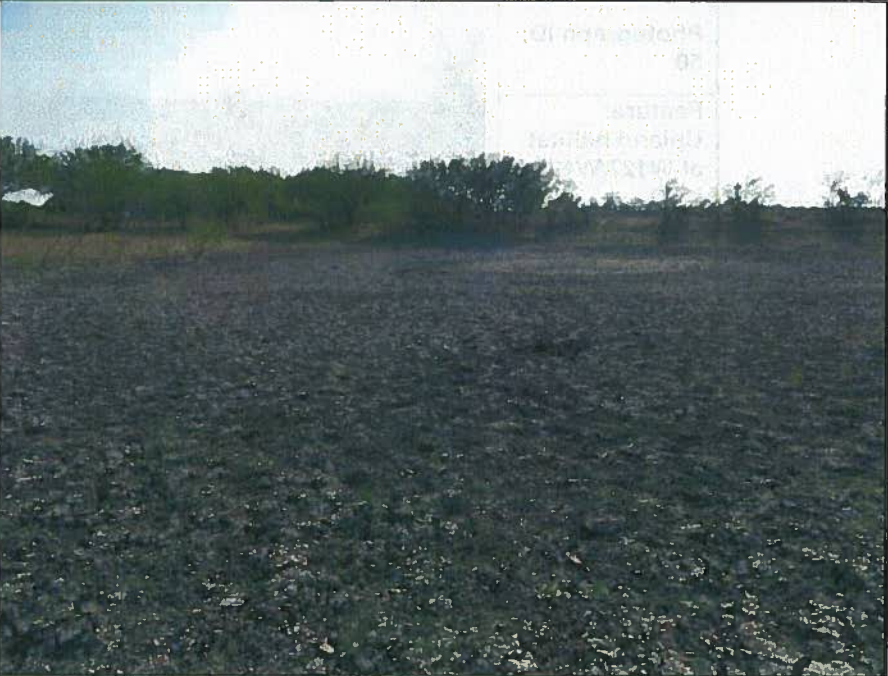
Feature: Stock Tank WB131	
Date: 4/21/2011			
Comments: Stock tank WB131. Facing west.

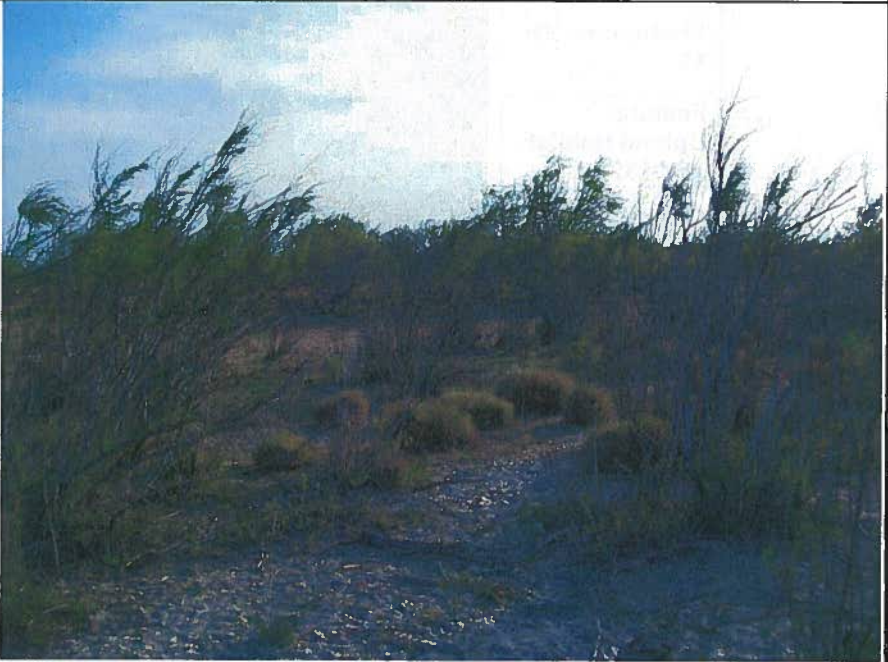
Client: Rancho Viejo Waste Management, LLC		Project Number: 182277	
Project Name: Pescadito Environmental Resource Center		County, State: Webb County, Texas	
Photograph ID: 53

Feature: Wetland W132			
Date: 4/21/2011			
Comments: Wetland W132. Facing southeast.			
Photograph ID: 54

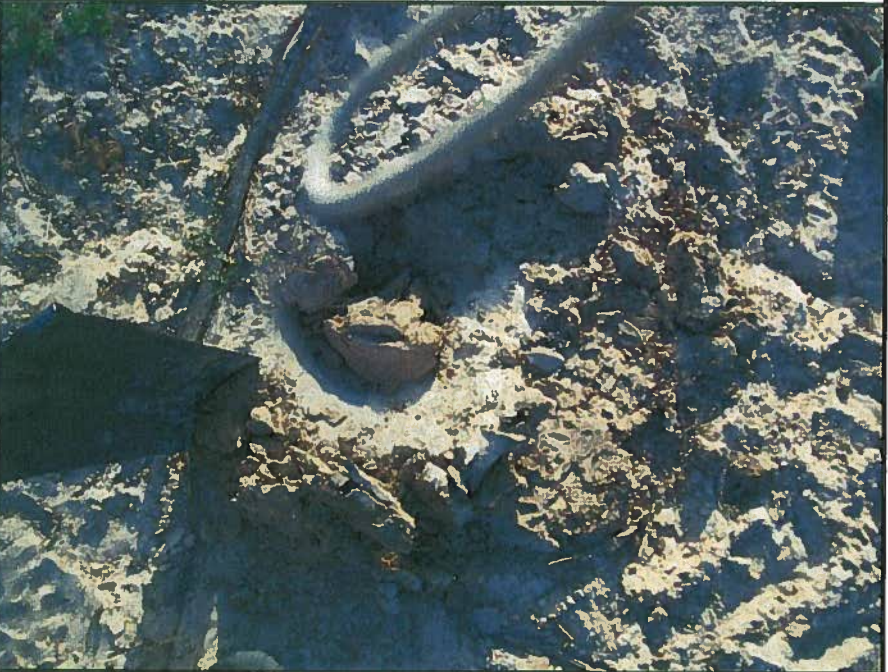
Feature: Soil at W132- WDP			
Date: 4/21/2011			
Comments: Soil at W132- WDP wetland data point.

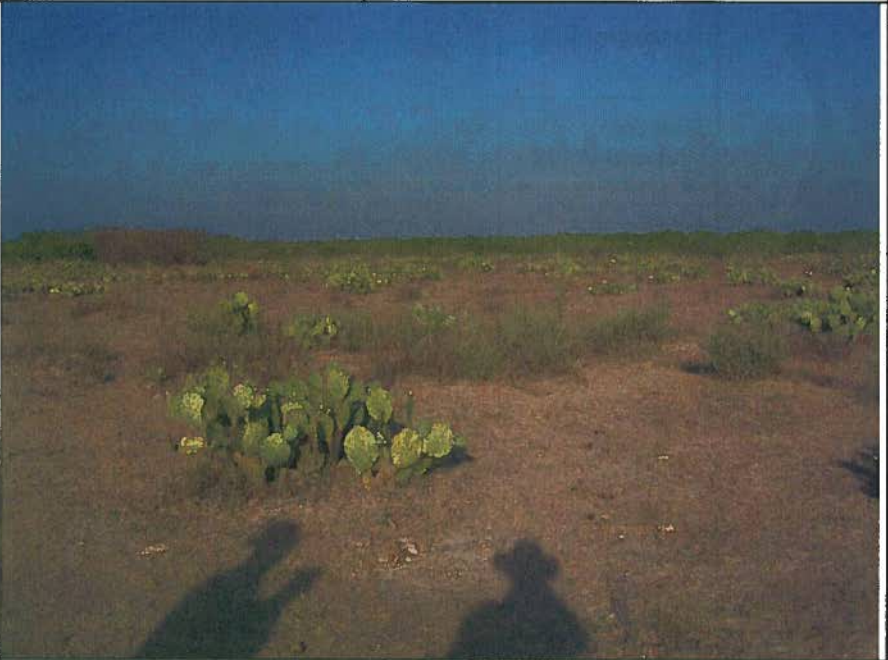
Client: Rancho Viejo Waste Management, LLC		Project Number: 182277	
Project Name: Pescadito Environmental Resource Center		County, State: Webb County, Texas	
Photograph ID: 55

Feature: Upland Habitat at W132-UDP			
Date: 4/21/2011			
Comments: Upland habitat at W132-UDP upland data point. Facing east.			
Photograph ID: 56

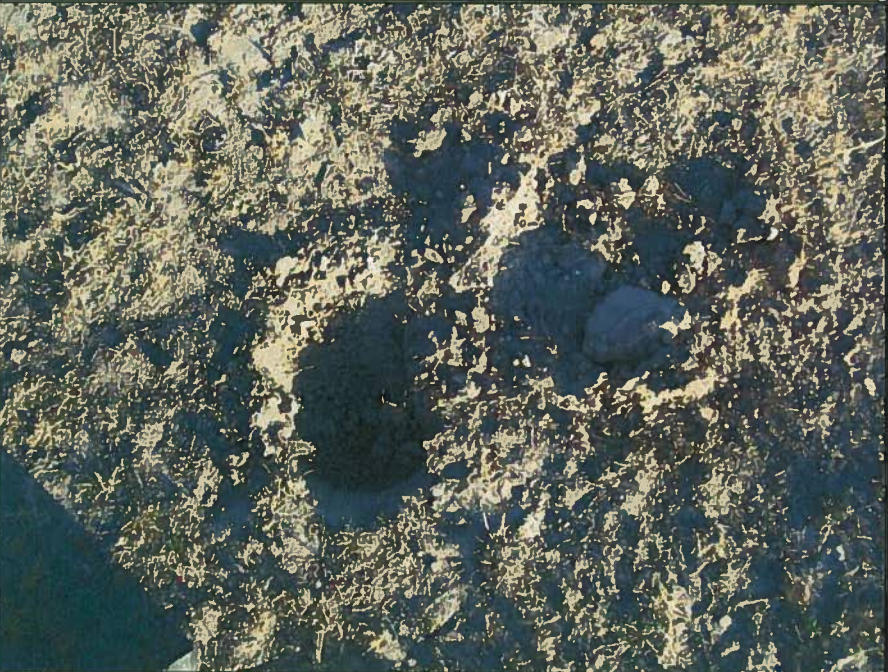
Feature: Soil at W132- UDP			
Date: 4/21/2011			
Comments: Soil at W132- UDP upland data point.
