GEOTECHNICAL DATA REPORT

PESCADITO ENVIRONMENTAL RESOURCE CENTER
TYPE I MUNICIPAL SOLID WASTE MANAGEMENT FACILITY
LAREDO, WEBB COUNTY, TEXAS
MSW PERMIT NO. 2374

PROJECT NO. ASF13-140-00

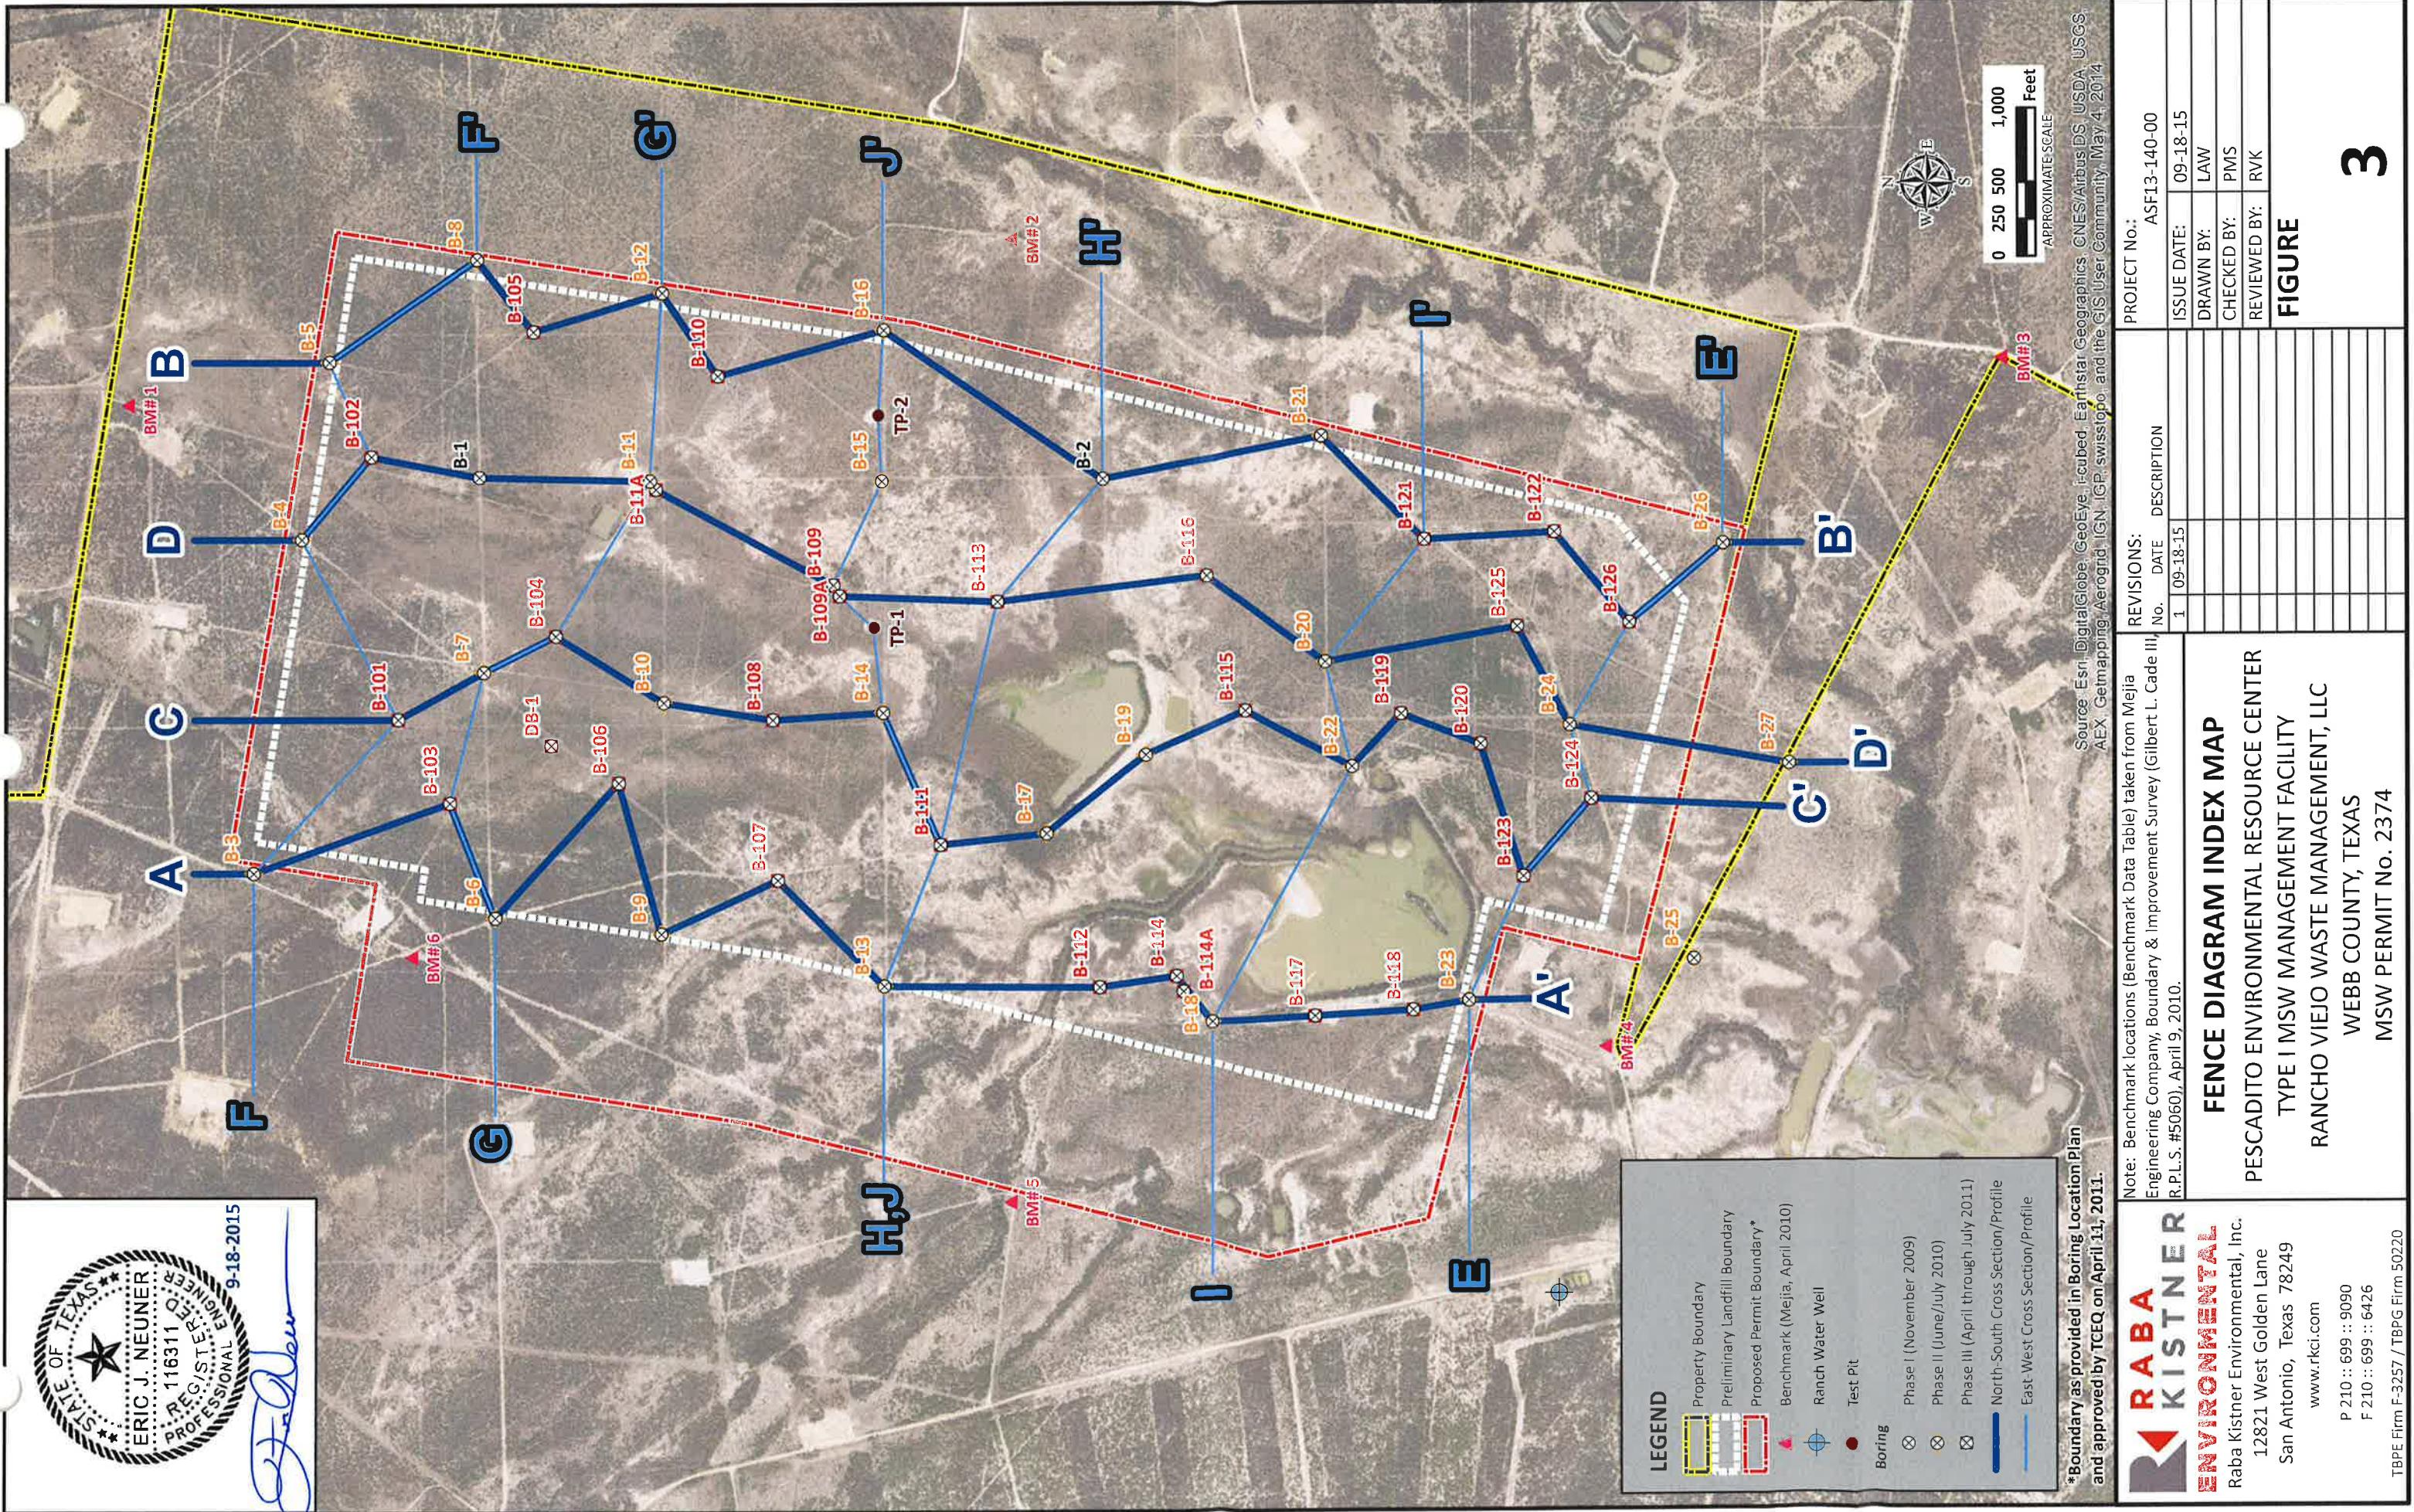
Generalized soil profiles corresponding to geologic (stratigraphic) fence diagrams included as **Figures 4 through 13** of the SIR present the soil type, layer thickness, and depth to water are also presented on **Figures C-1 through C-10** in **Appendix C** of this report. An index map is provided as **Figure 3 – Fence Diagram Index Map**. These profiles depict that the majority of soils observed in the borings were cohesive in nature and the granular inclusions were sporadic and discontinuous across the site.
