**Part III  
Attachment III-E  
Appendix III-E.5**

**SUPPLEMENTAL SUBSURFACE INVESTIGATION REPORT  
PHASE V**

**Pescadito Environmental Resource Center  
MSW No. 2374  
Webb County, Texas**

**Initial Submittal September 2015**

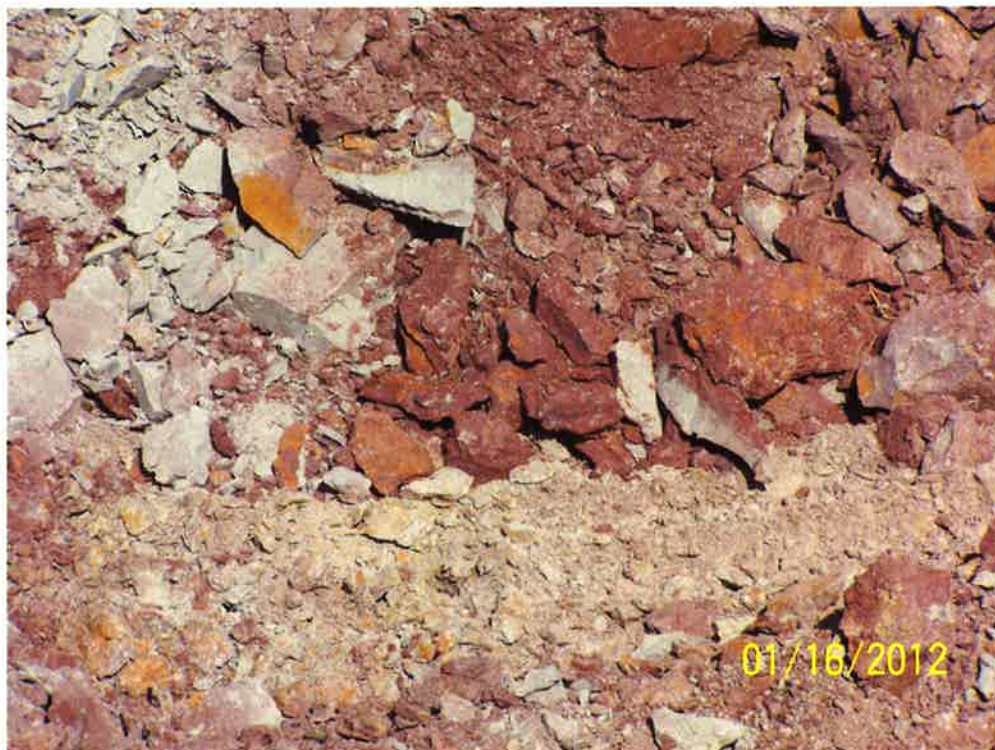
**Photo 1 - Test Pit 1 - January 2012**

The Y-J encountered at the site is predominantly (>90%) “claystone” with minor amounts of “sandstone” and “siltstone.” The encountered Y-J materials appear “rock-like” due to the fact that they have been heavily over-consolidated during their geologic history. In essence they are “compaction” claystones as opposed to cemented claystones. However, when exposed to the elements for a brief period or when processed, these rock-like materials quickly regain their soil identities. This rapid transformation is due to the fact that the “claystones” have a blocky, intensely-fissured structure (see Photo 1 - Test Pit - January 2012). A good example of the transformation is evident from the Phase IV test pits (See Photo 2 - Test Pit 1 January 2015 below). Other examples are the various dams constructed in the immediate area where only the Y-J colors remain, the rock-like materials have transformed back to soil.

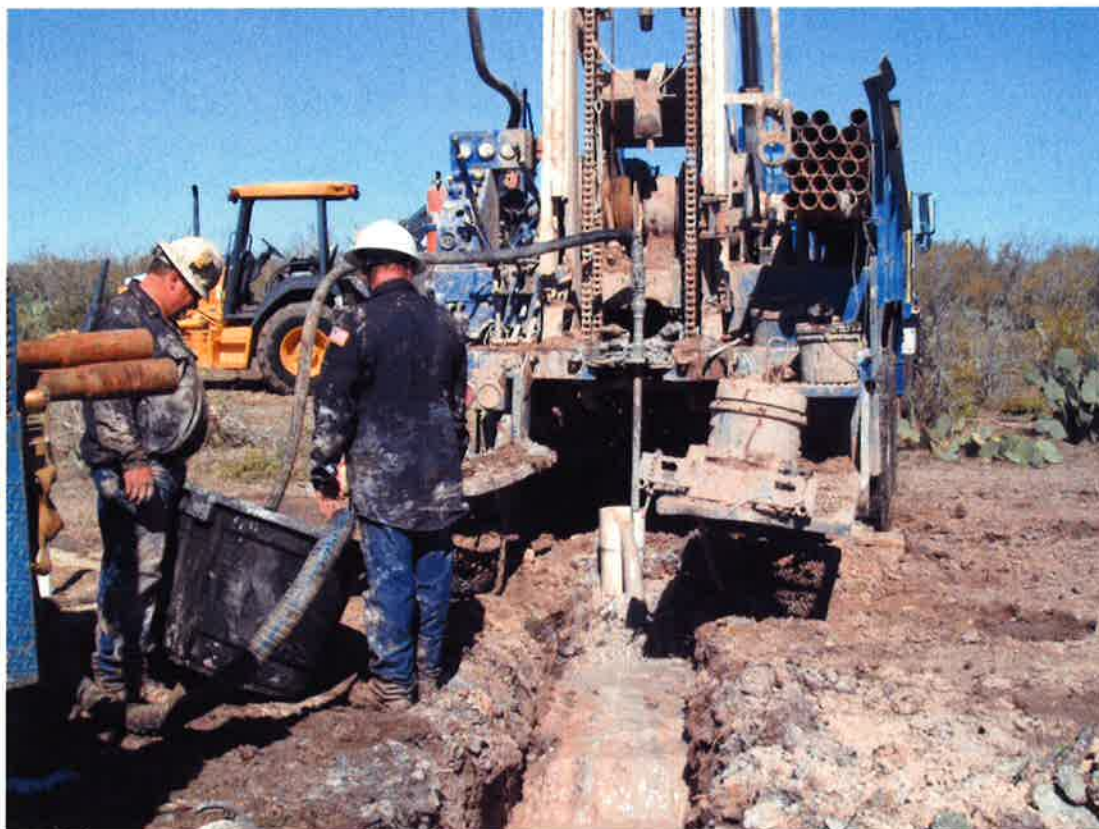
**Photo 3 - Grouting Boring B-52 – January 2015**

Sample drilling of the Y-J was conducted using a conventional Christensen 4-5/8 x 3-inch double tube core barrel employing a face-discharge ChrisDril bit and equipped with a split inner barrel. See photos 1 and 2 in Attachment C to this Appendix (III-E.5-C). Sample borings were cored continuously to the total depth with the recovered core being 3-inches in diameter. Both core recovery (as a percent) and Rock Quality Index or RQD (as a percent) are provided for each core run on the boring log. Recovered core was logged along with drilling observations, etc. Core samples were packaged and placed in waxed core boxes specifically manufactured for core storage. Visual reference samples were placed in glass jars. Boring B-58 was converted to a piezometer while borings B-55 and B-52 were pressure grouted from the bottom to top using a tremie and bentonite grout.

Two piezometers were set at the B-52 location – P-52S or shallow and P-52D or deep. Both piezometers were drilled with air rotary in separate holes for accurate subsurface water identification possibly unavailable from the original B-52 boring. Since the original B-52 was drilled using mud-rotary techniques, the process could have masked the identification of limited subsurface water and produced the results shown as moist on the log of borings. The "twin" holes were also used to avoid potential problems associated with plugging the original borehole back up to the desired screen interval.

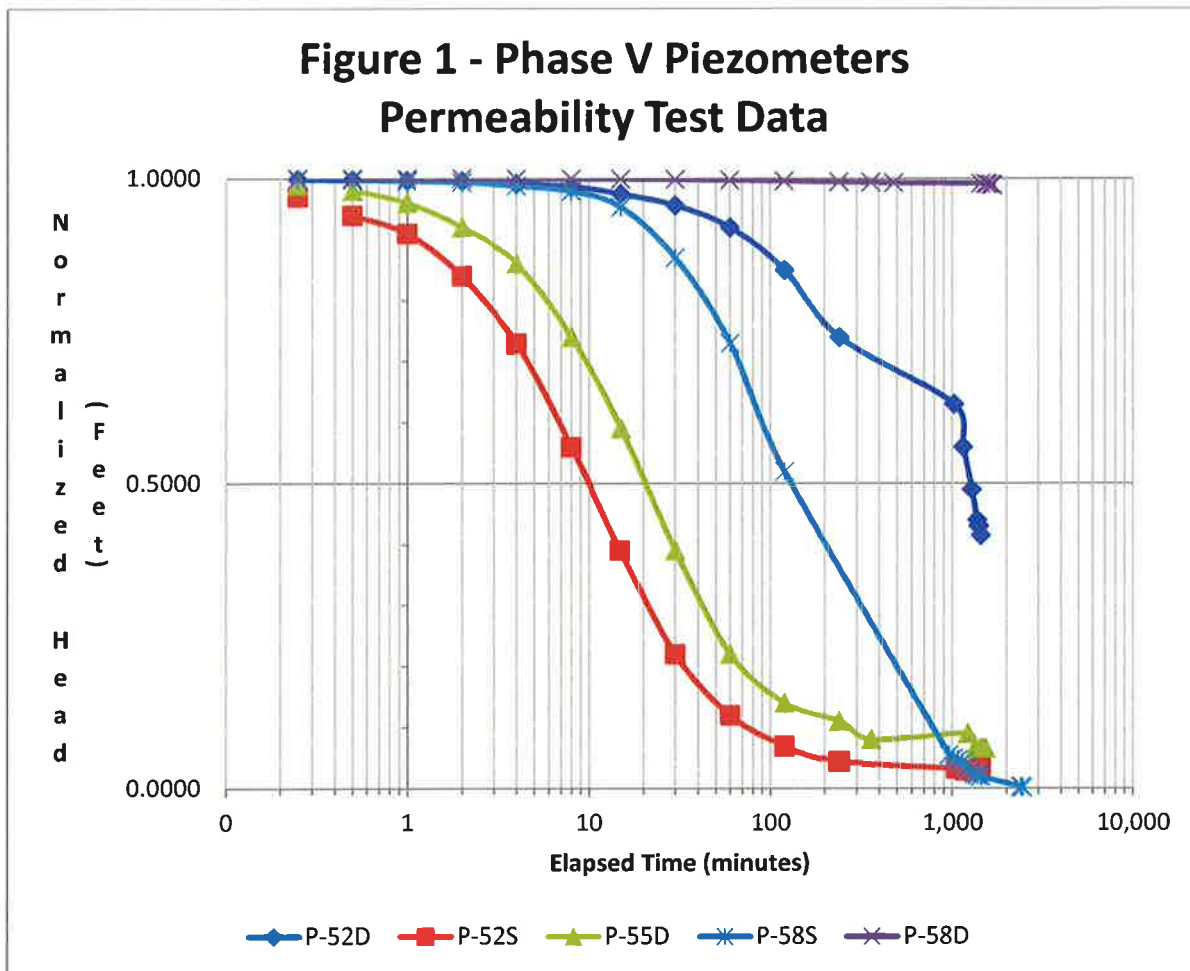
Piezometer recovery test data was obtained through February 14, 2015 for all five of the Phase V piezometers. Although recovery was not complete for all tests, the data for four piezometers was sufficiently complete for analysis. Semi-logarithmic plotting of the data indicated a classic or typical response with a good straight-line section in the middle of the signature. Points defining the ends of the straight lines on the graphs were picked from the tabular data. In addition, all data were tabulated and plotted in “normalized” form, i.e., the piezometer head reading at a given time was divided by the head reading at time zero. This procedure allows comparative

plotting of all piezometer tests to the same scale and is a useful tool to compare differences between geologic units, etc. See Figure 1.

Hvorslev’s Variable Head Method “F” (Hvorslev, 1951) was selected for the preliminary analysis. Method F may provide a more realistic estimate for a “sand” unit between “confining layers.” In addition, Method F provides a more conservative (higher) estimate of horizontal permeability than Method G. It should be noted that Method G is for a screen / filterpack in a uniform matrix without confining layers. Method G would also be potentially more applicable to the conditions at P-58S set in a shallow moist claystone interval. The Anisotropy ratio,  $m$ , was based on the typical assumption that horizontal permeability is at least 10 times the vertical permeability for bedded sedimentary materials. Note also that by assuming an anisotropy ratio

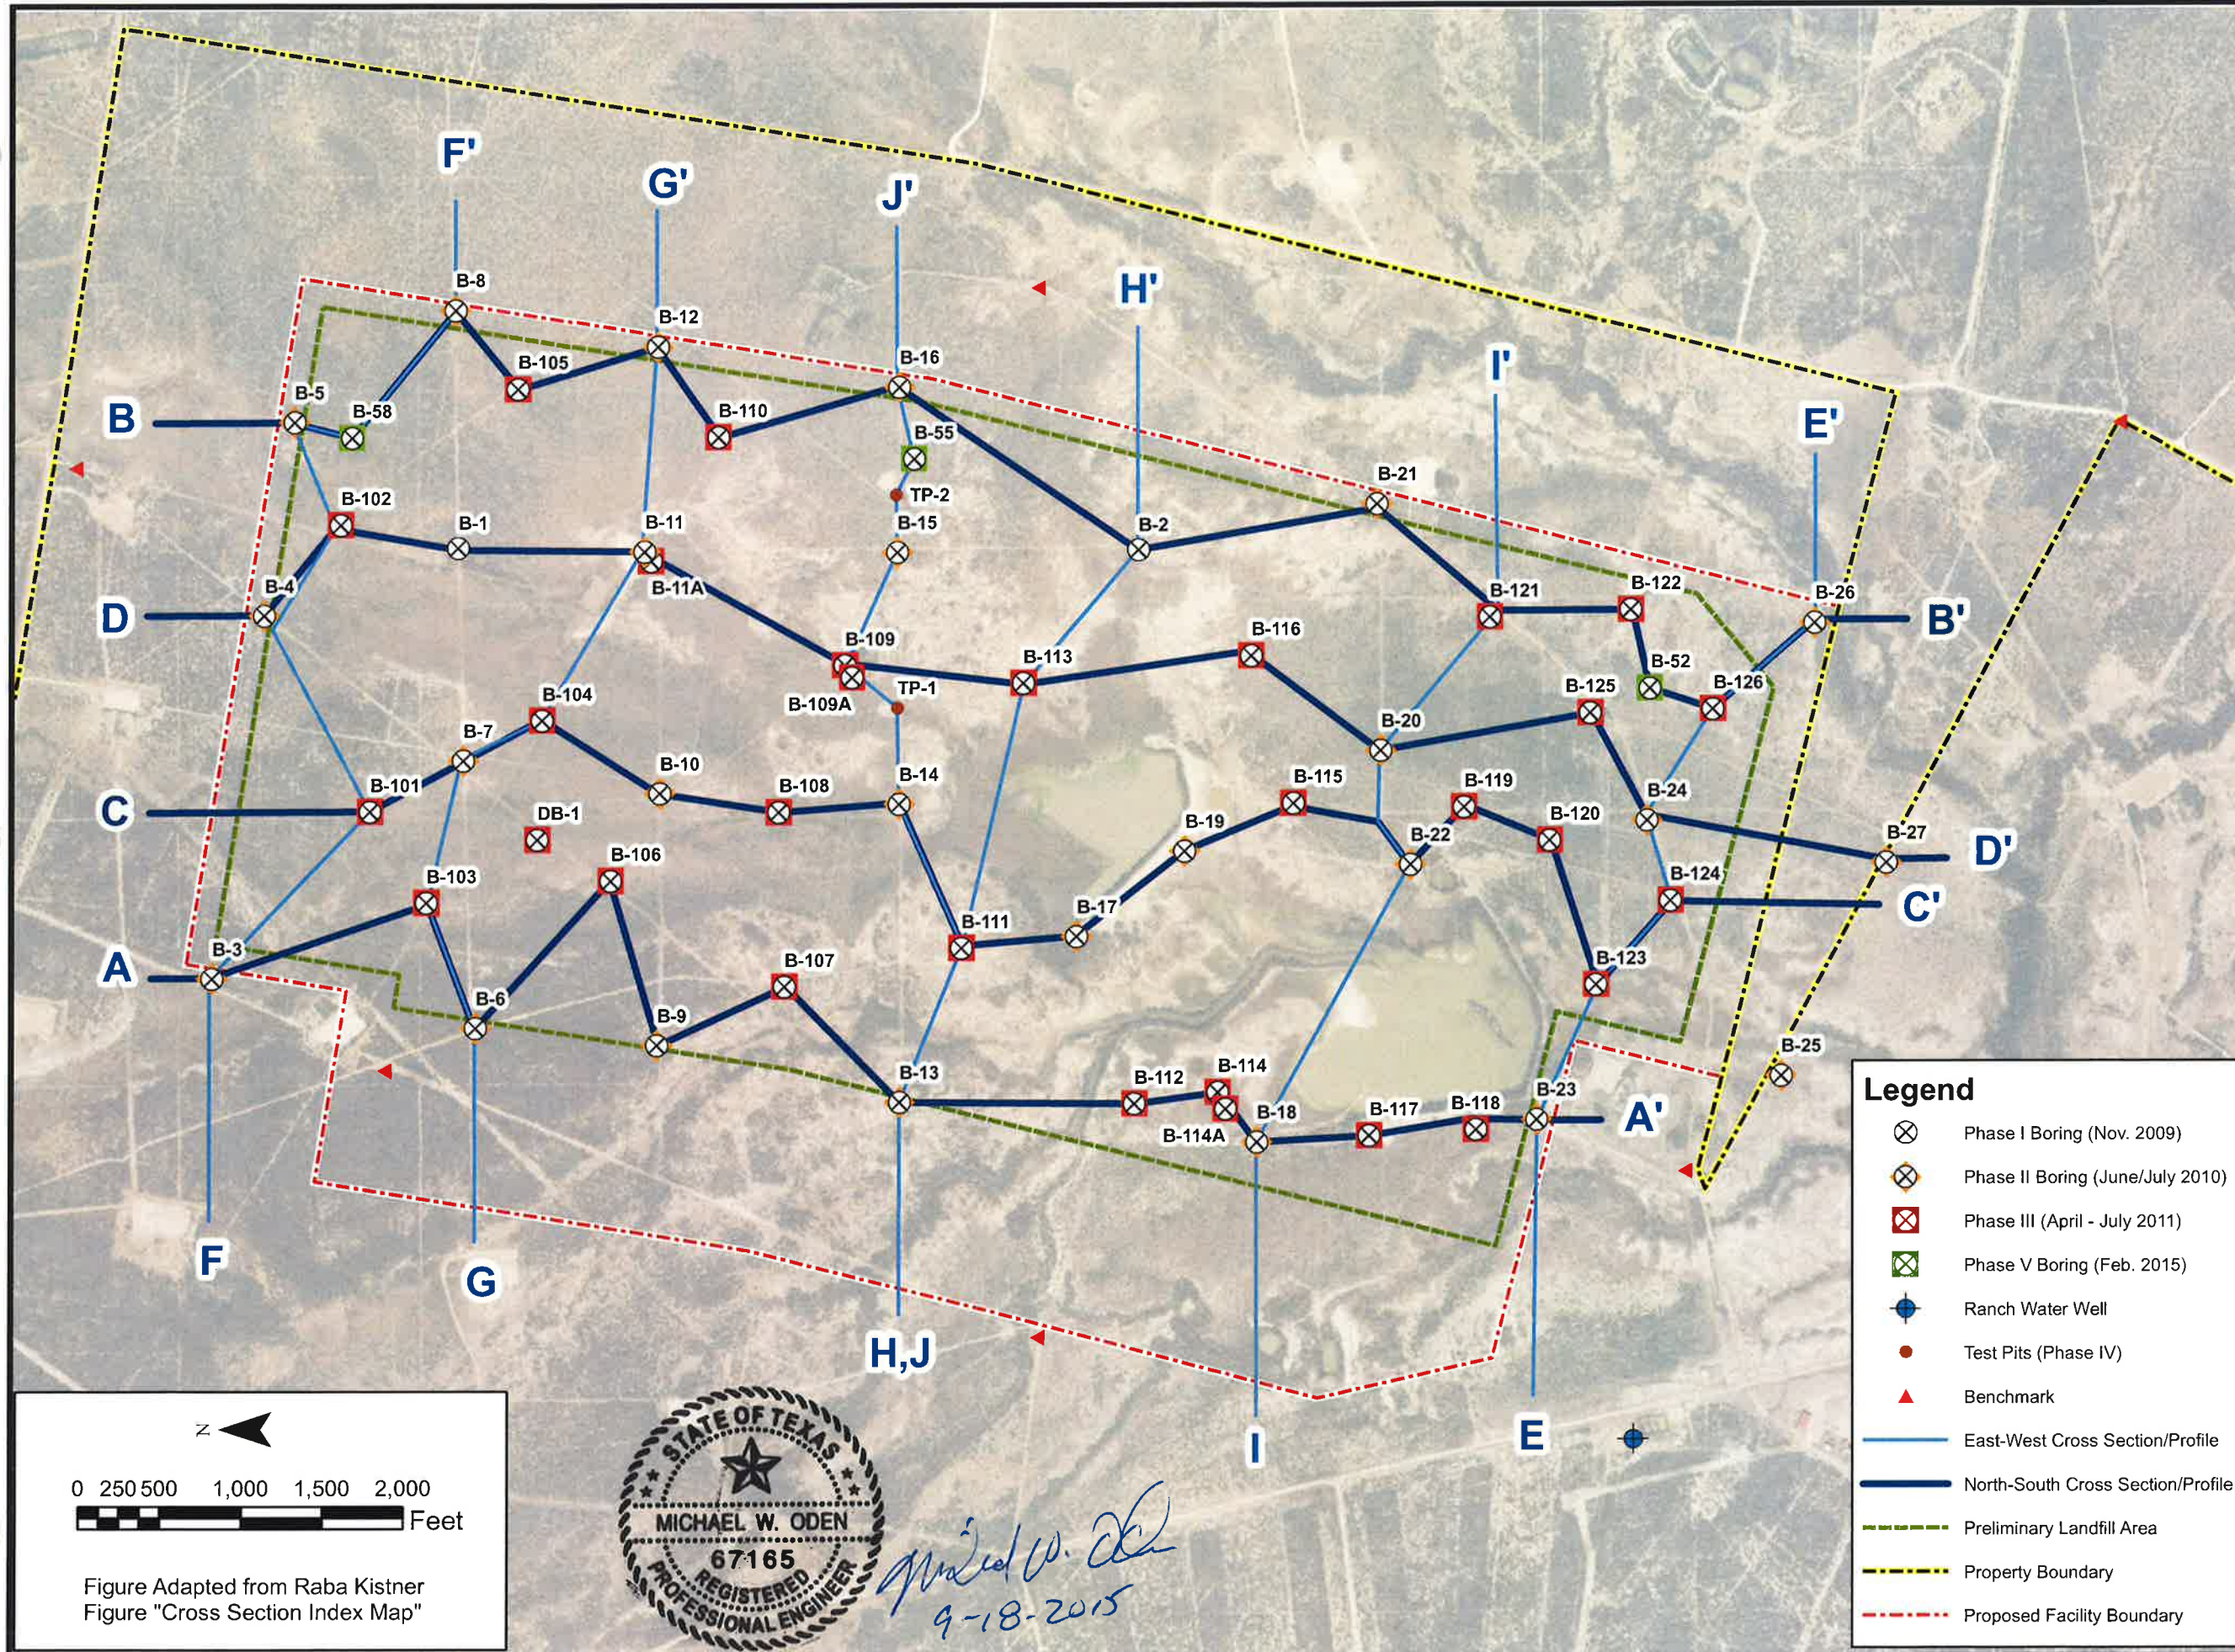
**FIGURE**  
**III-E.5-A.1**

### CROSS SECTION INDEX MAP

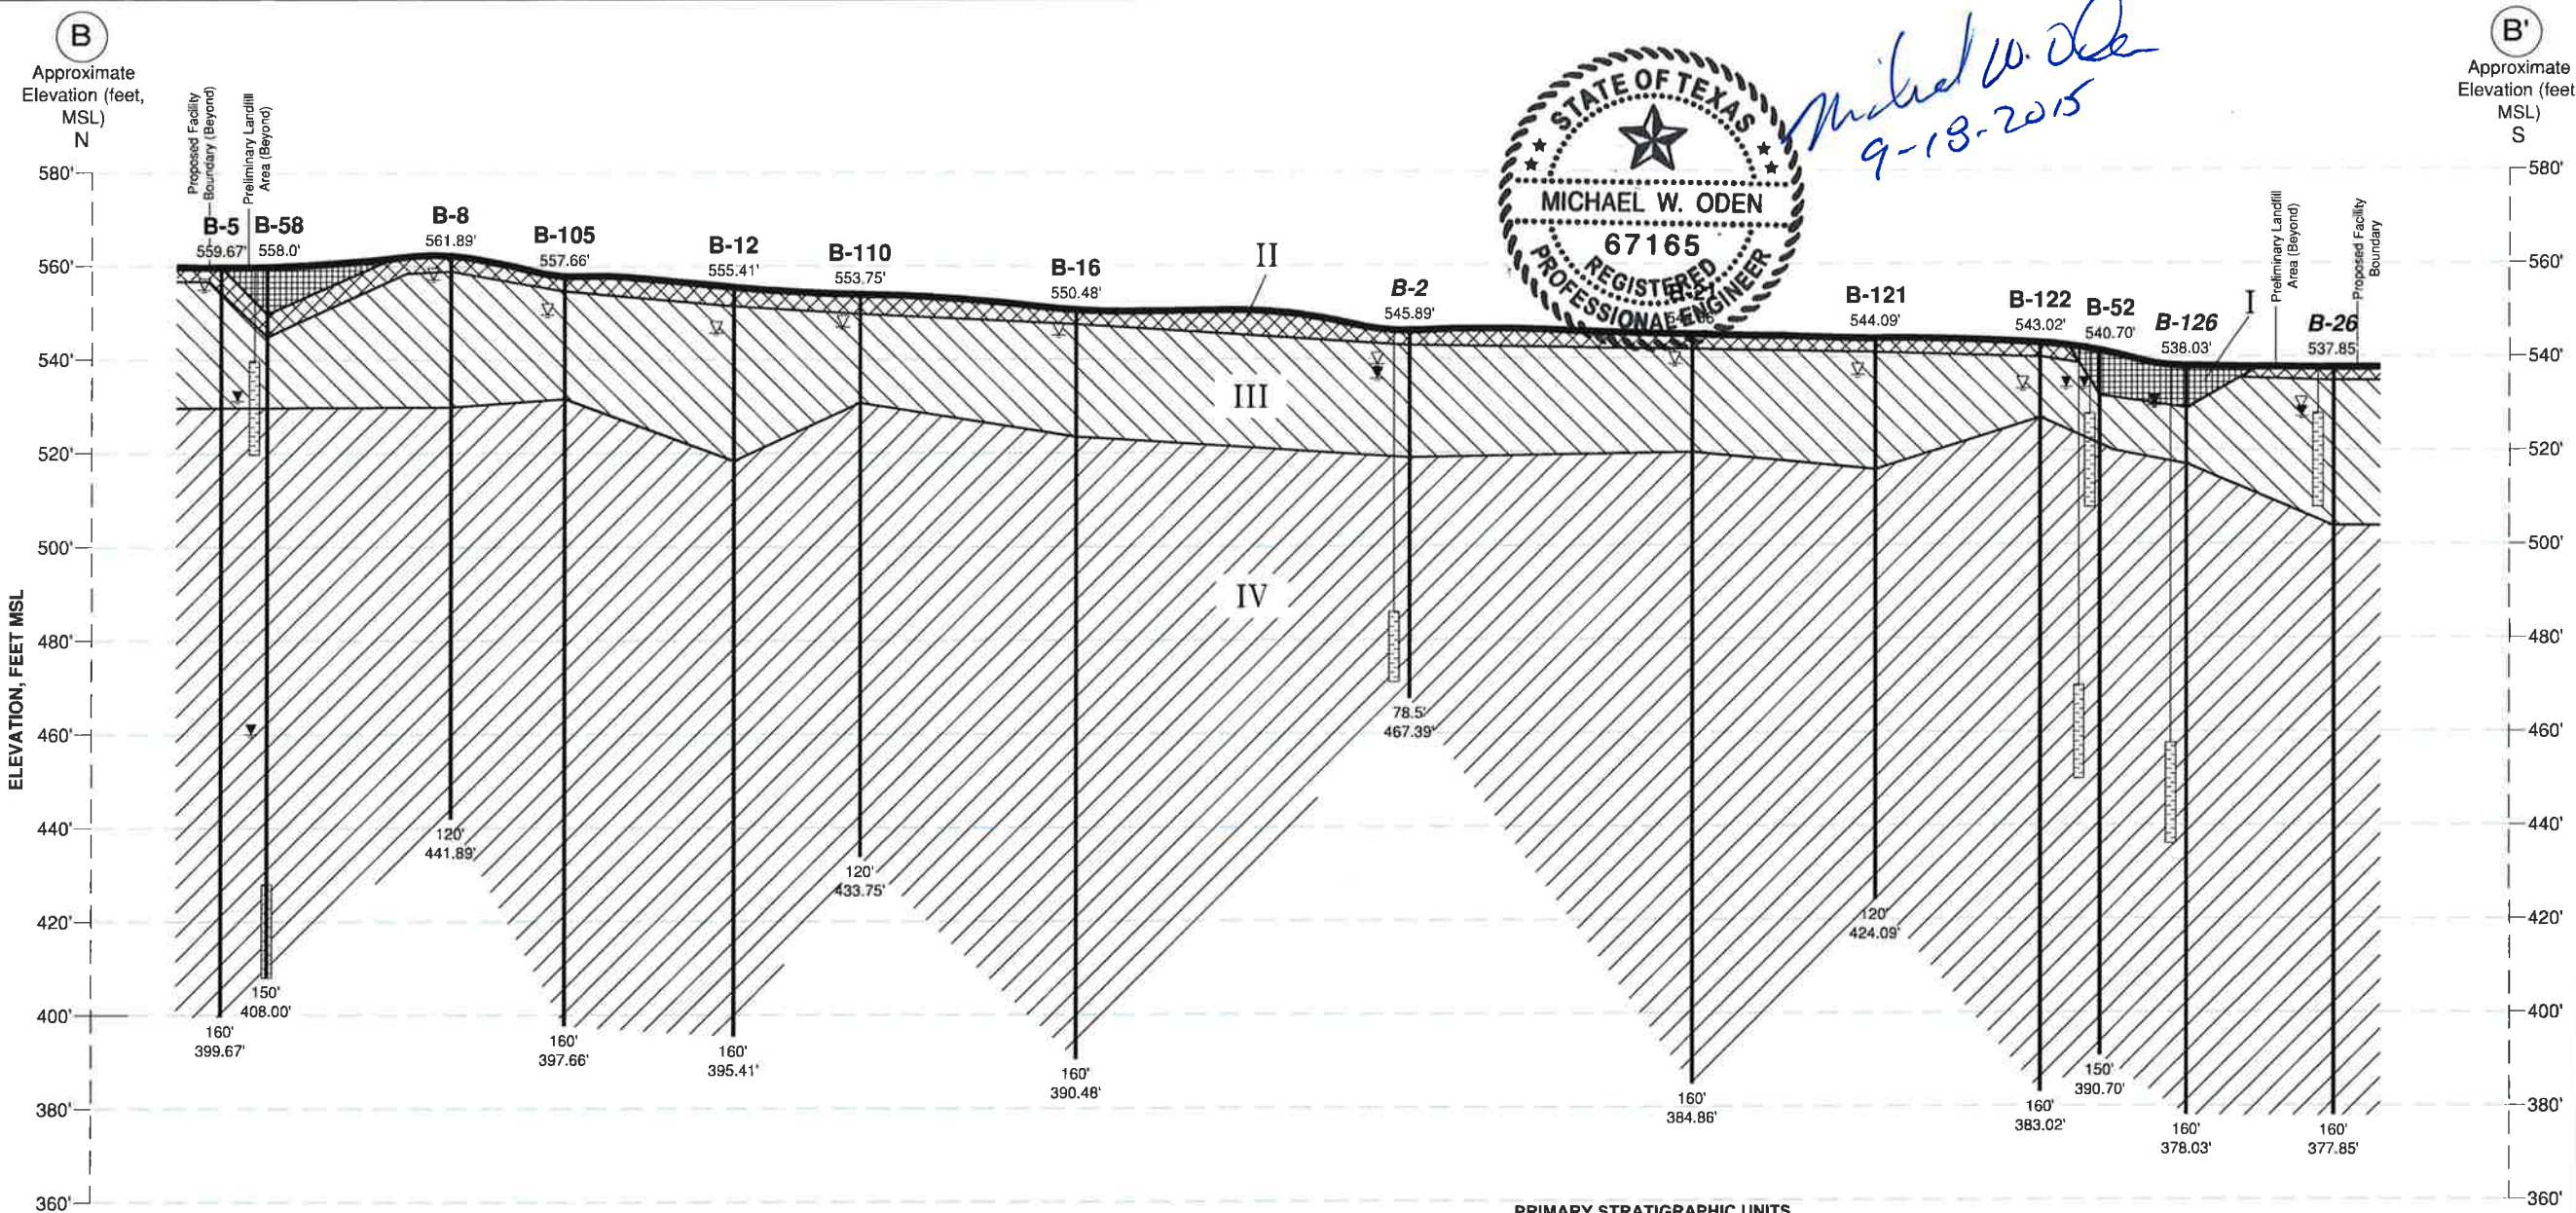
**INTERPRETIVE GEOLOGIC CROSS SECTION B-B'**  
PESCADITO ENVIRONMENTAL RESOURCE CENTER  
RANCHO VIEJO WASTE MANAGEMENT, LLC  
WEBB COUNTY, TEXAS - MSW PERMIT No. 2374

**PRIMARY STRATIGRAPHIC UNITS**

**STRATUM I - Recent-Pleistocene Soils:**  
This stratum consists of Recent-Pleistocene (R-P) deposits and generally corresponds to surface and near-surface soil strata logged within low-lying portions of the site underlain by Quaternary Alluvium (Qal) as designated on the published geologic maps of the area, in addition to upland areas having little to no topographic slope. This stratum consists of clays and sandy clays, with limited sand and occasional gravel and cobbles. The clays are stiff to firm, brown to light brown, and occur at ground surface (where present) to depths of approximately 18 feet bgs. At most boring/test pit locations the base of Stratum I may be identified by the presence of a thin gravel layer containing a wide variety of igneous and sedimentary rock types. Stratum I was not identified at all boring locations and is inferred to be absent in areas of the site having a slight to moderate topographic slope adjacent to upland areas. Seasonally, perched subsurface water may be encountered in this stratum. Based on observations during test pit excavation, an ephemeral fresh water lens appears to be present following rainfall events to depths on the order of 1 to 3 feet bgs, which controls the thickness of the plant root zone.

**STRATUM II - Highly Weathered Eocene Residuum:**  
This stratum corresponds to highly weathered surface and near-surface Eocene age soil strata logged throughout the majority of the site, both below the Qal, and in upland areas designated on the *Geologic Atlas of Texas Laredo Sheet (1976)* geologic map as the Yegua-Jackson Group formation (Y-J). This stratum is essentially a weathered-in-place (residual) soil horizon exhibiting similar structure and layering as underlying, less-weathered materials. This stratum consists of predominantly clay with minor sandy clay with ferruginous staining, calcareous nodules, and organic (plant root) materials. The clays are fissured, stiff to hard, overconsolidated, and brown to light reddish brown with some brownish gray to greenish gray layers. At some locations, gypsum (selenite) and ironstone concretions were encountered. This stratum occurs from ground surface (where exposed) or below Stratum I soils to depths of up to 10 feet bgs, with a maximum thickness of 10 feet. Transmissive secondary soil structure (i.e., fissures, fractures, joints, and horizontal bedding) is present, but pursuant to criteria established by Terzaghi and Peck in *Soil Mechanics in Engineering Practice (1967)*, materials are classified as relatively or practically impermeable based on measured laboratory permeability values. As a result of post-Eocene geologic processes, Stratum II is not uniformly developed or laterally continuous throughout the site; and therefore was not always identified discretely in boring logs. In many instances, Stratum II was not logged as a separate unit, but simply described as the uppermost weathered portion of Stratum III as described below. Seasonally, the perched shallow subsurface water associated with Stratum I may also be encountered in this stratum. Based on observations during test pit excavation, an ephemeral fresh water lens appears to be present following rainfall events to depths on the order of 1 to 3 feet bgs, which controls the thickness of the plant root zone. Below this depth, scattered ephemeral saline water lenses occur throughout the remaining vertical extent of weathered Stratum II and/or Stratum III soils.

**STRATUM III - Weathered Eocene Sediments:**  
This near-surface stratum underlies Stratum I and Stratum II throughout the site and is considered to represent Eocene sediments associated with the upper weathered (e.g., ferruginous stained) surface of the Yegua-Jackson Group formation (Y-J). This stratum consists of clay and sandy, silty clay with thinly to very thinly interbedded claystone, siltstone, and sandstone seams and lenses (i.e., bedding units typically 1 to 2 feet or less). The clays are fissured, hard, overconsolidated, light brown and brown to reddish brown with some olive to pale yellow layers, with scattered greenish gray to gray mottling and ferruginous staining, and have a blocky structure. Stratum III is encountered at depths ranging from approximately 2 to 39 feet bgs, and ranges from approximately 8 to 33 feet in total thickness. This stratum is generally differentiated from Stratum IV as defined below by its consistently weathered appearance along partings (i.e., ferruginous and carbonaceous staining), isolated presence of weathered zones containing groundwater, and the less frequent occurrence of interbedded sandstone, siltstone, or claystone layers. Transmissive secondary soil structure (i.e., fissures, fractures, joints, and horizontal bedding) is present, but pursuant to criteria established by Terzaghi and Peck (1967), materials are classified as relatively or practically impermeable based on measured laboratory permeability values.

**STRATUM IV - Relatively Unweathered Eocene Soils:**  
This stratum underlies Strata III throughout the site, was encountered to total exploration depth for the landfill project on the order of 160 to 500 feet (based on single deep boring, DB-1), and is considered to represent relatively unweathered Eocene soils of the Yegua-Jackson Group formation (Y-J). This stratum consists predominantly of clay and sandy, silty clay, with thinly to very thinly interbedded claystone, siltstone and sandstone seams and lenses (i.e., bedding units 1 to 2 feet or less). The clays are hard and fractured, overconsolidated, light green to green and greenish gray (with some dark gray to gray and brown to reddish brown layer with scattered greenish gray mottling) with some ferruginous staining, and have a blocky (intensely fissured) structure. Stratum IV is encountered throughout the site at depths ranging from approximately 16 feet to greater than 160 feet bgs, and has a thickness exceeding 144 feet. As indicated on boring logs, this stratum is complexly interbedded and does exhibit significant variation in the nature and occurrence of indurated materials, although very thinly interbedded claystone units are most frequently encountered throughout. Although relatively unweathered relative to Stratum III, zones of localized weathering indicated by ferruginous staining and weathered surfaces of clay partings are present likely in association with shallow groundwater movement. Transmissive secondary soil structure (i.e., fissures, fractures, joints, and horizontal bedding) is present, but pursuant to criteria established by Terzaghi and Peck (1967), materials are classified as relatively or practically impermeable based on measured laboratory permeability values.

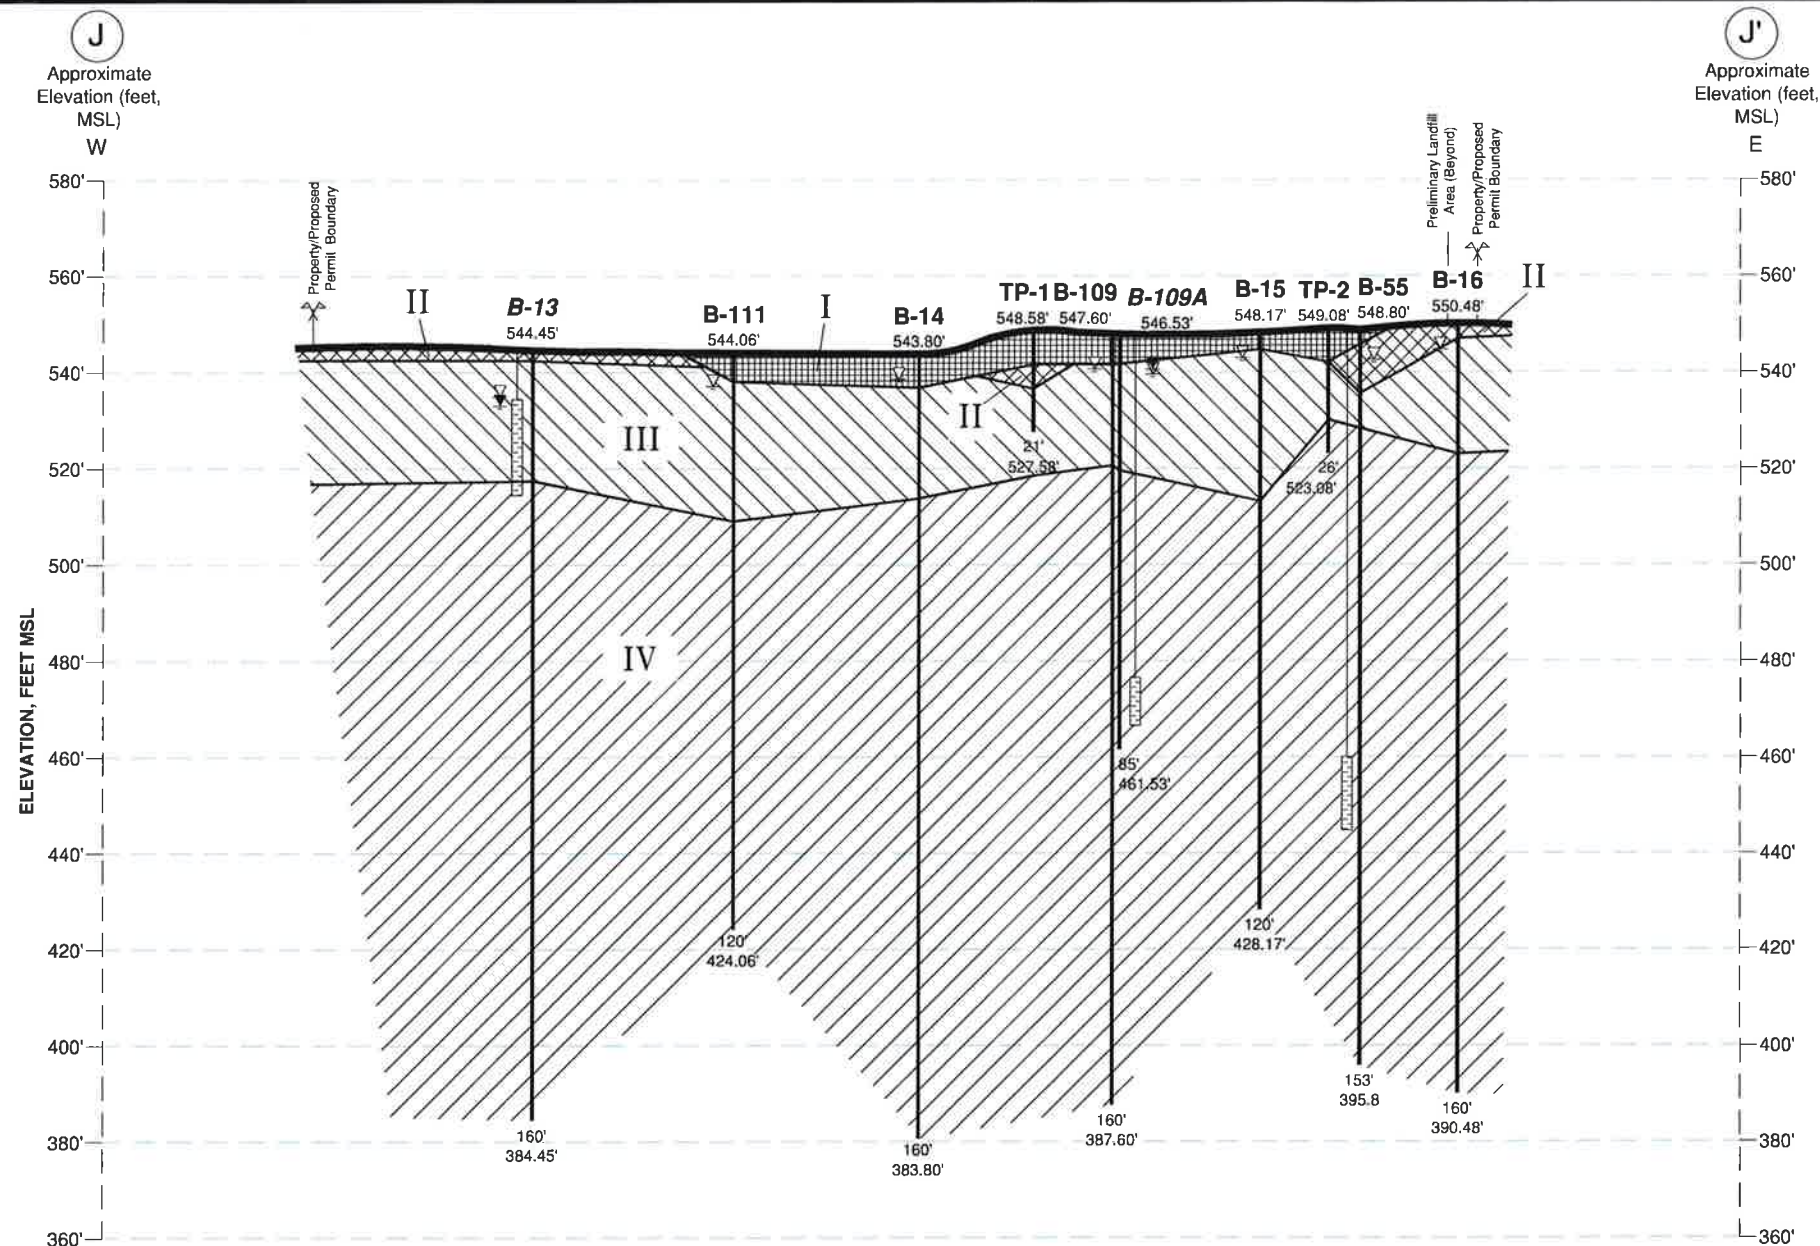
INTERPRETIVE GEOLOGIC CROSS SECTION J-J' PESCADITO ENVIRONMENTAL RESOURCE CENTER RANCHO VIEJO WASTE MANAGEMENT, LLC WEBB COUNTY, TEXAS - MSW PERMIT No. 2374

PRIMARY STRATIGRAPHIC UNITS

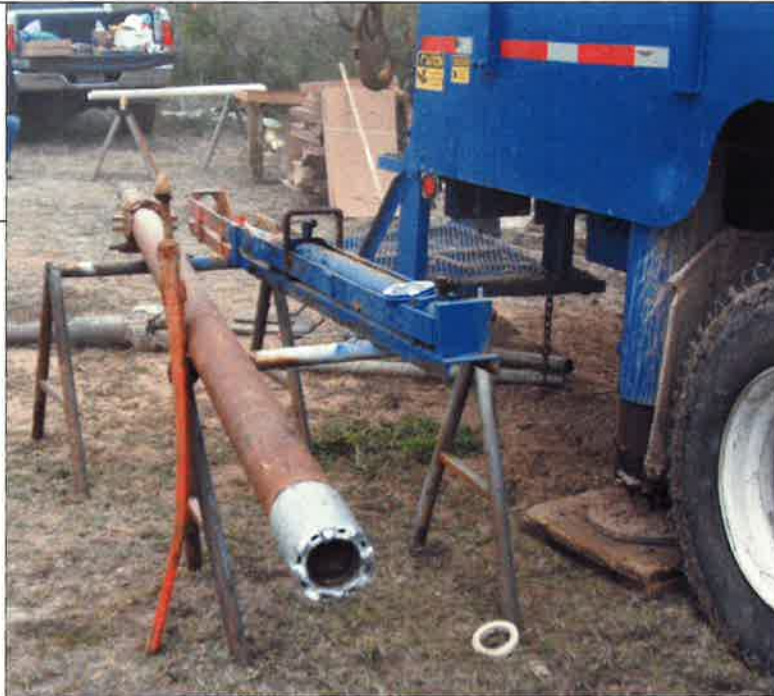
### Photograph No. 1

**Description:**  
Double Tube Core Barrel

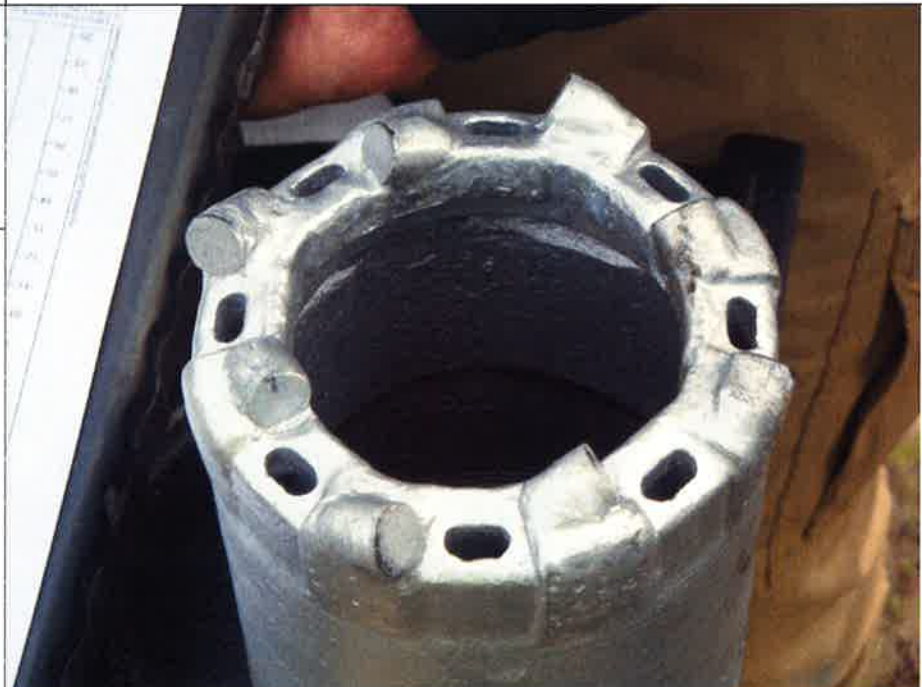
### Photograph No. 2

**Description:**  
Drill Bit

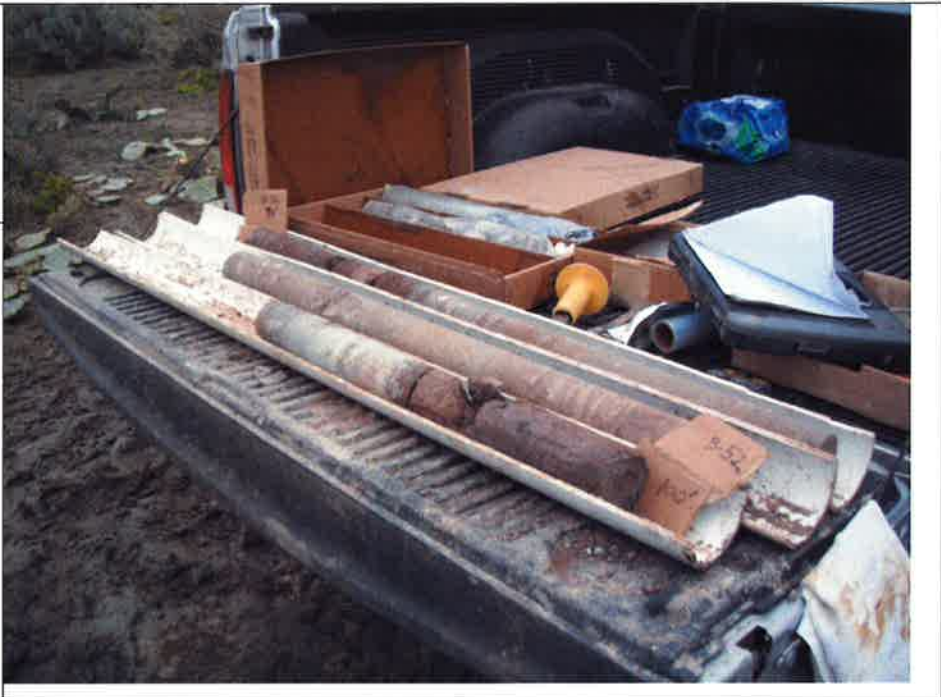
<p><b>Photograph No. 5</b></p>

<p><b>Description:</b> B-52  90' to 100'</p>	
<p><b>Photograph No. 6</b></p>

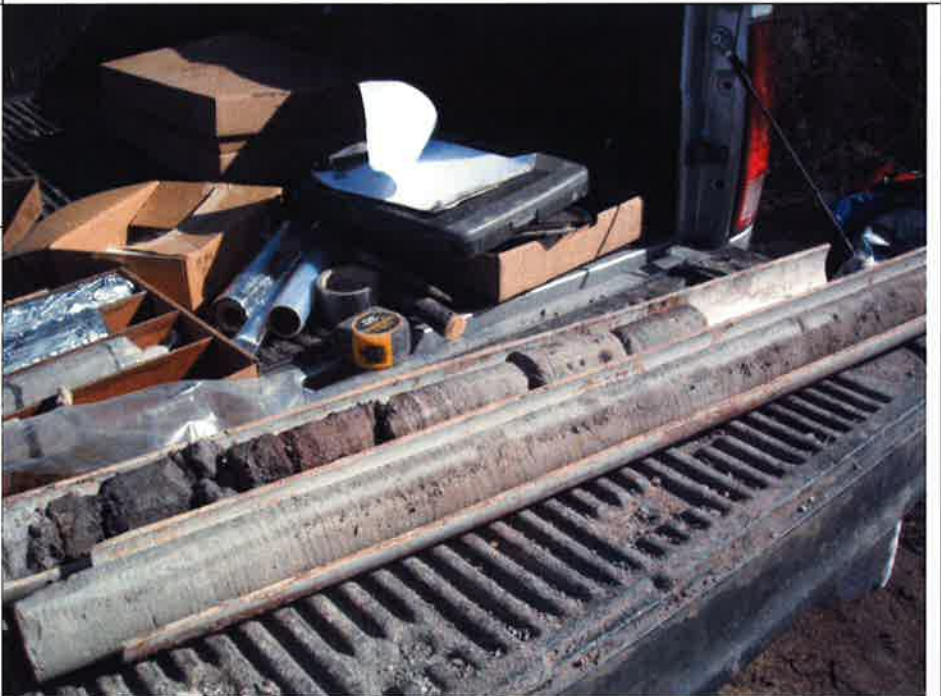
<p><b>Description:</b> B-52  141' to 150'</p>

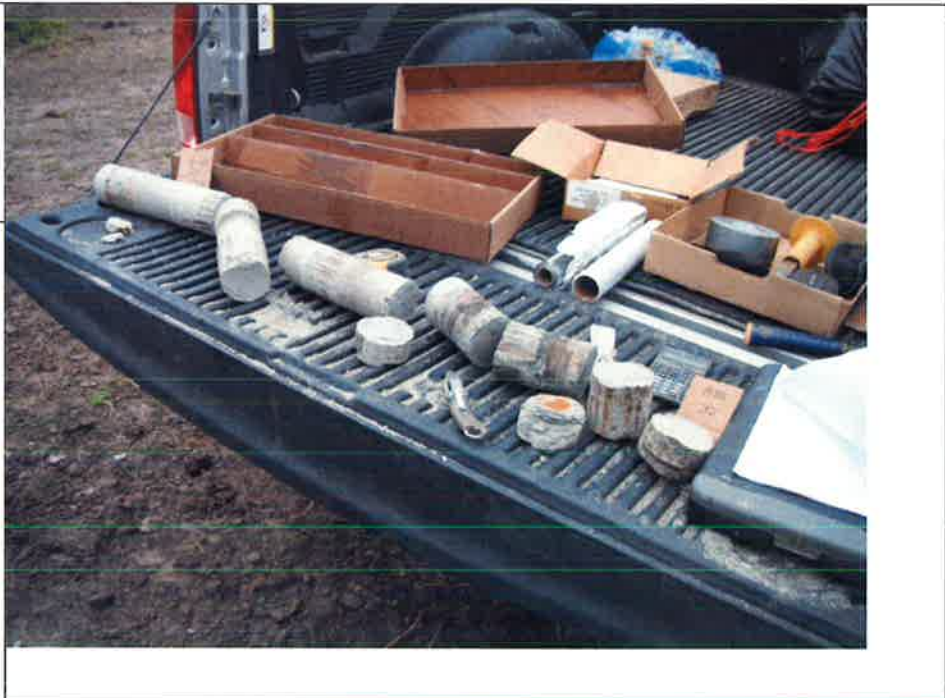
<p><b>Photograph No. 7</b></p>

<p><b>Description:</b> B-55  27' to 32'</p>	
<p><b>Photograph No. 8</b></p>

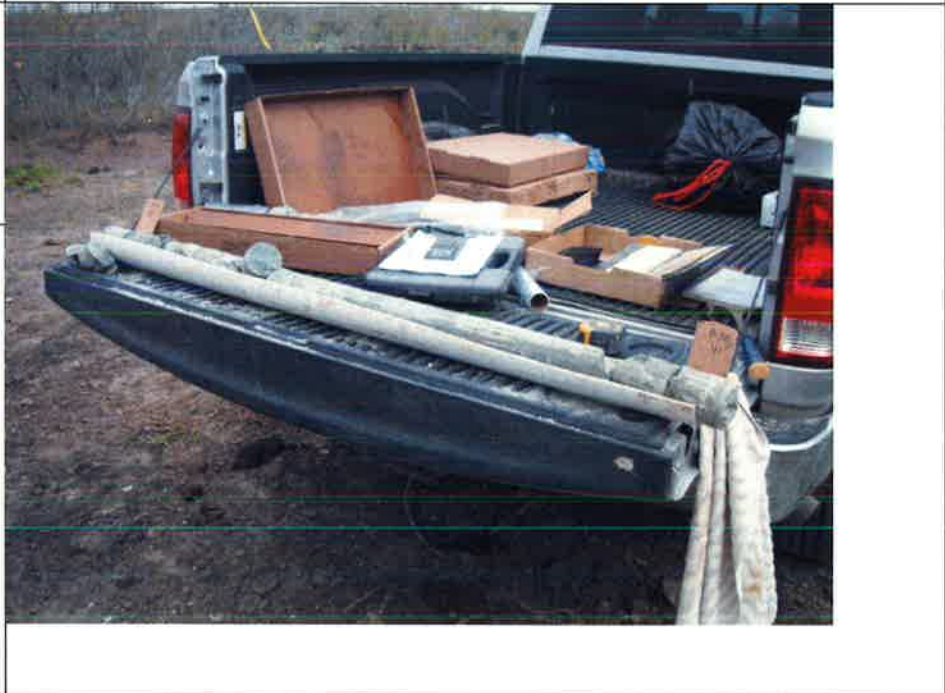
<p><b>Description:</b> B-55  36' to 41'</p>

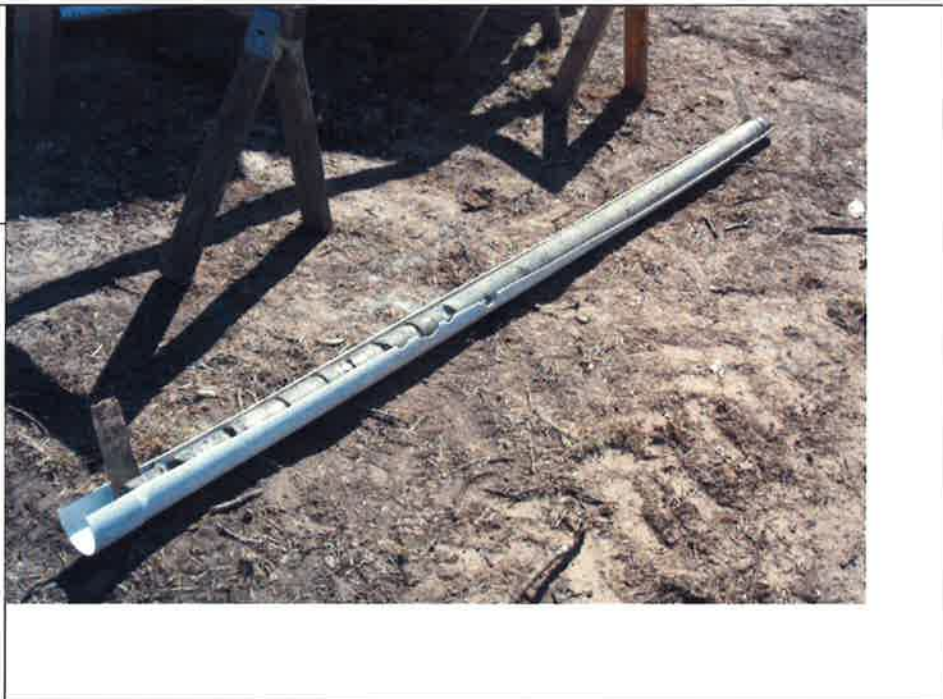
<p><b>Photograph No. 13</b></p>

<p><b>Description:</b> B-58  63' to 73'</p>	
<p><b>Photograph No. 14</b></p>

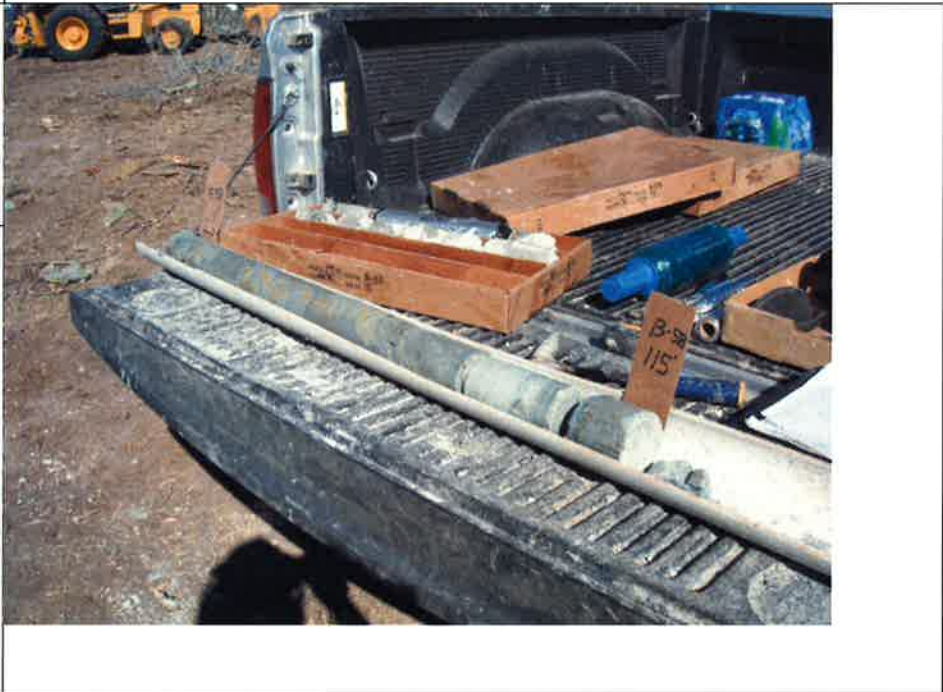
<p><b>Description:</b> B-58  111' to 115'</p>

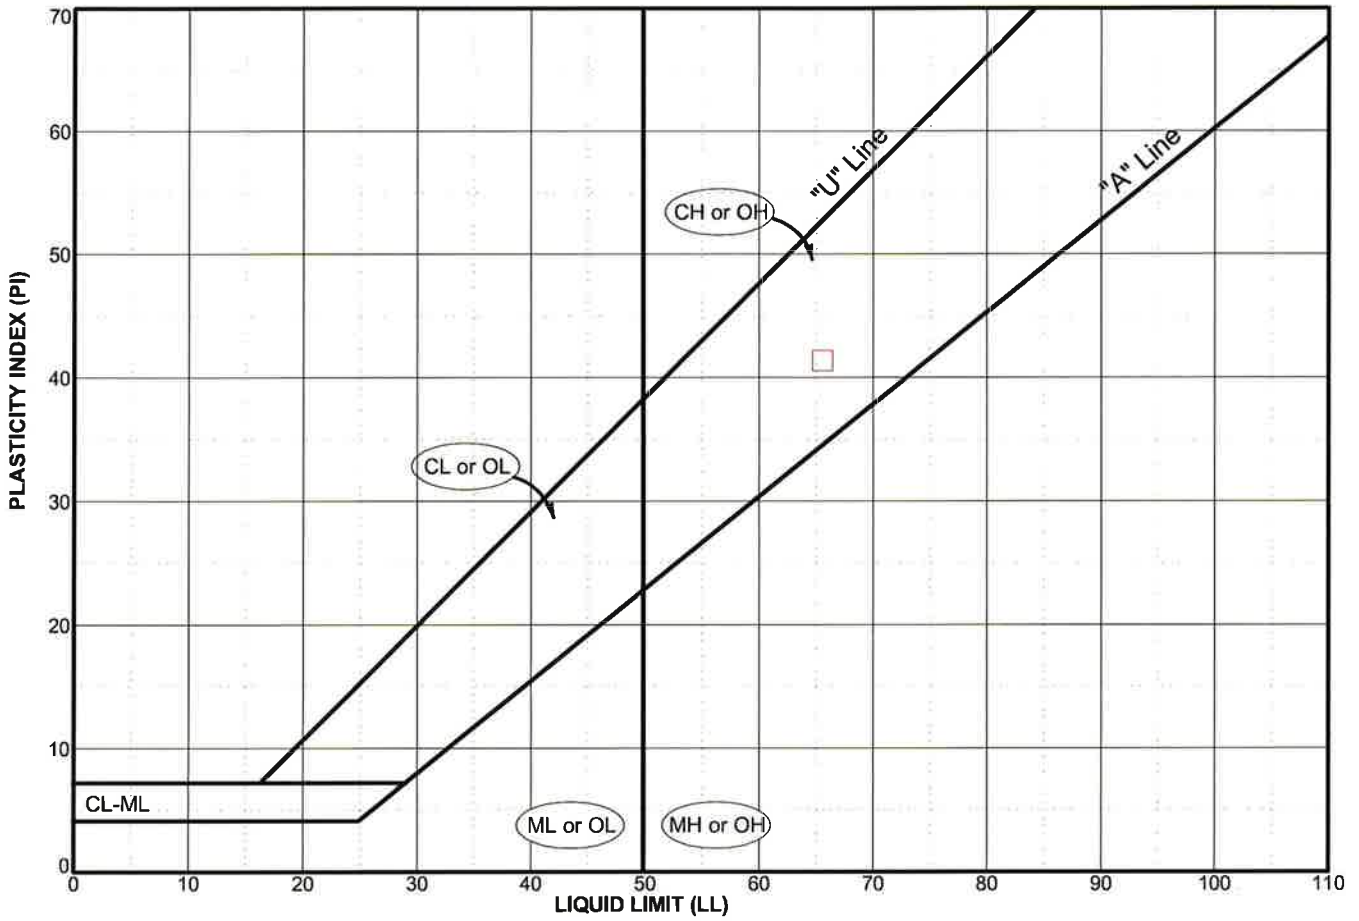
PLASTICITY CHART - FUGRO DATA TEMPLATE 100610.GDT FUGRO LIBRARY 052413.GLB I:\PROJECT FILES\PROJECTS\3-1038 PESCADITO ENVIRONMENTAL RESOURCE CENTER\MISC\04.4015-1038.GPJ vargasrn 6/27/15

Specimen Identification	LL	PL	PI	Fines	Classification
<input type="checkbox"/> B-55	79.0	66	24	42

- Atterberg Limits (ASTM D4318) – Thirty-two tests were conducted. With the exception of one non-plastic result, the remaining thirty one tests showed a consistent relationship when plotted on a Plasticity Chart commonly used as part of soil classification. The plotted data was consistent with previous Phases I-IV results. It is noted that all of the data plots well above the “A-Line” and only eight results had Liquid limits less than 50, i.e., the majority of the tested materials were highly plastic.
